AGL ENERGY LIMITED

**DILAPIDATION CLOSE OUT REPORT
ON CONDITION OF PUBLIC ROADS
OLD MAITLAND ROAD, OLD PUNT ROAD
AND PACIFIC HIGHWAY AFTER
COMPLETION OF HP PIPELINE
CONSTRUCTION FOR THE
HEXHAM TO NEWCASTLE NGSF**

**Job No.: 1661/15
Report No.: 11/15**

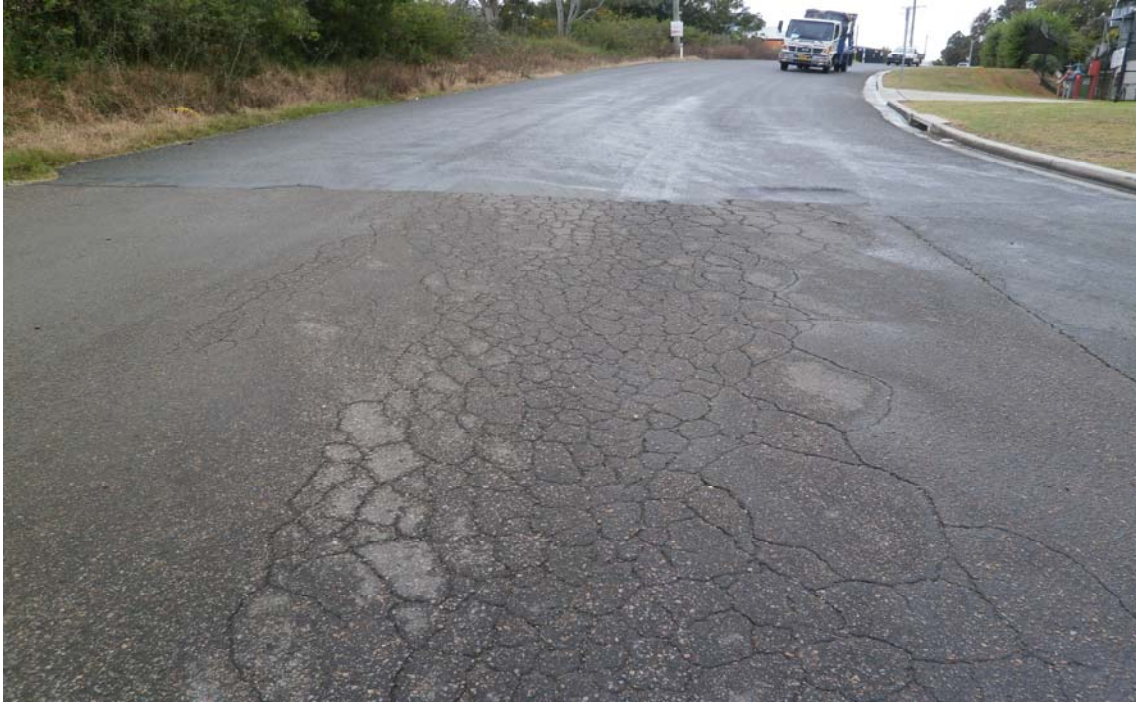
PHOTO P3

There is a small area of pavement failure evident by 'crocodile cracking' shown in **photograph P3**. An adjoining area in Laverick Avenue where there was no pipeline construction traffic has similar pavement distress, as shown in **photograph P4**.

**VIEW NORTH OF CRACKED PAVEMENT IN OLD PUNT ROAD AT
LAVERICK AVE.**

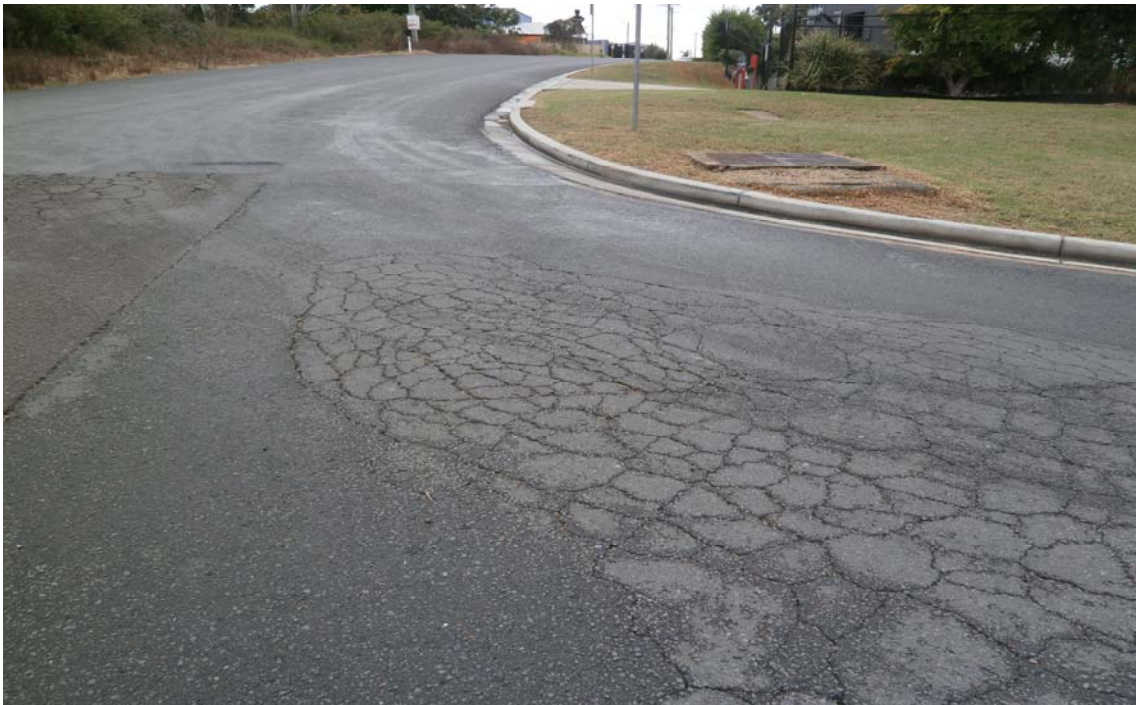
PHOTO P4

VIEW OF CRACKED PAVEMENT IN LAVERICK AVE.

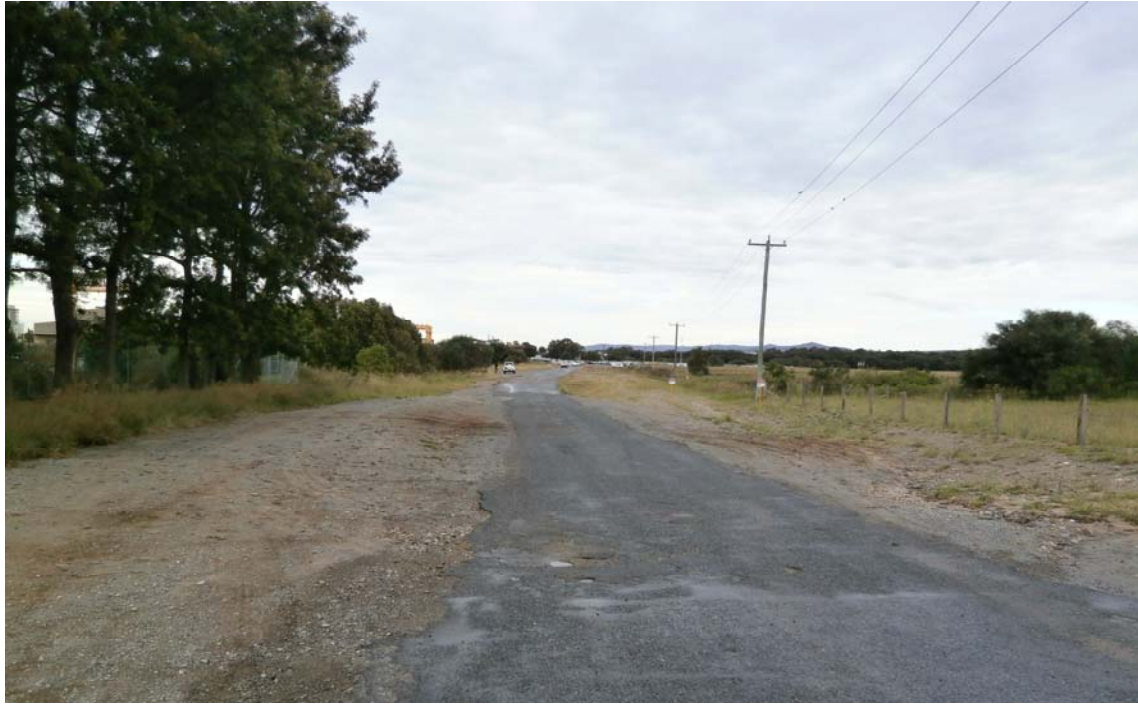
PHOTO P5 VIEW SOUTH OF PRIVATE ROAD TO FORGACS. PAVEMENT POOR CONDITION FOR 50 METRES. UNCHANGED SINCE 11-12-13.

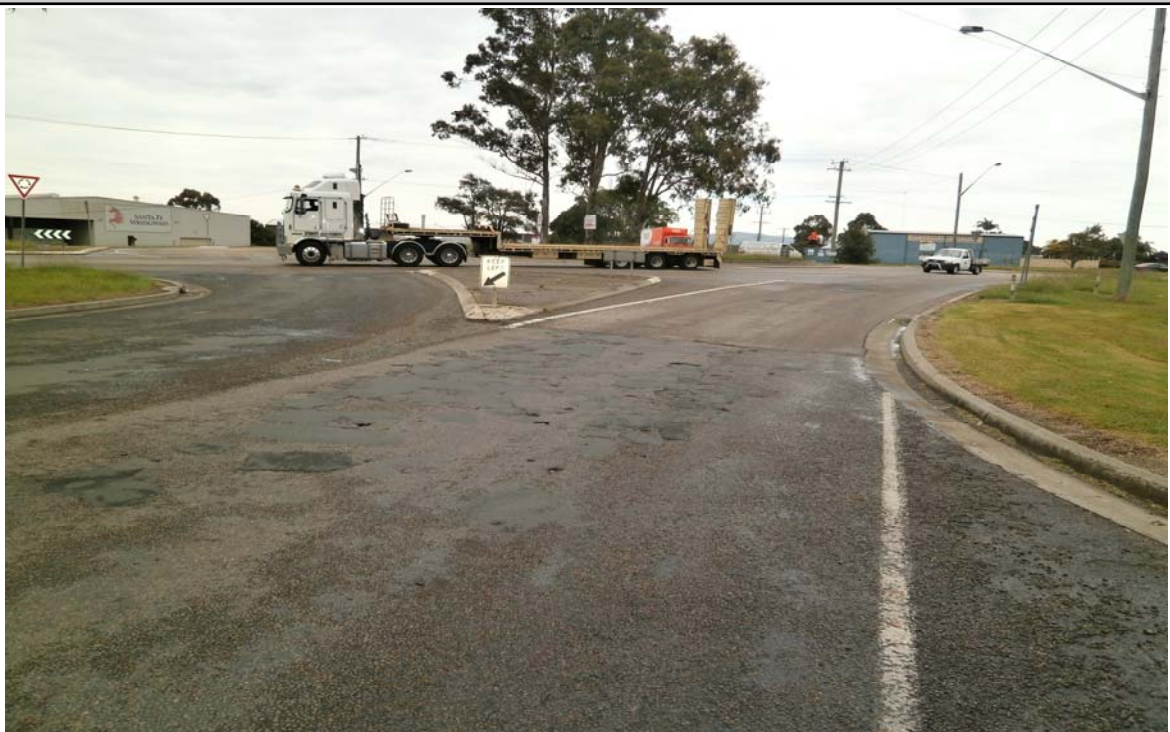
There is some surface distress in the form of stripping, delamination and ravelling visible on these areas due to the passage of heavy vehicles over a long period in **photos P6** and **P7**. Surface patching has been carried out as part of the maintenance programme. Chainage **3635** (Sheet **7/19**) is at the northern end of the splitter island.

PHOTO P6 OLD PUNT ROAD NORTH OF ROUNDABOUT. PAVEMENT POOR CONDITION ON NORTHERN DEPARTURE.

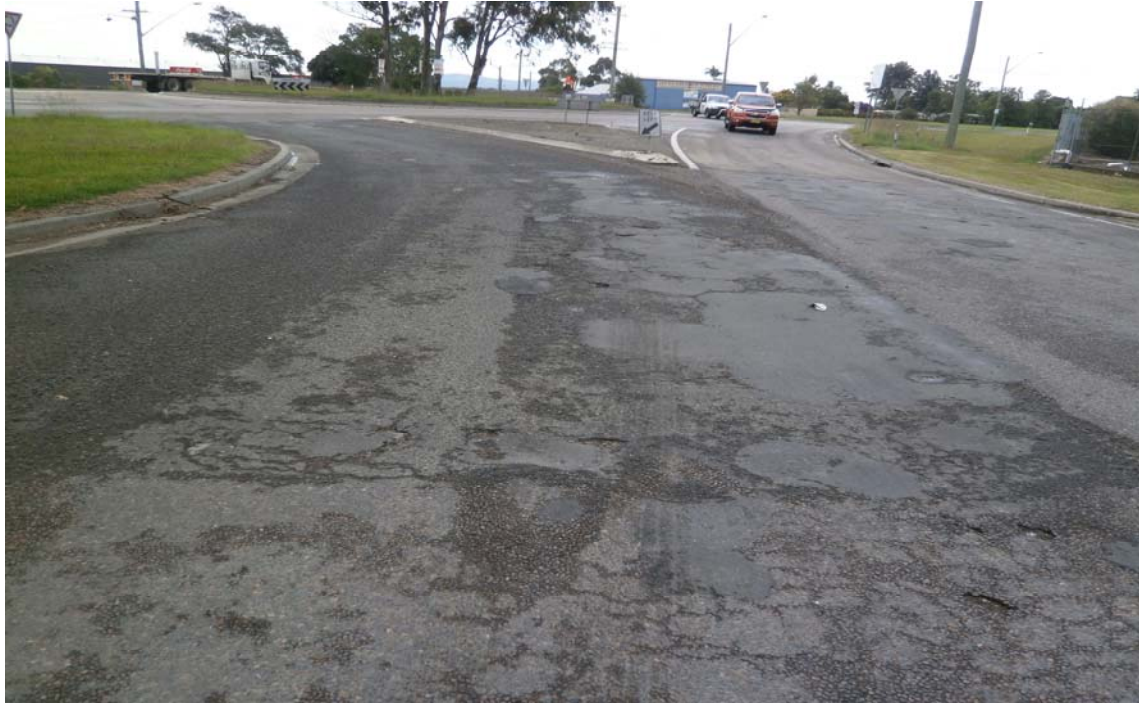
**PHOTO P7 PAVEMENT POOR CONDITION NORTHERN APPROACH TO ROUNDABOUT IN
OLD PUNT ROAD. Ch3602 to Ch3635**

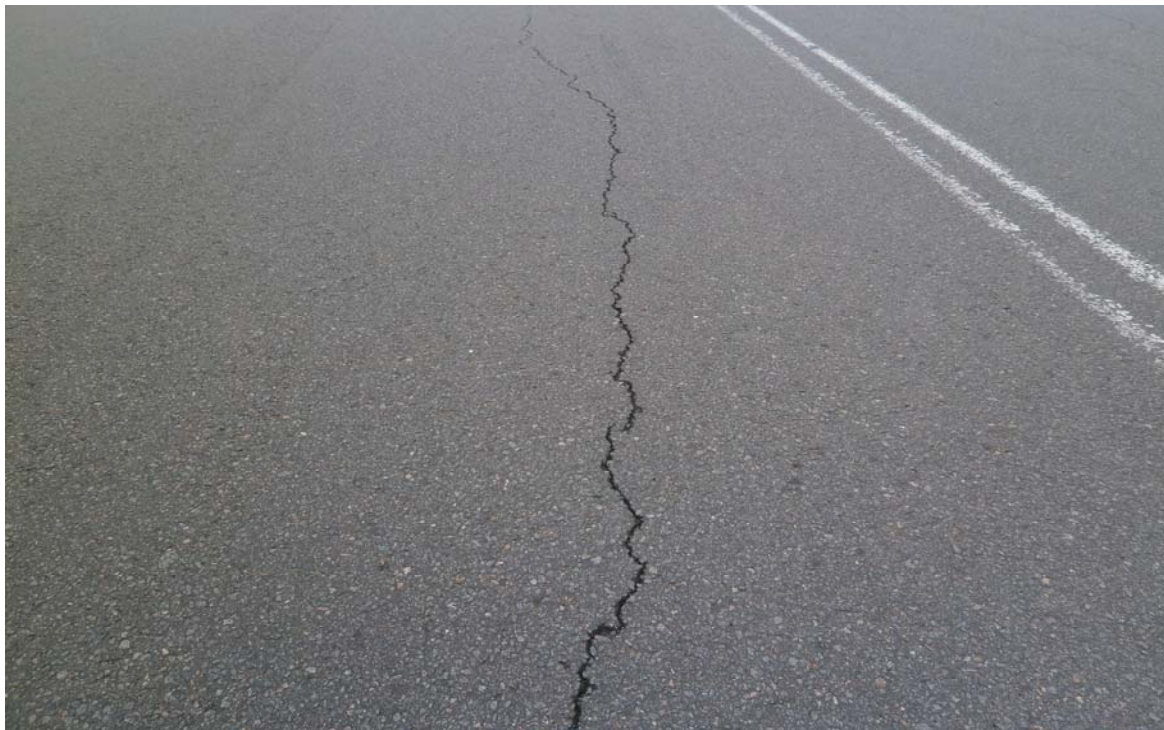
The pavement is in reasonable condition except for a short length of **10 to 15 metres** at **Ch 2850 Photo P9** where crocodile cracking indicates pavement failure. Some minor transverse and longitudinal shrinkage cracks in asphalt surfacing. **Photo P8** at **Ch 3275** is the longest crack.

**PHOTO P8 TYPICAL LONGITUDINAL CRACK IN ASPHALT NEAR EXIT DRIVEWAY FROM
KOMATSU. THESE CRACKS WERE EVIDENT IN DECEMBER 2014. Ch 3275**

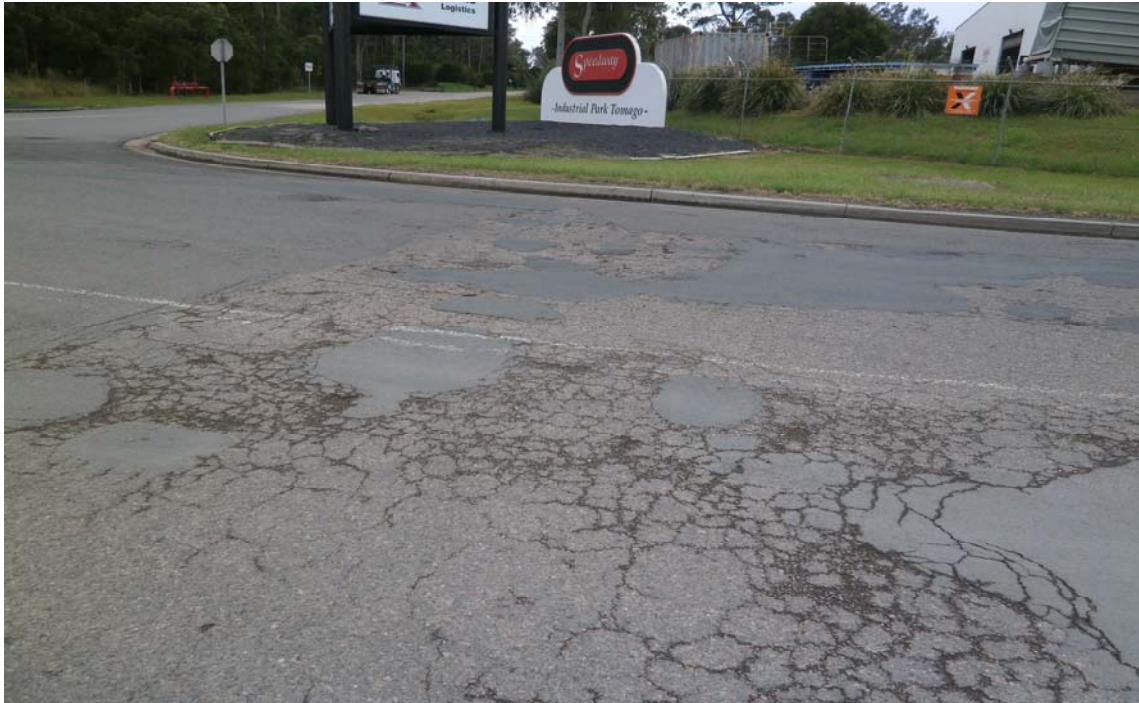
PHOTO P9 CROCODILE CRACKING IN PAVEMENT IN OLD PUNT ROAD CH 130.0 SOUTH OF SPEEDWAY ROAD TO INDUSTRIAL PARK. Ch 2850 (Sheet 9/19)

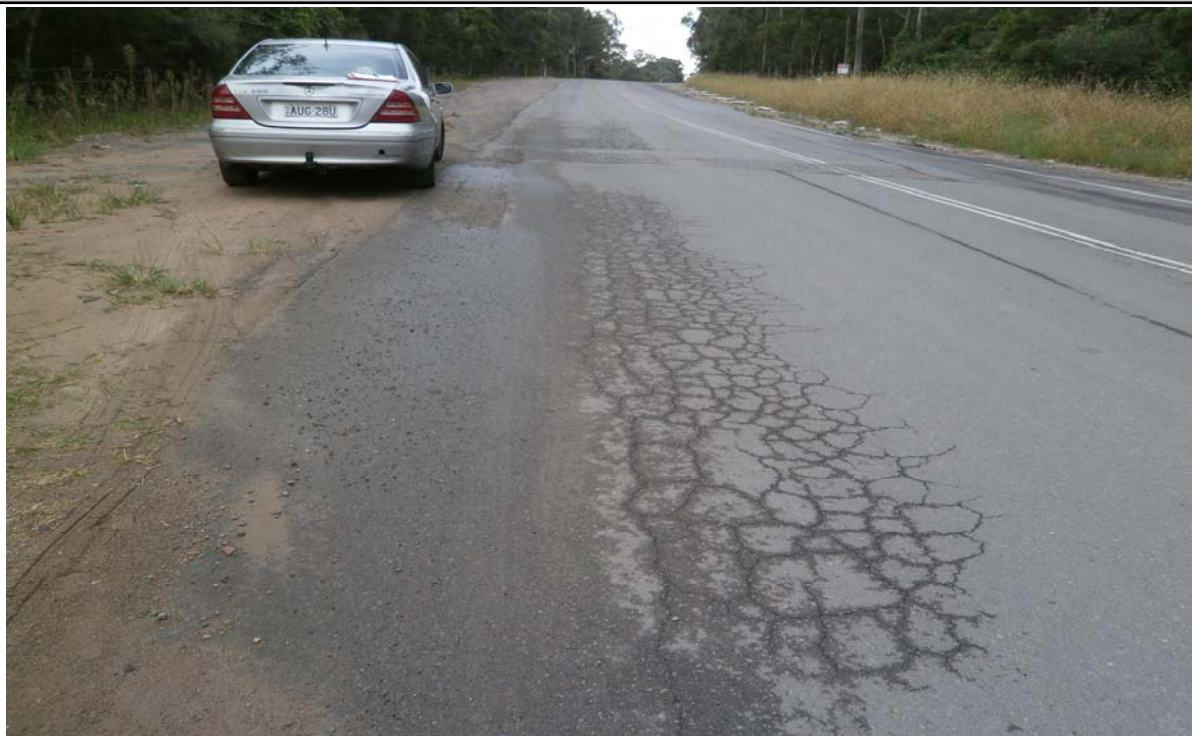
Pavement failure in northbound lane over about **11 metres** at **Ch 2610 Photo P10**. The pavement failure was evident in 2013.

PHOTO P10 CROCODILE CRACKING IN OLD PUNT ROAD CH 2610 (Sheet 10/19) NORTH OF KENNINGTON DRIVE AT END OF KERB AND GUTTER.

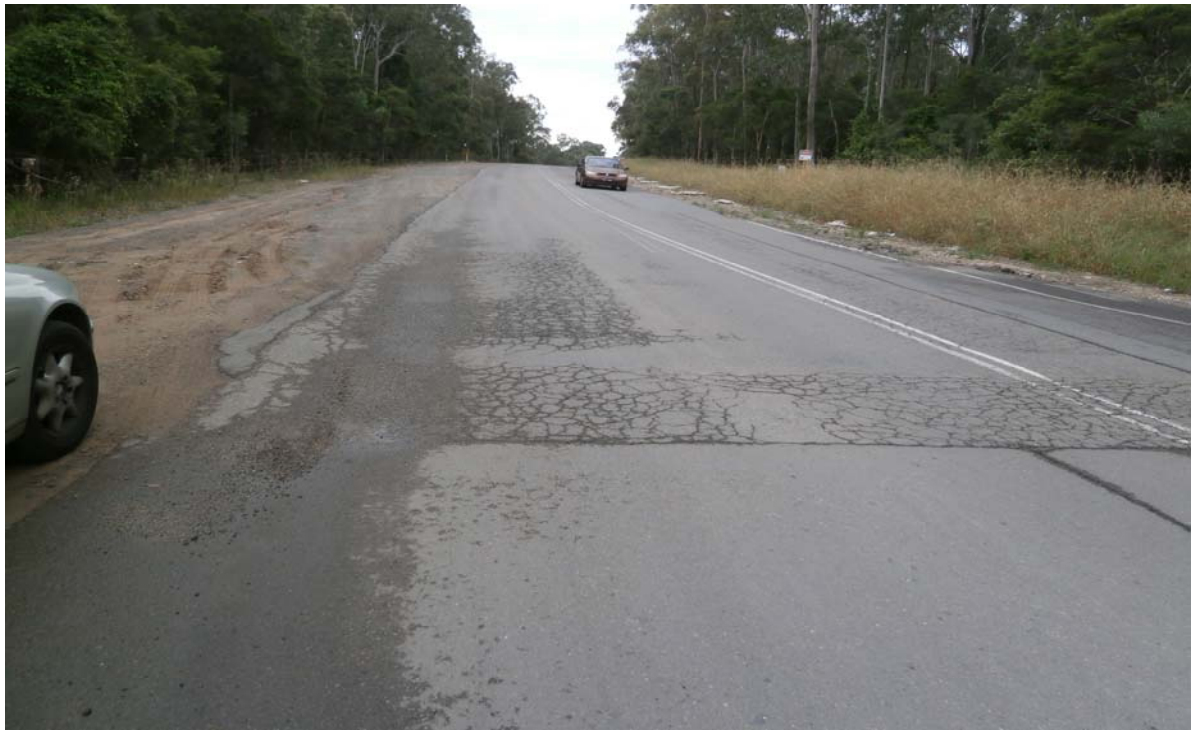
PHOTO P11 TYPICAL CROCODILE CRACKING 2.5 METRES FROM EDGE OF BITUMEN IN OLD PUNT ROAD NORTH FROM CH 2599

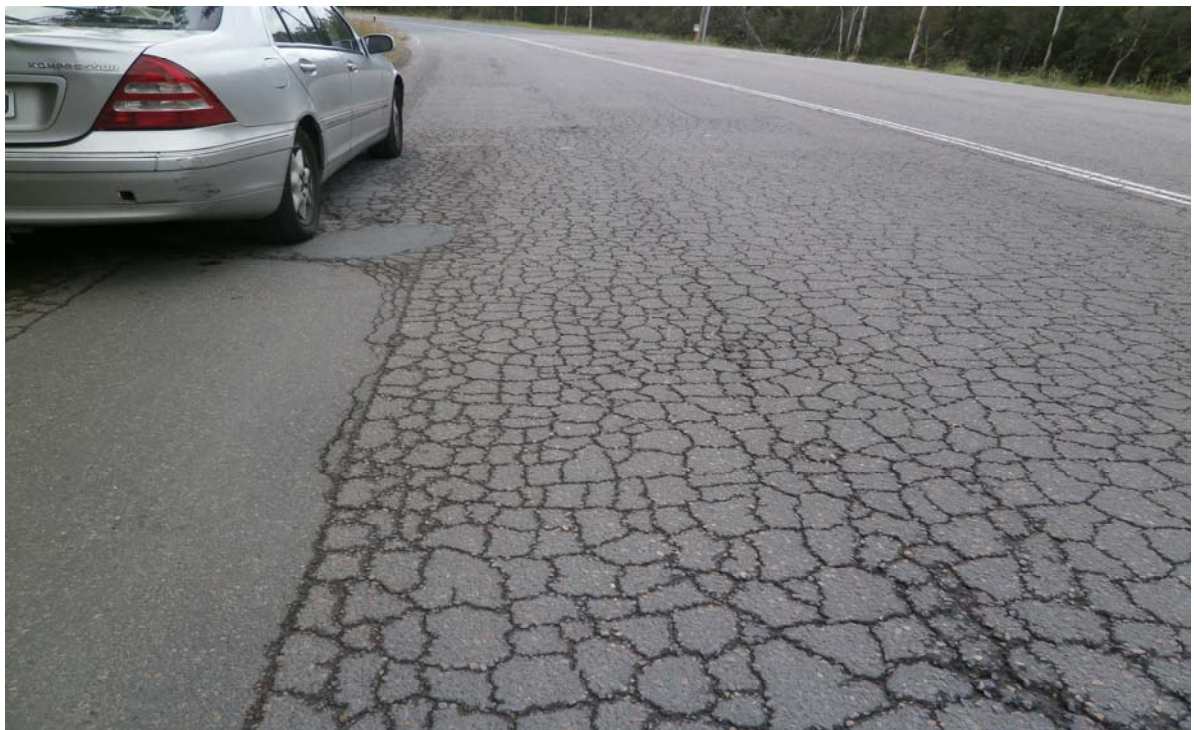
The pavement in both lanes has extensive crocodile cracking due to smelter heavy vehicles. **Photo P12**. This section of pavement is in the same condition as in 2013 and requires reconstruction.

PHOTO P12 CROCODILE CRACKS IN BOTH LANES | OLD PUNT ROAD FOR 256.6M WEST OF NORTHERN SMELTER ACCESS ROAD. (TAC) Ch 1720 TO Ch 1975 (Sheet 13/19)
