### PROPERTY CONDITION SURVEY

Old Punt Road  
TOMAGO NSW

24 March 2015

AD1475

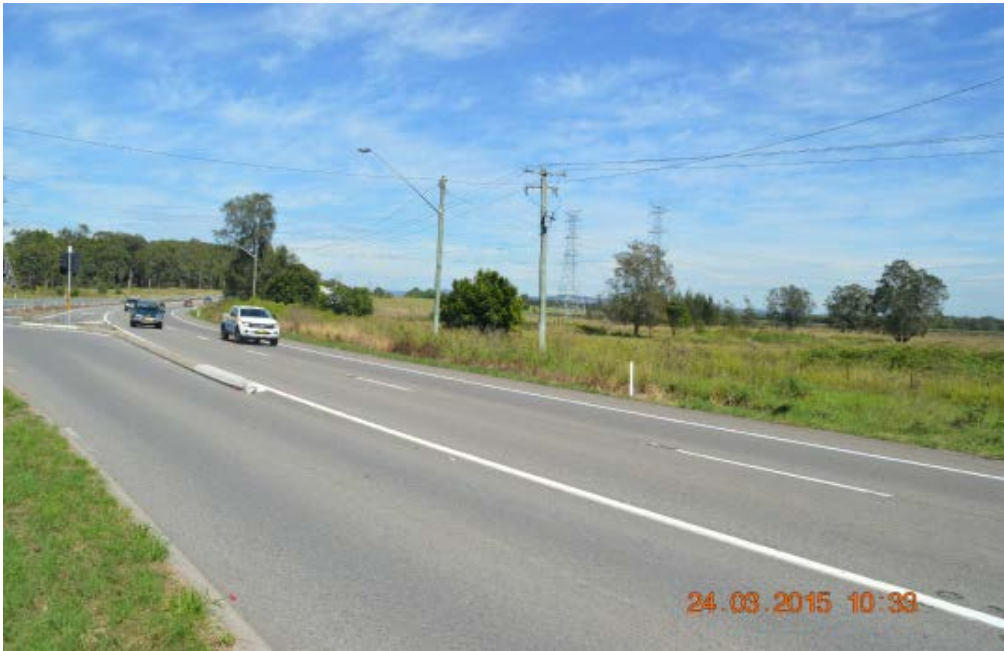
Refer to photo 27.

1. Showing new road signs. See photo 19-21.
2. Showing missing reflector post. See photo 27.
3. Showing replaced reflectors. See photo 29.
4. Showing repainted road lines. See photo 30.

Showing missing reflector post.

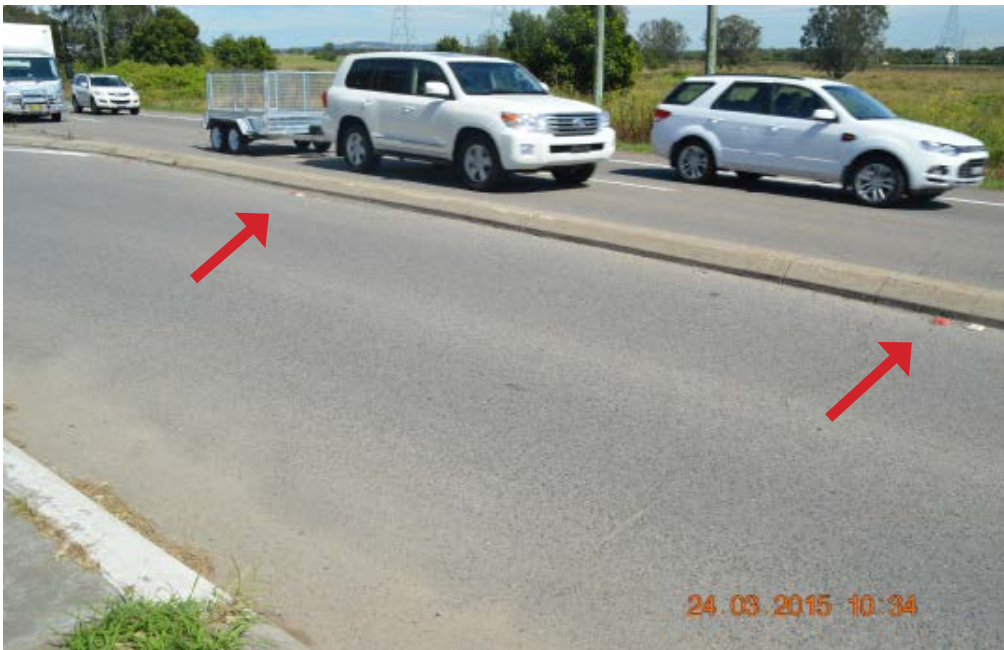
Refer to photo 29.

Showing replaced reflectors.

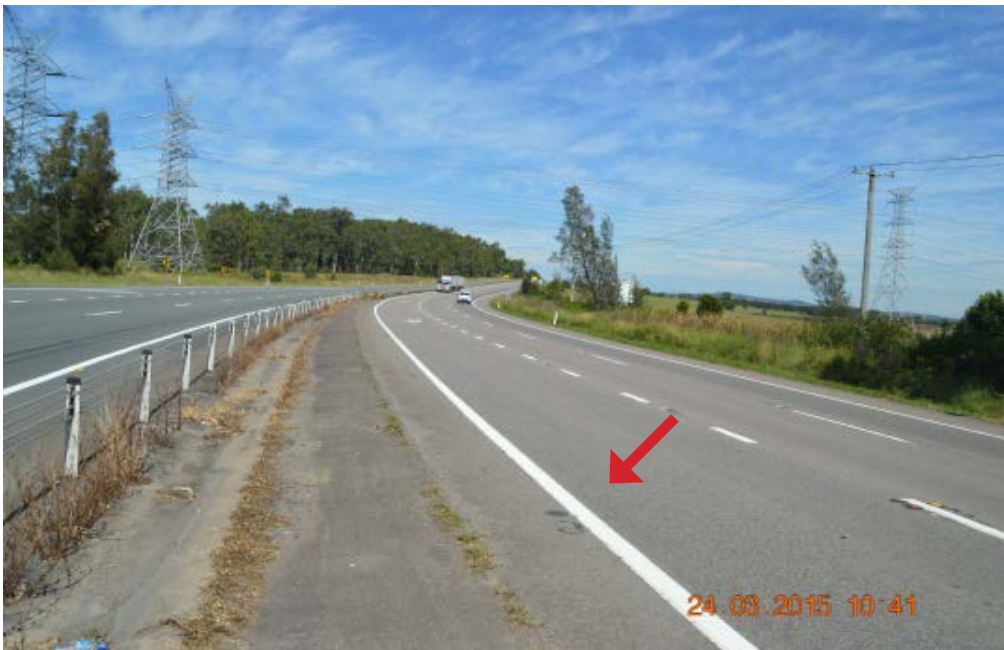
Refer to photo 36.

Showing missing reflectors.

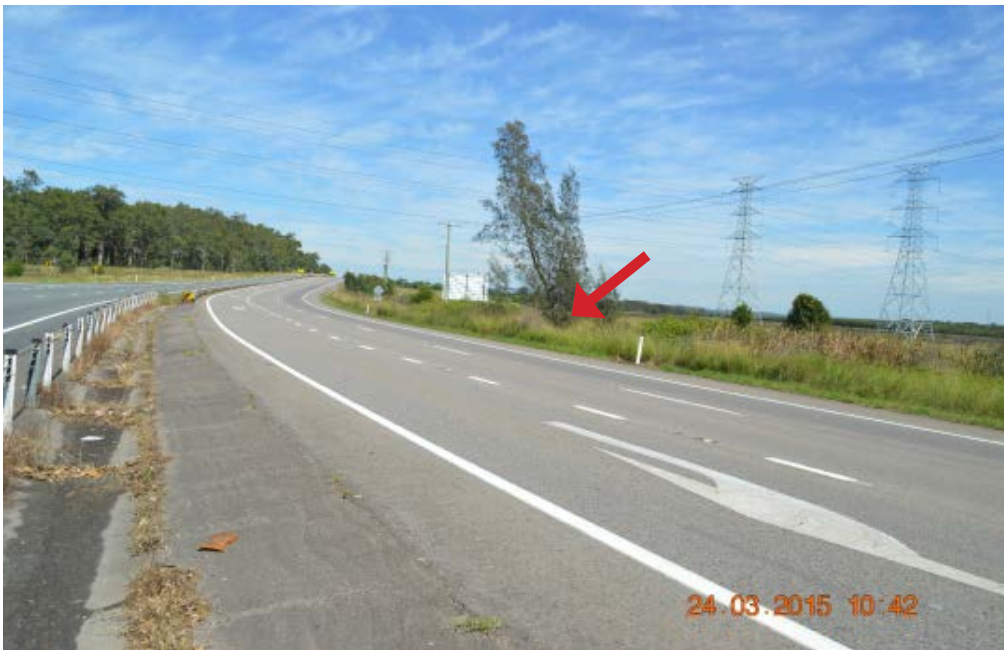
Refer to photo 39.

Showing missing reflector post.

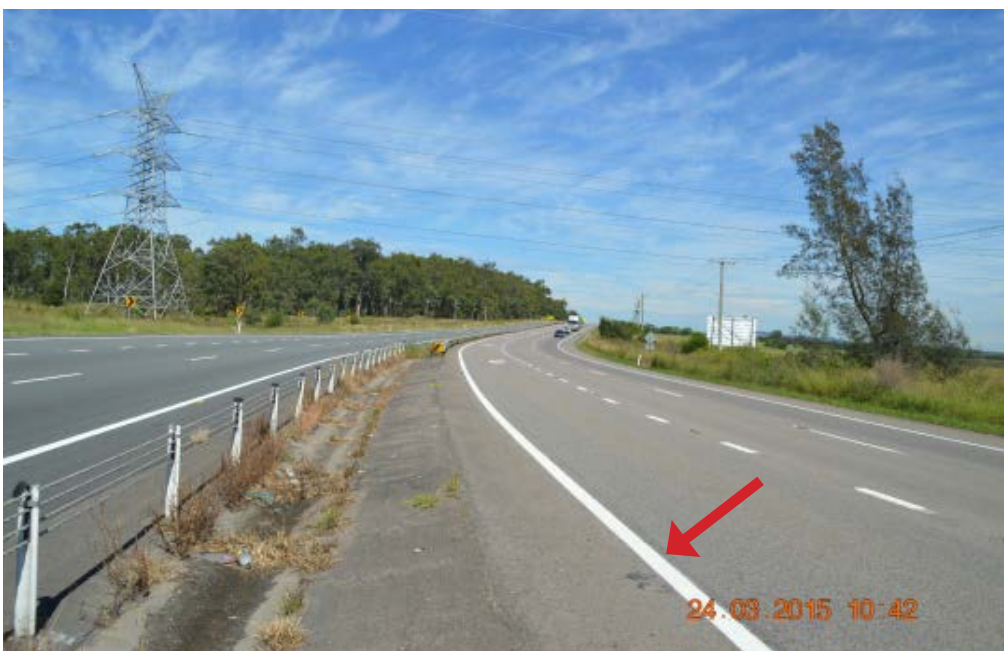
Refer to photo 40.

Showing missing reflector.

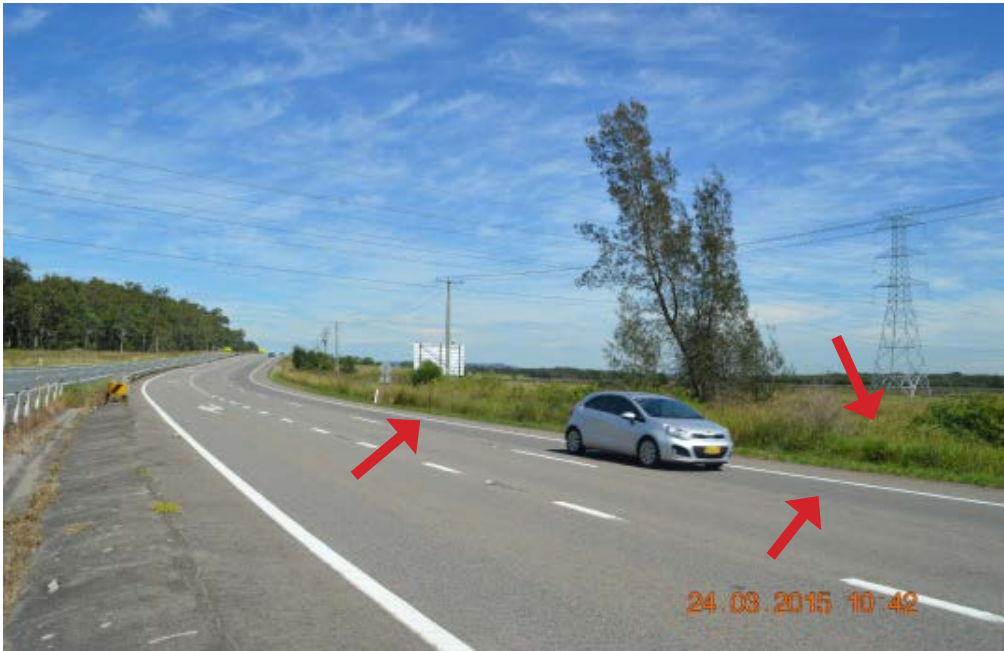
Refer to photo 42.

Showing missing reflector post and altered sidelines.

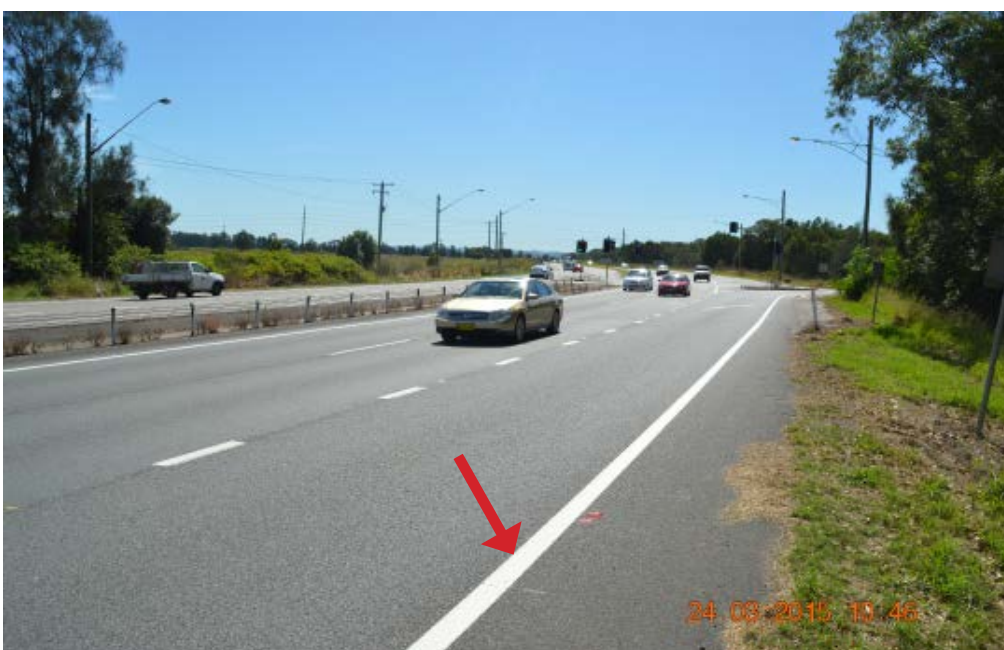
Refer to photo 51.

9. Showing missing reflector post and altered sidelines. See photo 40.
10. Showing altered sidelines. See photo 41-42.
11. Showing missing rumble strip. See photo 48.

Showing missing rumble strip.

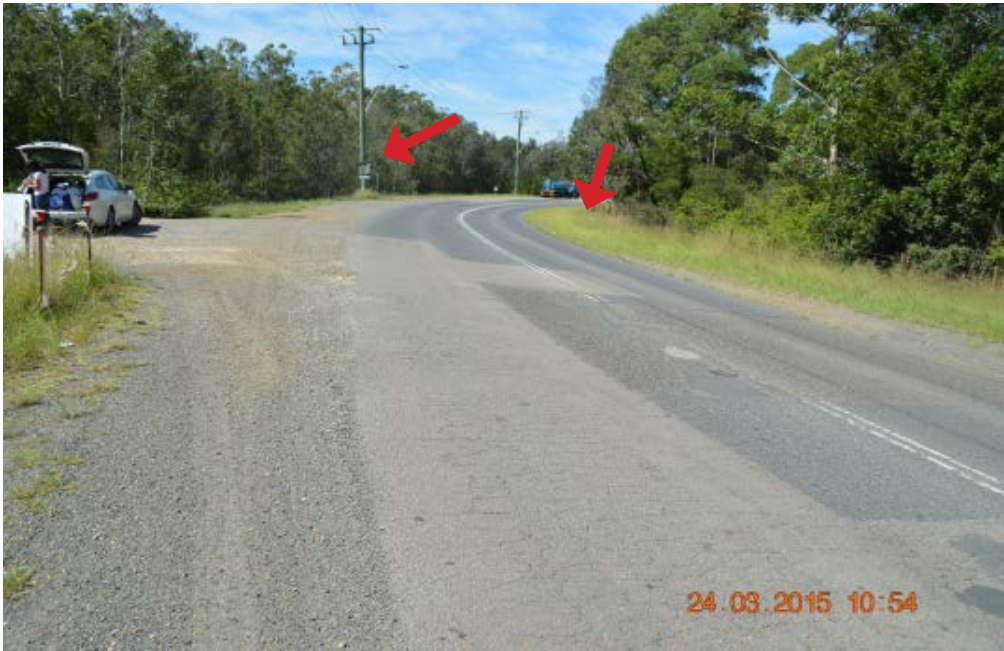
Refer to photo 82.

16. Showing additional road sign. See photo 69-76.
17. Showing additional road sign and missing reflector post. See photo 79.
18. Showing additional road sign and pot-holes, and missing reflector post. See photo 80.

Showing additional road sign and missing reflector post.

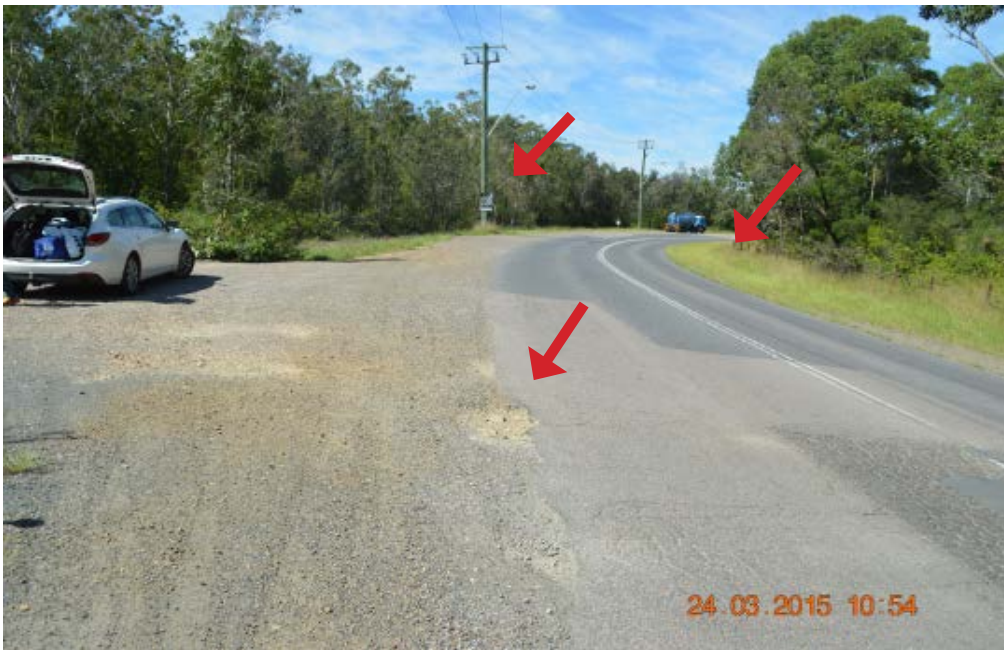
Refer to photo 83.

Showing additional road sign and pot-holes, and missing reflector post.

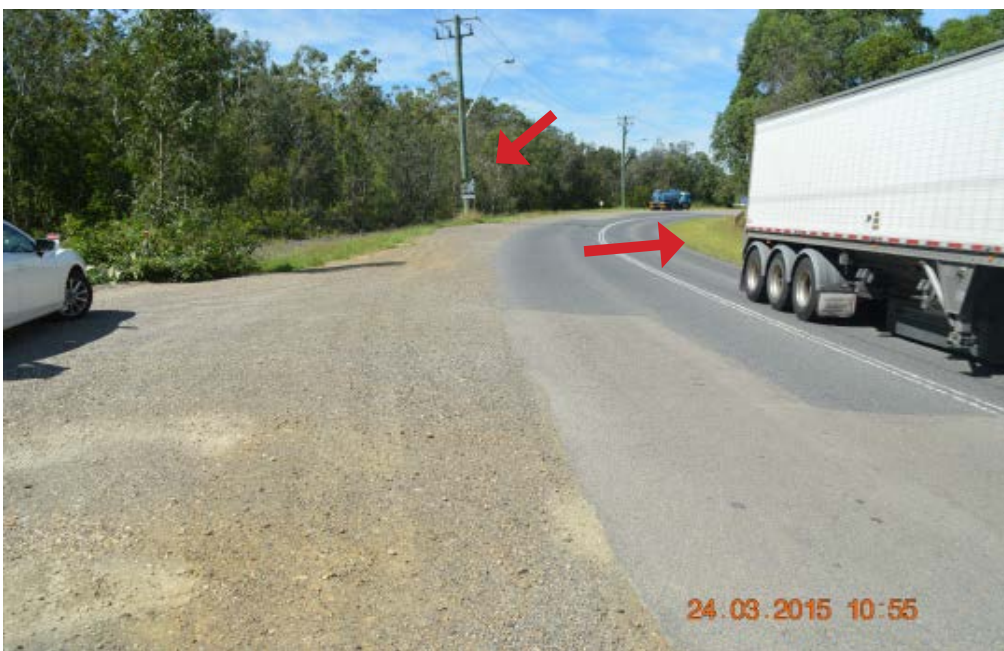
Refer to photo 84.

19. Showing additional road sign and missing reflector post. See photo 81-83.
20. Showing additional road sign. See photo 84-85.
21. Showing additional road sign. See photo 88.

Showing additional road sign and missing reflector post.

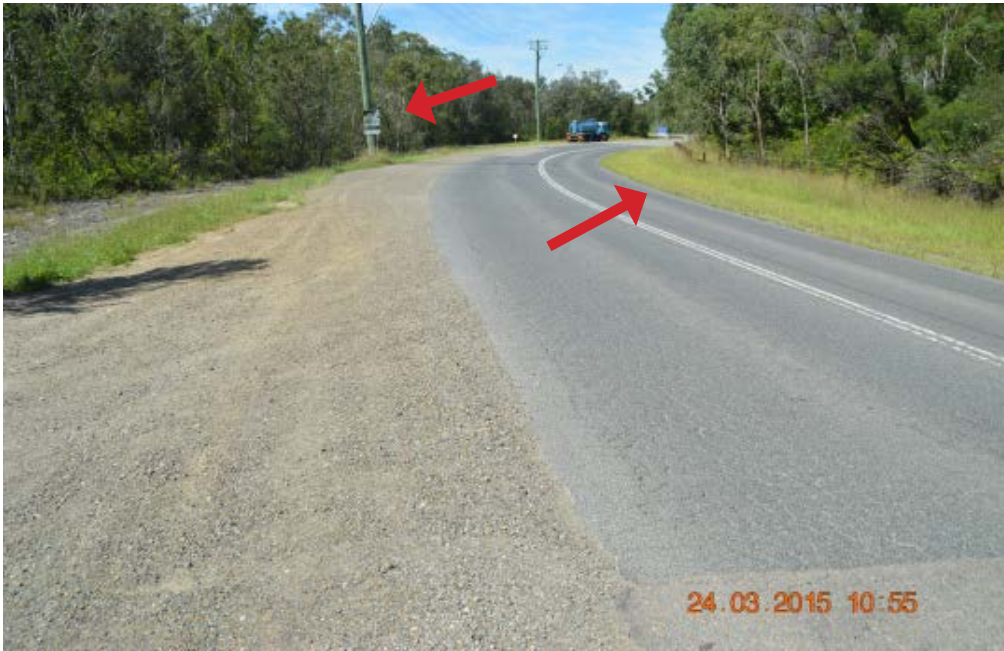
Showing additional road sign and missing reflector post.

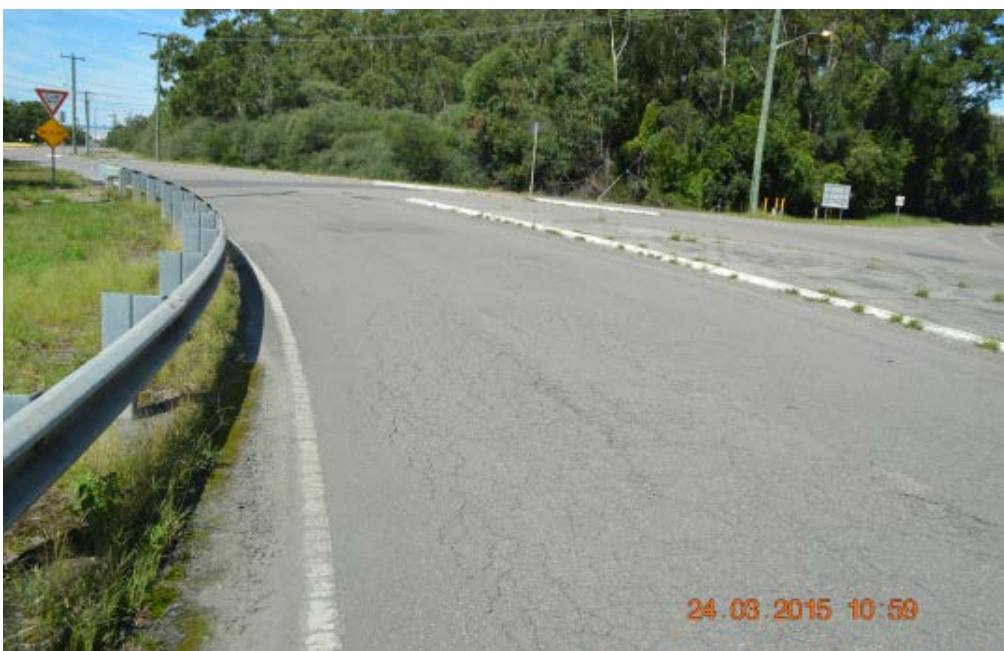
22. Showing replacement of road signs. See photo 97-99.
23. Showing additional road sign and power poles. See photo 102-104-
24. Showing additional power poles, street lights and side road. See photo 105-112.

Showing replacement of road sign.
