SITE INSPECTION REPORT

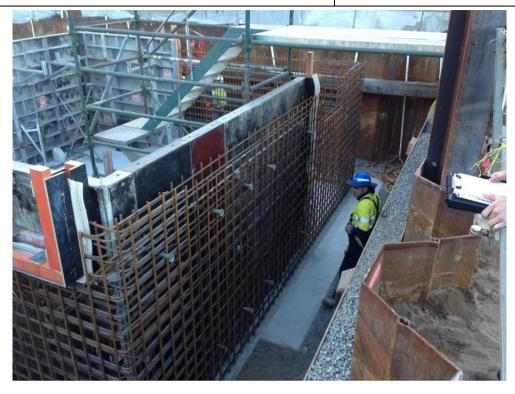
Photo showing installation of reinfocement.

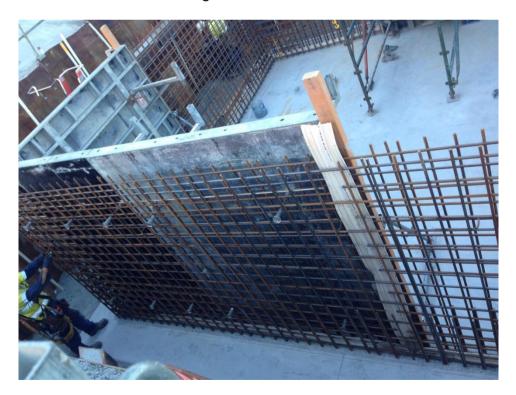
Waterstop located in side wall

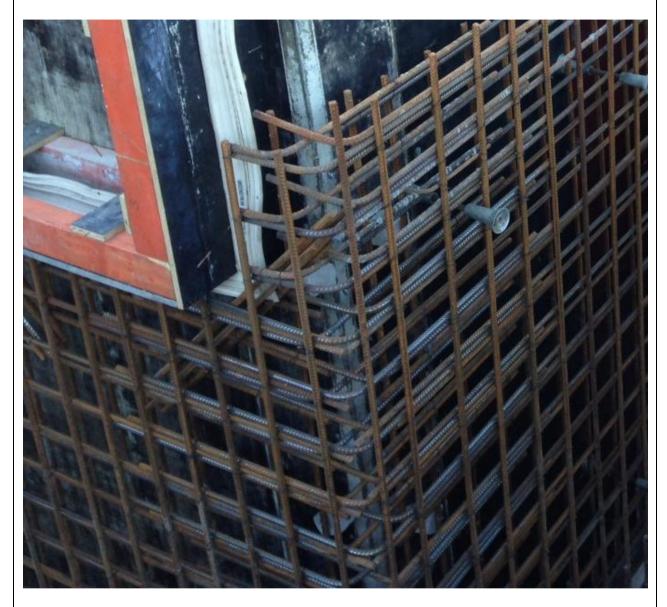
Corner reinforcement
