Broken Hill Solar Plant

ENVIRONMENTAL ASSESSMENT

Volume 7 – Appendix F to Appendix H
October 2012

Aboriginal Archaeological Assessment

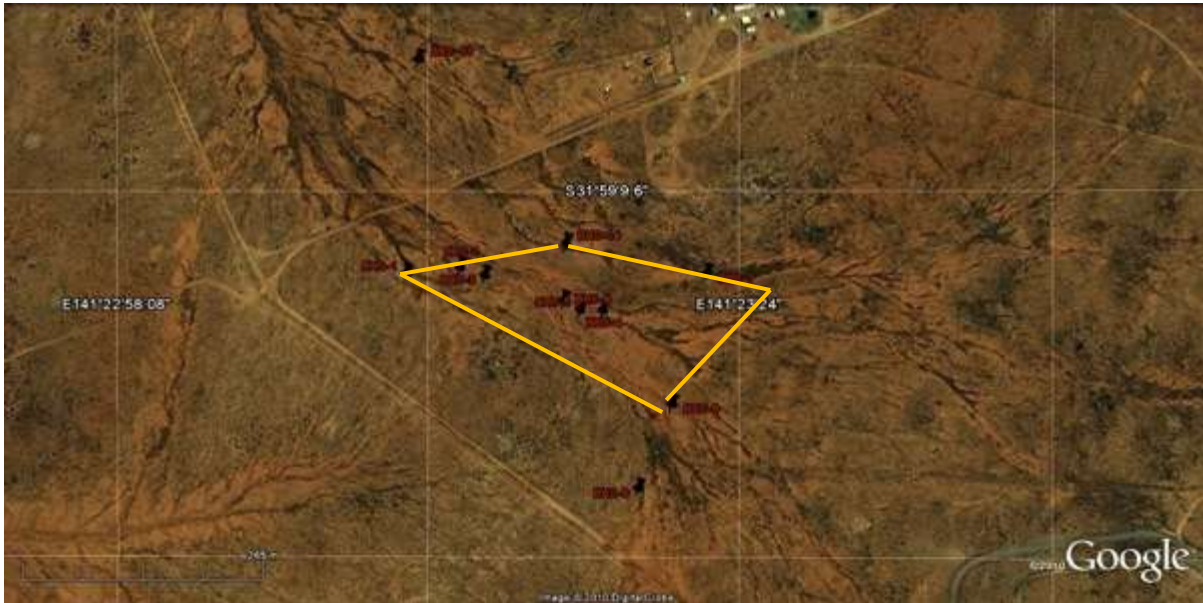
Figure 7: Approximate extent of area of highest artefact density shown in yellow.

site record and/or (b) define this portion of the ephemeral channel as an area of localised archaeological sensitivity. However, the raw artefact density calculation for such an area is only 1.6×10^{-4} artefacts/sq.m which increases to 3.7×10^{-4} artefacts/sq.m (i.e. 3.6 artefacts/ sq.km) if archaeological visibility and surface exposure is also taken into account. This does not suggest an archaeological signature for this environment beyond the background scatter that is generally expected where Aboriginal people are known to have traversed an area in the past, although it is acknowledged as being higher than the surrounding surveyed areas.

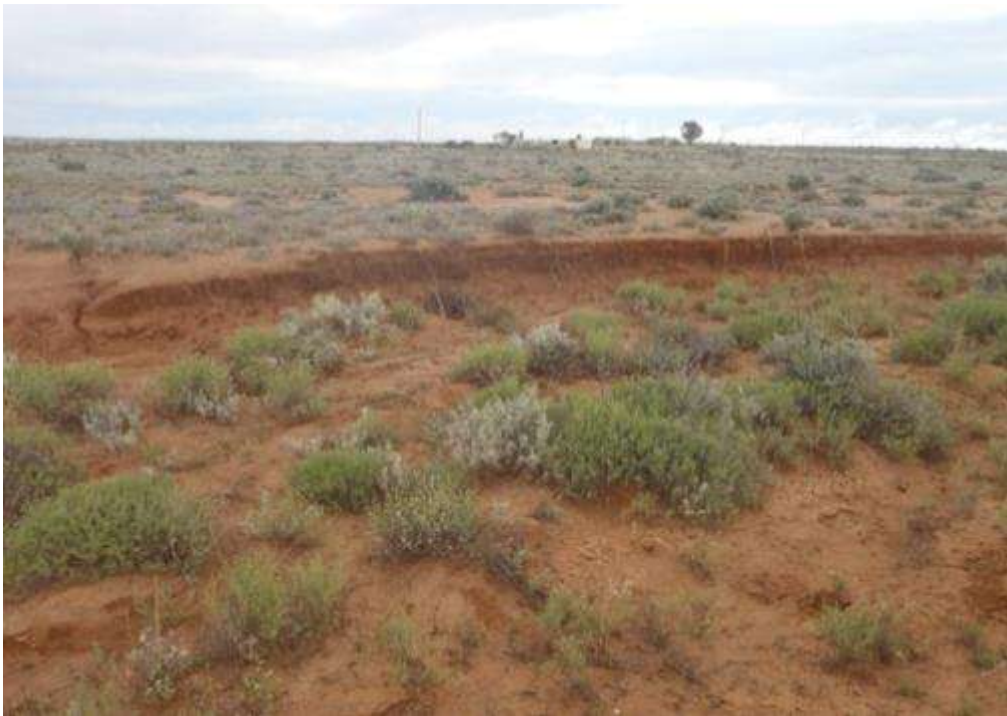
Plate 1: Landform Element 1: A narrowly incised ephemeral channel and associated alluvial fan & washout zone observed during foot traverse of Transect 2. Note the red sandy alluvium within the channel bank and the sparse low chenopod shrubland that is associated with the adjoining alluvial fan (Image, M. Cotter).

LFE 1: *Ephemeral channel/alluvial fan washouts.* This landform element is comprised of the narrowly incised ephemeral drainage channels that trend from southeast to northwest across the study area and the bare alluvial fan washout areas that adjoin these channels (**Plate 1**). The channels though variously incised can form erosional gullies to 0.75m deep. The gully banks are comprised of red sandy clay soils that are readily dispersed during rainfall events and the gully floors are typically comprised of deep loose red sands. These ephemeral channels are minor tributaries of Stirling Vale Creek. Exposed claypans within the alluvial fan areas of this landform element are generally covered by a thin deposit of sub-angular quartzose grit. This most likely reflects the deflating nature of this landscape where significant wind erosion has caused the finer sediments to be blown away leaving a moderately sorted layer of gravels too heavy to be wind-transported. Aboriginal stone Artefacts are found to lie within or above this grit layer (**Plate 2**).

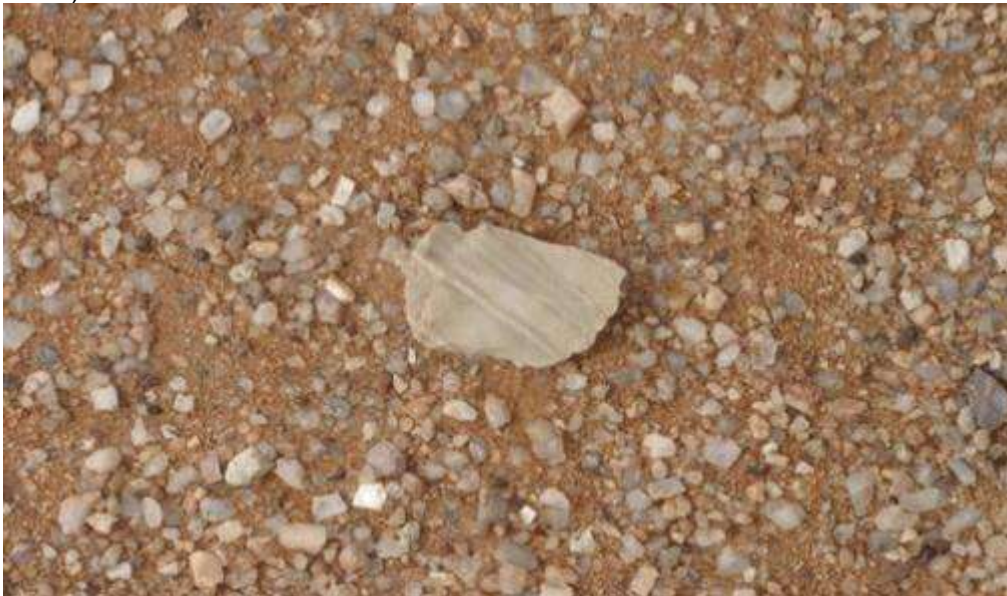
Plate 2: A small banded chert flake (BHS-13) (length=15.6mm) found within an exposed clay pan during foot traverse of Transect 17. Note that the flake lies within or above a thin layer of fine sub-angular quartzose gravels (Image, M. Cotter).

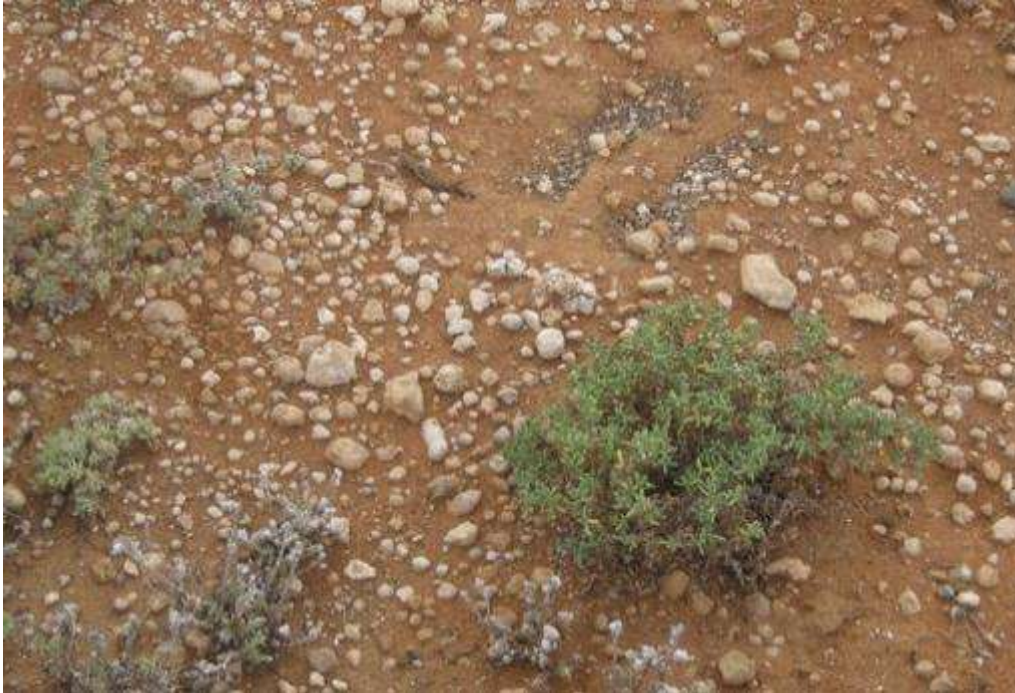
Plate 3: Landform Element 2: Textural characteristics of the coarse, quartz dominated gravel colluvium that covers the mid-slope portions of the study area. (Image, P. Hams).

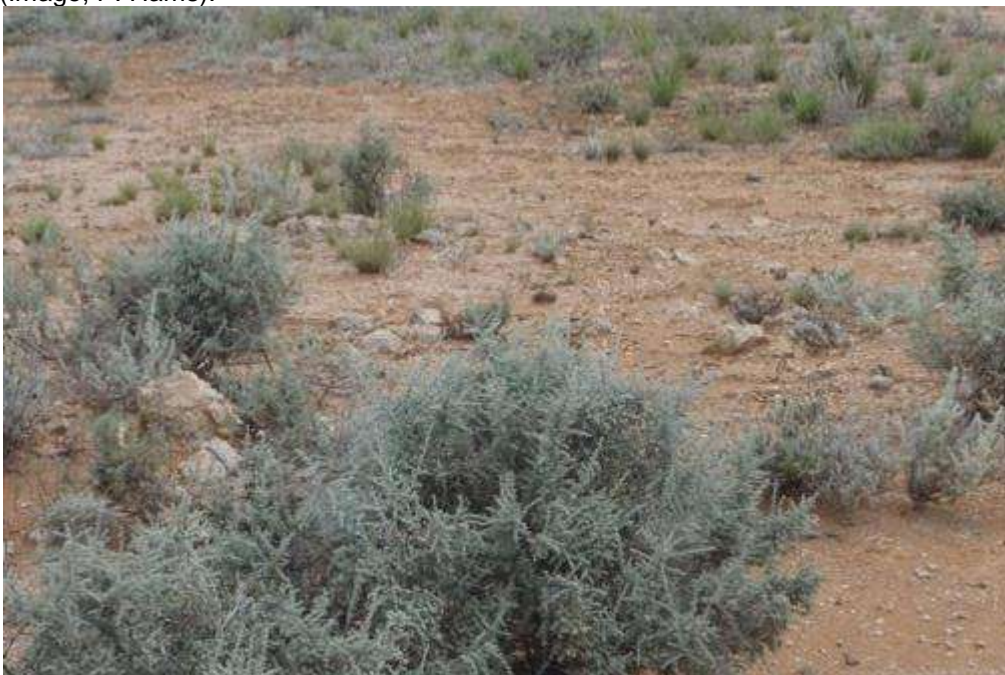
Plate 4: Landform Element 3: Localised bedrock exposure observed in central west portion of the study area. The blue, quartz rich rock is characteristic of the psammite rich Proterozoic metasediments that underpin the geology of the study area. (Image, M. Cotter).

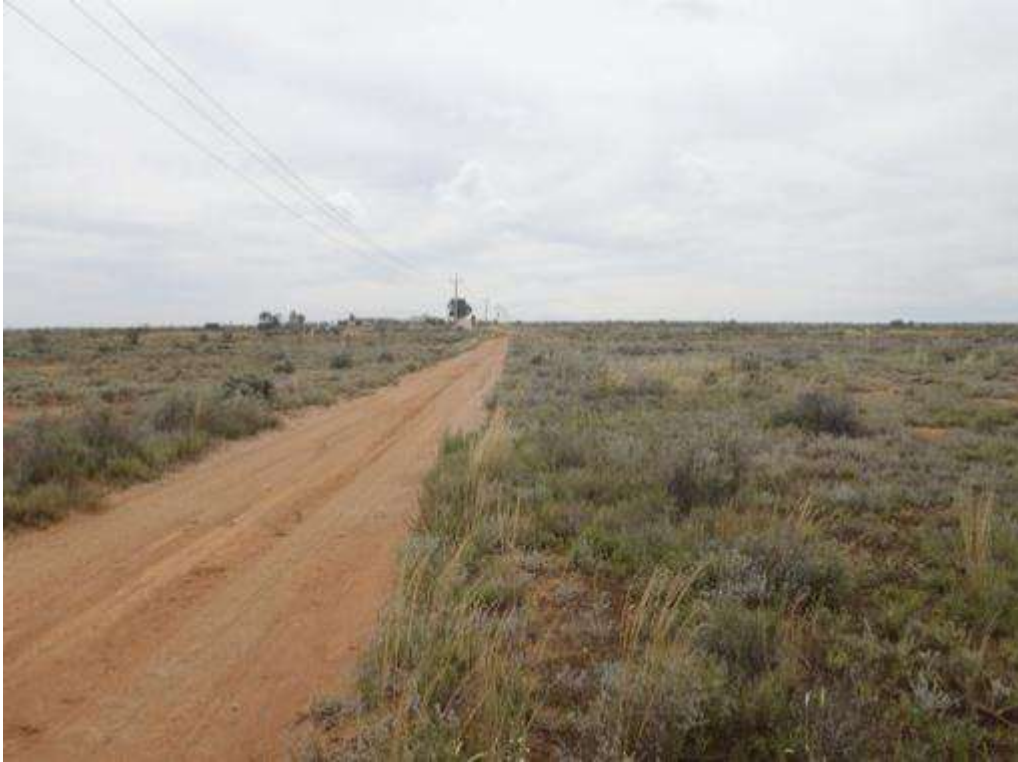
Plate 5: Landform Element 4: Disturbed hill-slope track: This graded sandy track parallels the transmission line easement that runs east to west across the study area (Image, M.Cotter).

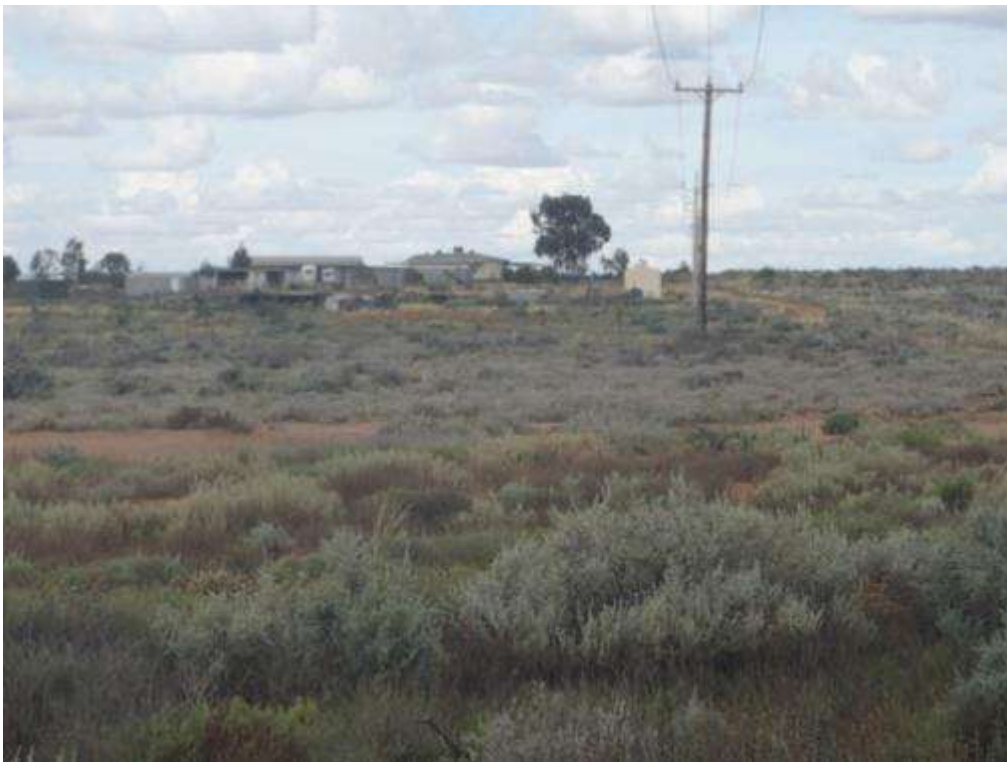
Plate 8: The residential dwelling and associated outbuildings situated within the Central northern portion of the study area. The image was taken from the approximate start of Transect 17 facing west. (Image, M. Cotter).

- A residential dwelling and associated out-buildings are situated within the northeast of the study area (**Figure 3; Plate 8**).
- A transmission line easement crosses the study area from west to east. Disturbances associated with this easement include those related to the original installation of each overhead pole and line, as well as to the installation and maintenance of the access track along this utility easement (**Figure 3; see Plate 5**).

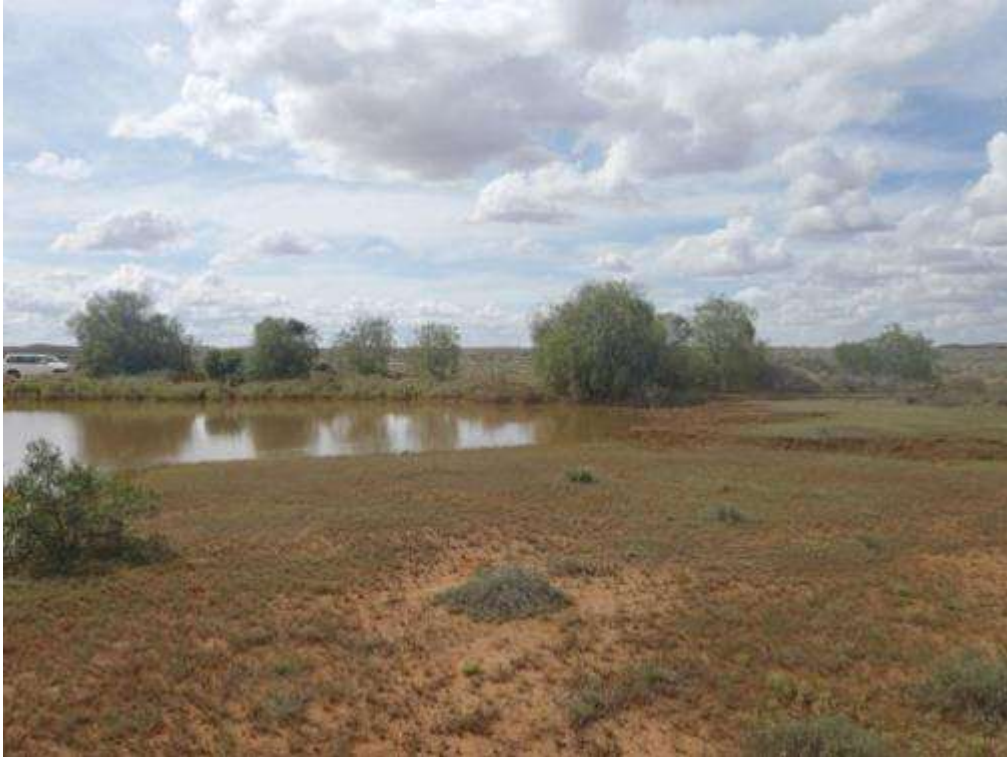
Plate 9: A full dam is situated in the topographic low of the study area immediately south of the Old Adelaide Road. Image taken facing north west (Image, M. Cotter).

- A dam has been emplaced in an ephemeral channel to impede drainage and allow water storage (**Figure 3; Plate 9**).
- Numerous graded gravel tracks cross the study area and give access to all landform elements within it (**Figure 3; see Plate 6**).

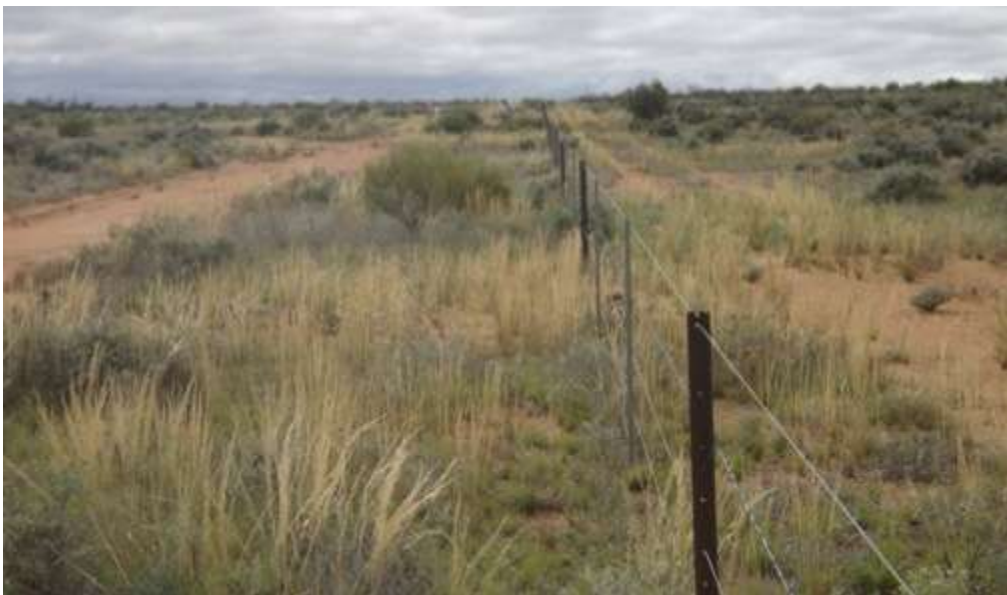
Plate 10: The star-picket and wire fence that marks the western boundary of the open paddock that surrounds the house-block. Image facing south east toward the Port Pirie-Broken Hill Railway (Image, M. Cotter).

- The property is bounded by star picket and wire fences (**Plate 10**).
- The skeleton of a horse and numerous, variously sized, horse shoes were observed in the field, particularly within the alluvial landform element. Though no horses were immediately observed at the time of the study, it is clear that the study area has served as horse paddocks in recent times.

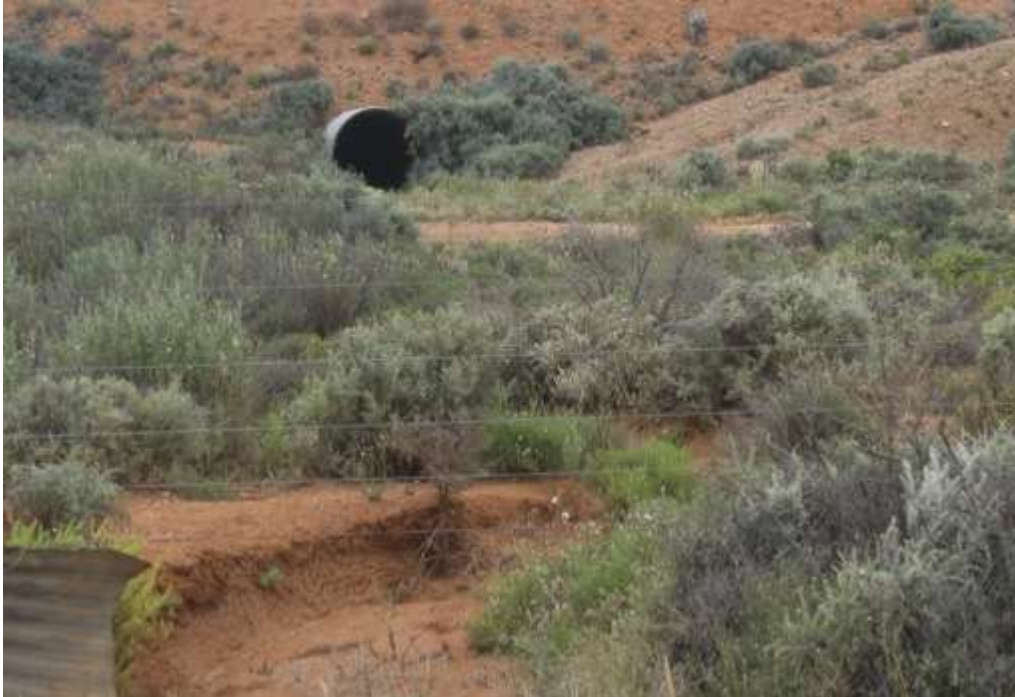
Plate 11: The culvert beneath the Port Pirie to Broken Hill Railway line. The fence in the foreground marks the southern boundary of the study area. Note the potential for the ephemeral channel to increase in width and depth as the metal piping within the culvert concentrates and diverts water along the drainage channel. (Image, M. Cotter).

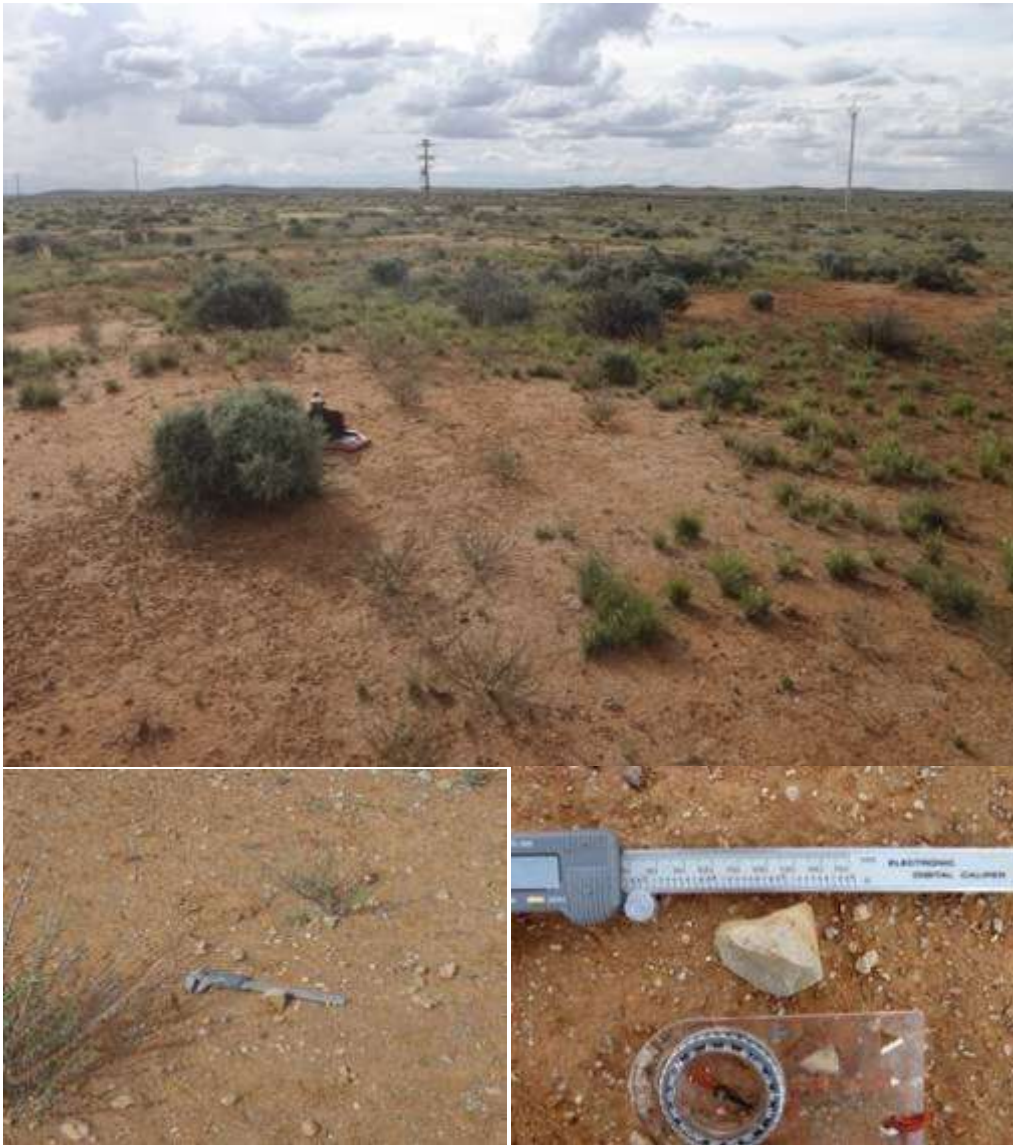
Plate 13. View facing west-northwest across the eroded claypan/alluvial fan outwash area upon which isolated artefact Site BHS-2, a multi-platform silcrete core, was found. (Images M. Cotter).

Site type: An isolated find/ Single artefact (see **Plate 13**)

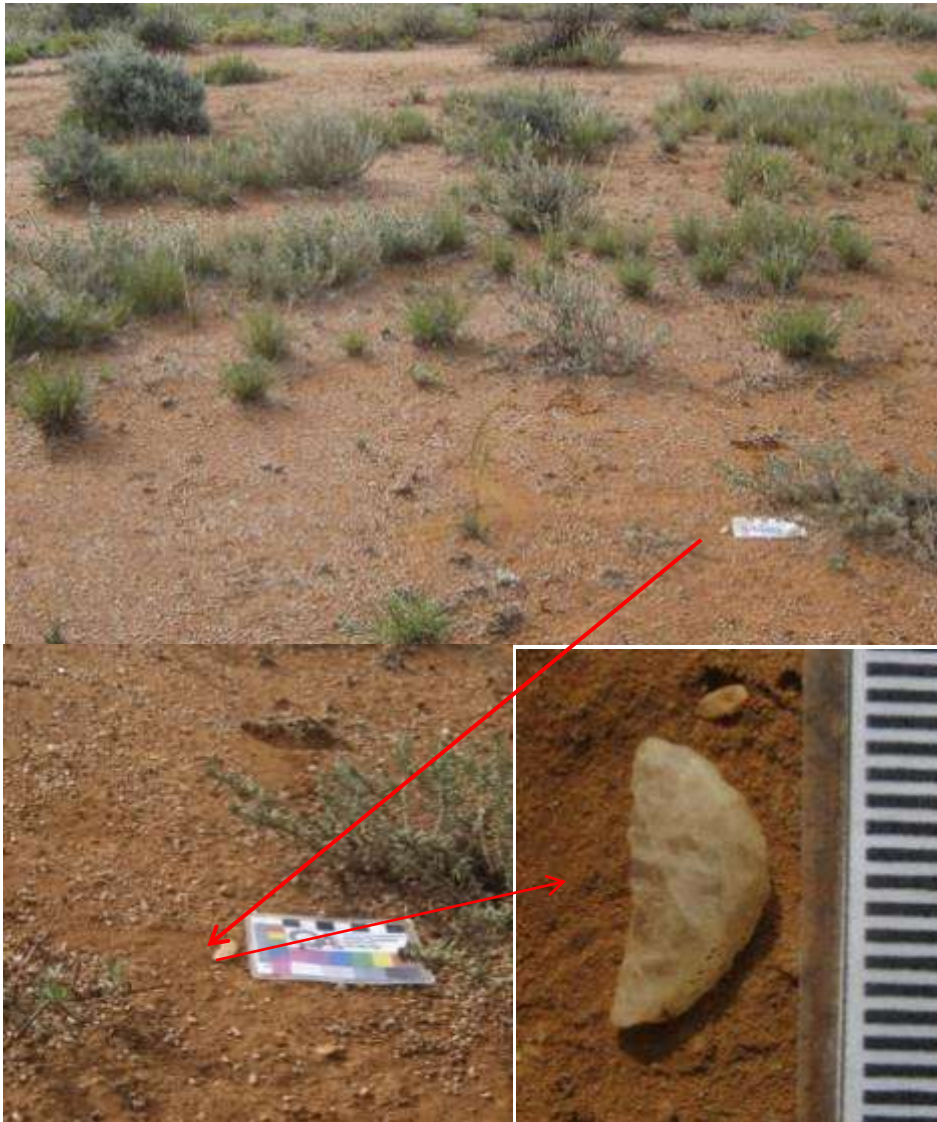
Plate 14. View facing east-northeast of the eroded alluvial fan upon which isolated find BHS-3, a single retouched quartz flake, was located. (Images P. Hams).

Site type: An isolated find/ Single artefact (see **Plate 14**)

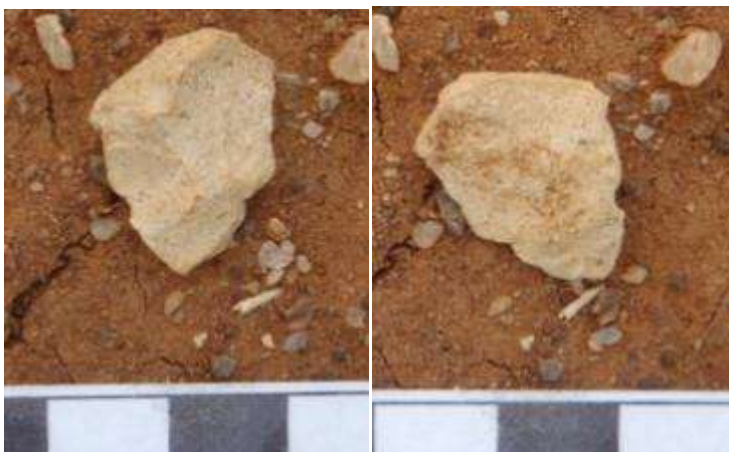
Plate 15: Ventral and dorsal views of isolated find BHS-4 (Images M.Cotter).

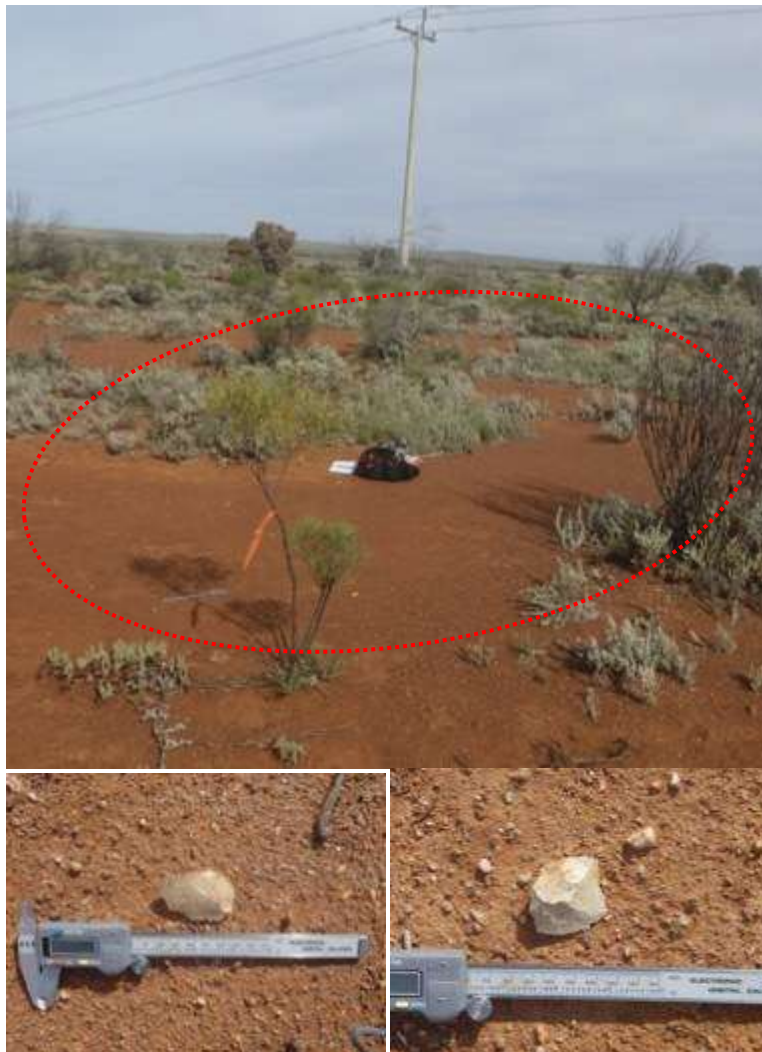
Plate 22 View facing north west of the location of artefact scatter BHS-11 (Images, M. Cotter).

Site type: A low density, artefact scatter (see **Plate 22**)

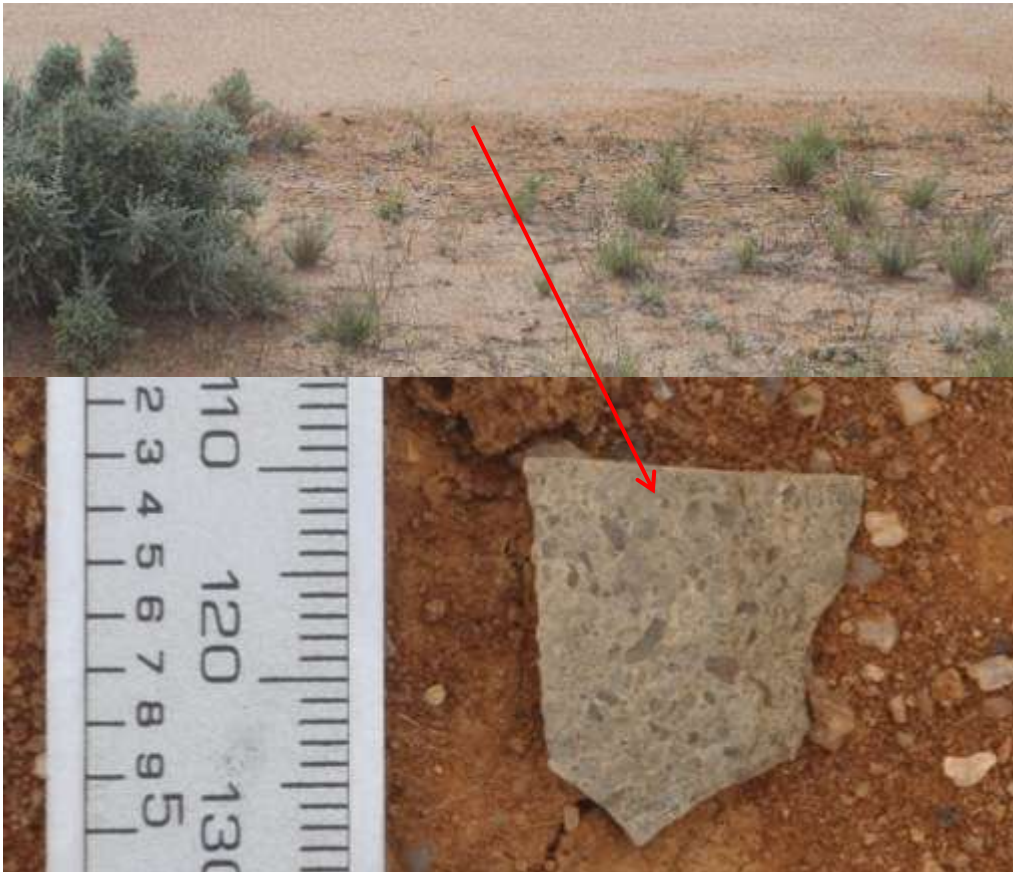
Plate 23: Broken silcrete flake described as artefact # 1 of artefact scatter site BHS-12 (Image M. Cotter).

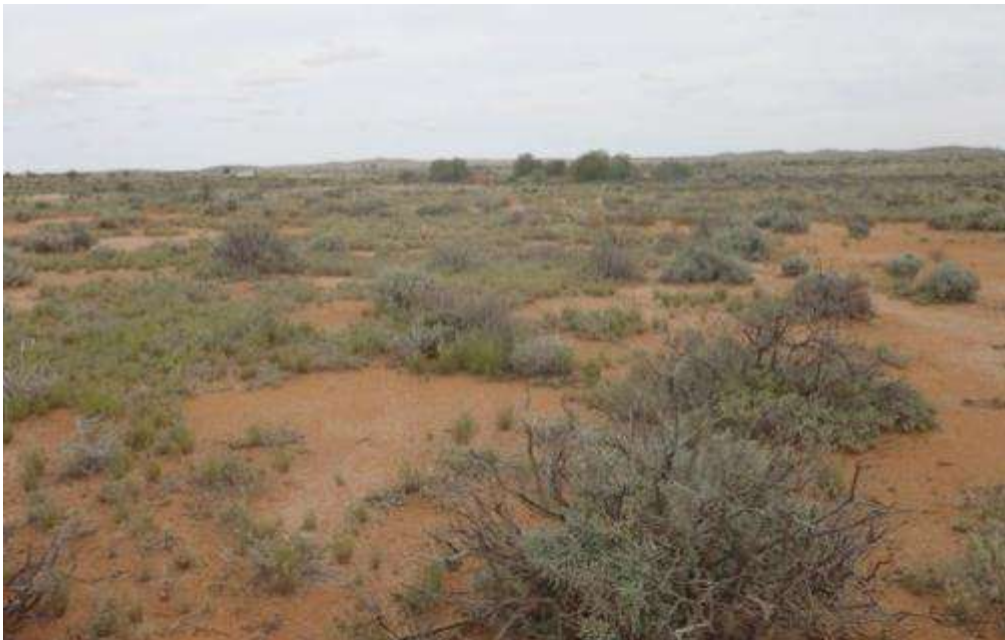
Plate 24: Within Transect 17: view facing northwest towards dam of low chenopod shrubland on exposed alluvium typical of area within which sites BHS-12 & BHS-13 were located (Image M. Cotter).

Location of site: In alluvial fan washout/claypan/scald in sparse low chenopod shrubland c. 60m south of the Old Adelaide Road disturbance Corridor and 130m east of the dam in the northwest portion of the study area (see **Plate 24**). Details of each artefact are provided in Table 9 Below.

Location of site: In exposed alluvial fan washout/claypan in sparse low chenopod shrubland c. 180m southeast of the Old Adelaide Road disturbance corridor (see Plate 24).

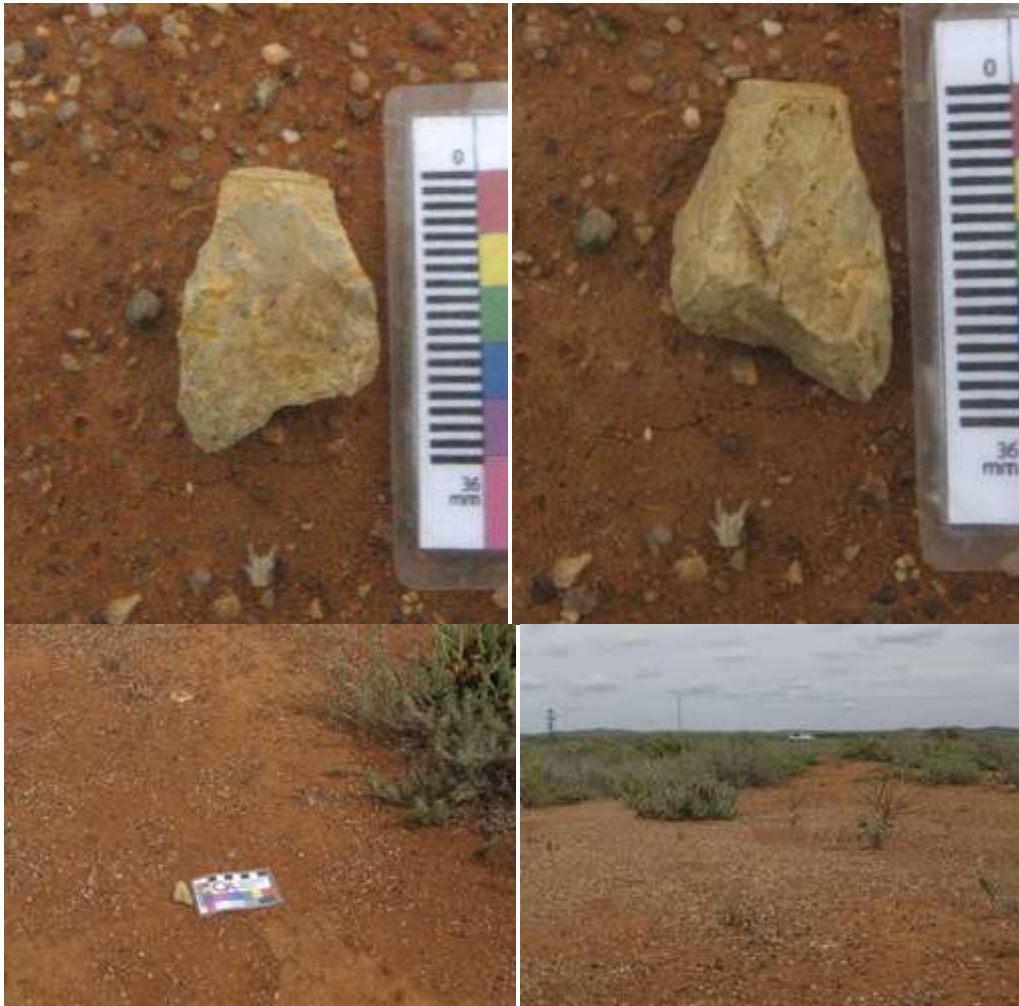
Plate 26: The silcrete flake recorded as BHS-14 (Images P. Hams).

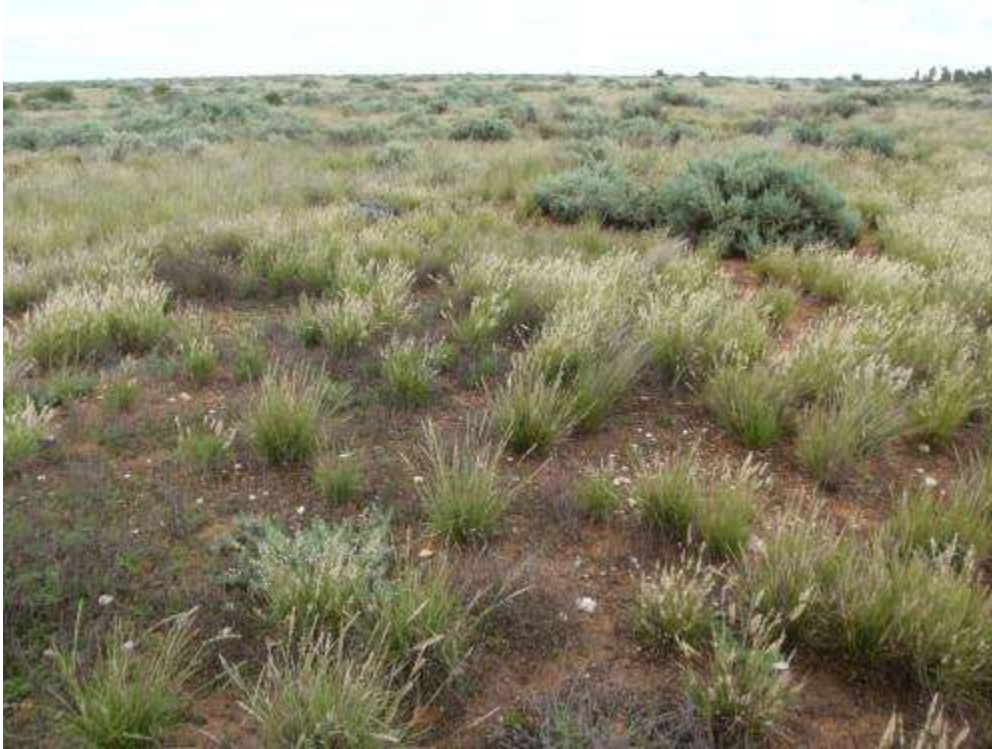
Plate 28: View north along the proposed ETL route to the existing ETL easement. Image demonstrates degree of ground surface visibility and background noise of quartz material.

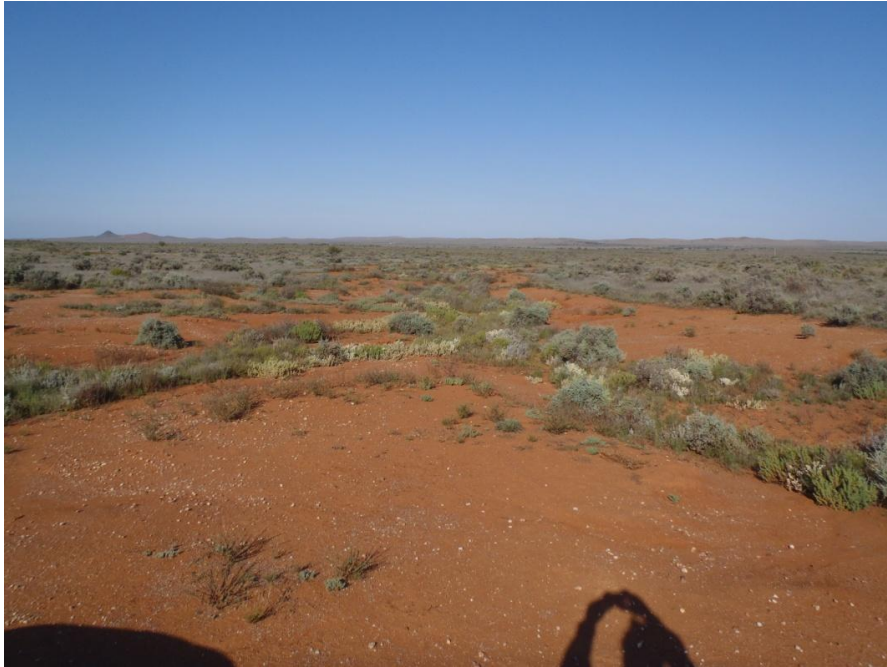
- **Plate 2-1 Drainage and landscape in the south-eastern part of the site (looking north-east)**

Plate 2-1 shows the drainages lines and typical landscape in the south eastern part of the site looking north-west. Shallow gullies and sheet flow are the typical drainage systems. **Plate 2-2** shows typical drainage and landscape in the south western part of site looking north-east. **Plate 2-3** shows the area to the west of the farm house (looking east). **Plate 2-4** shows a typical drainage line in the area west of the farm house.

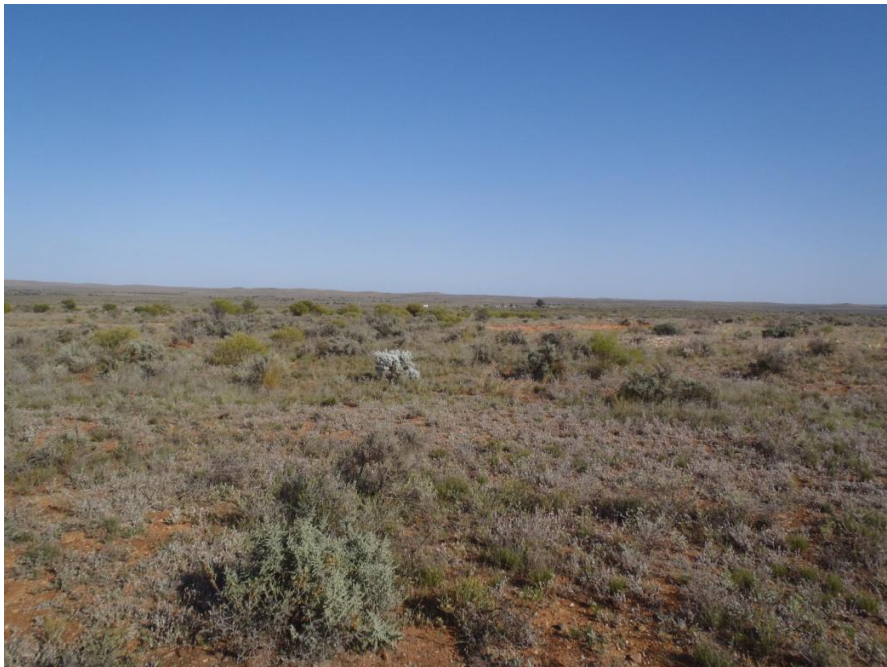
- **Plate 2-2 Drainage and landscape in the south-western part of the site (looking north-west)**

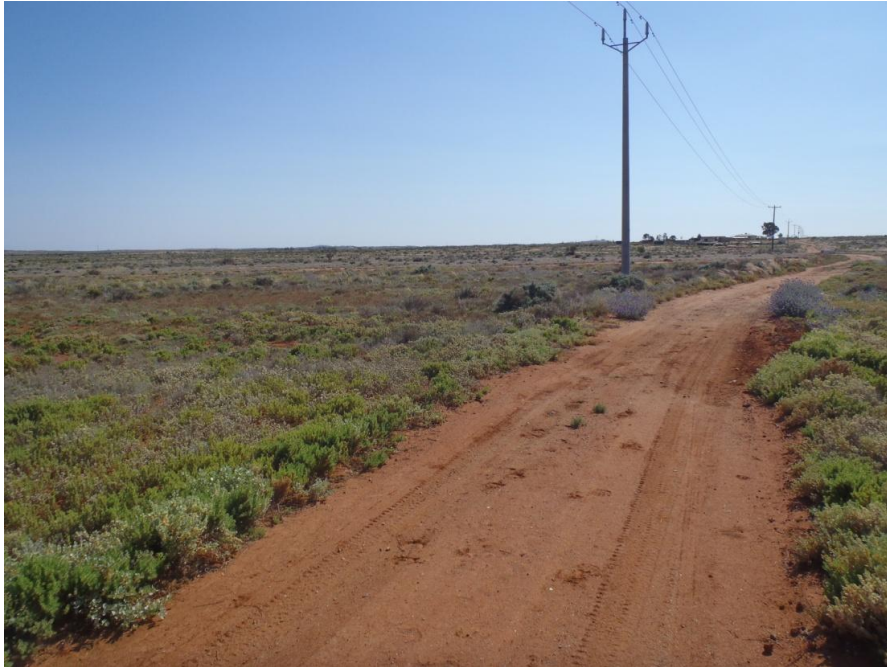
■ **Plate 2-3 Landscape west of the farm house (looking east)**

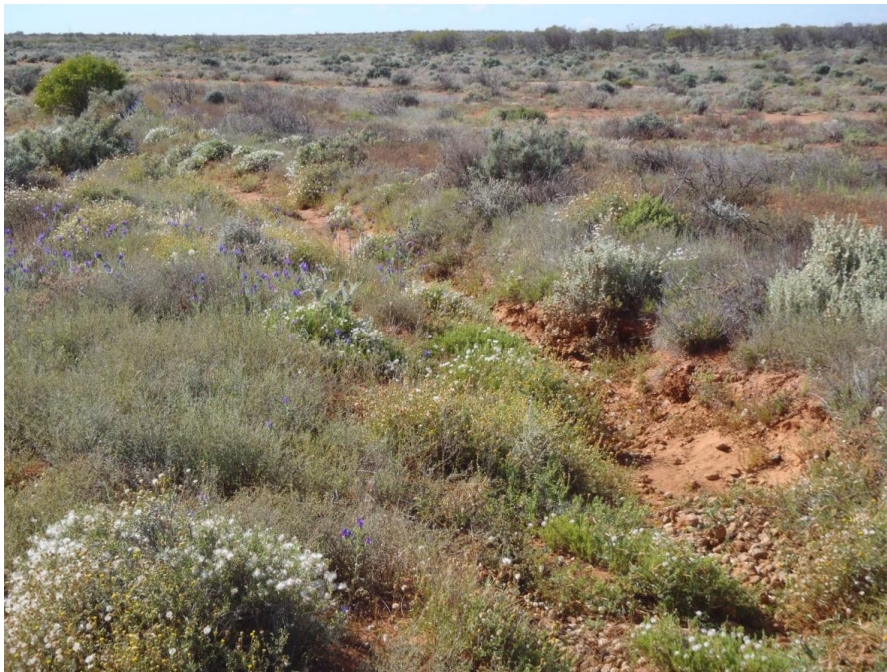
■ **Plate 2-4 Typical drainage line in the area west of the farm house**

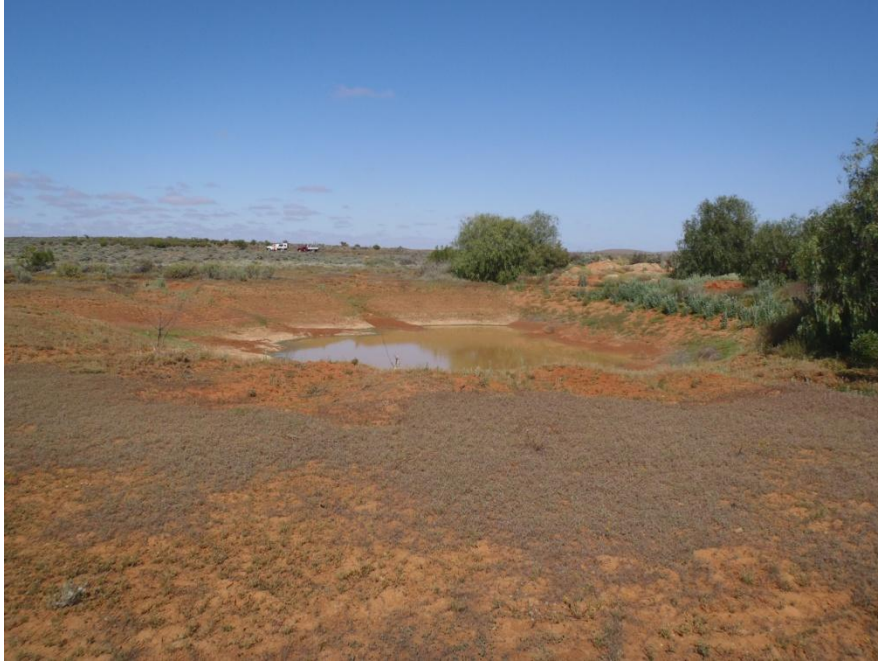
■ **Plate 2-5 Farm dam**

Plate 2-5 shows the farm dam located at the northern boundary of the site. The dam is approximately 25 m² and 1.5 metres deep. There is no formalised spillway from the dam; however,

surcharge from the dam would flow around the dam wall and westward towards Stirling Vale Creek. **Plate 2-6** illustrates typical drainage channels flowing to the farm dam.

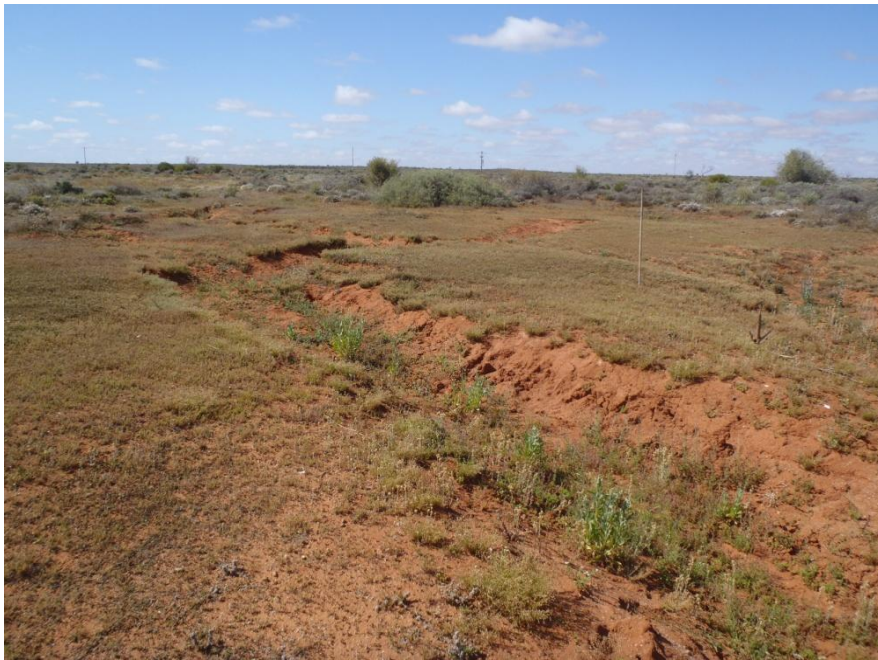
■ **Plate 2-6 Drainage channels into farm dam**

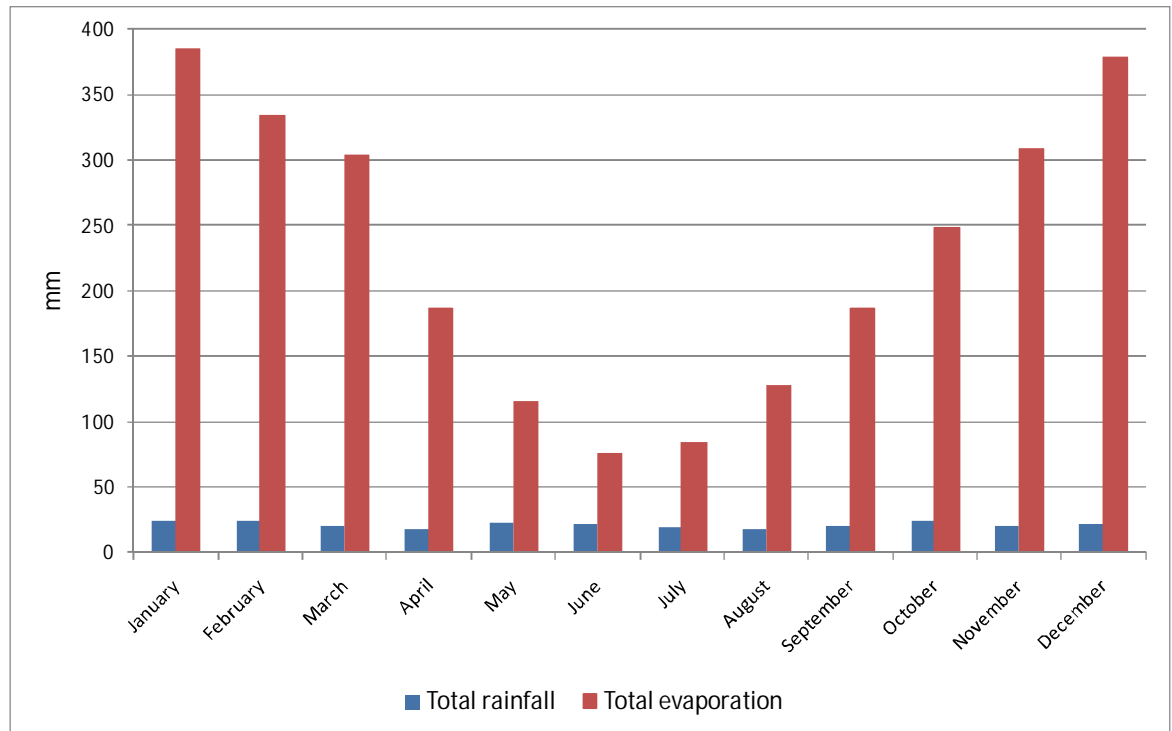
■ **Figure 2-1 Average monthly rainfall and evaporation at the site**

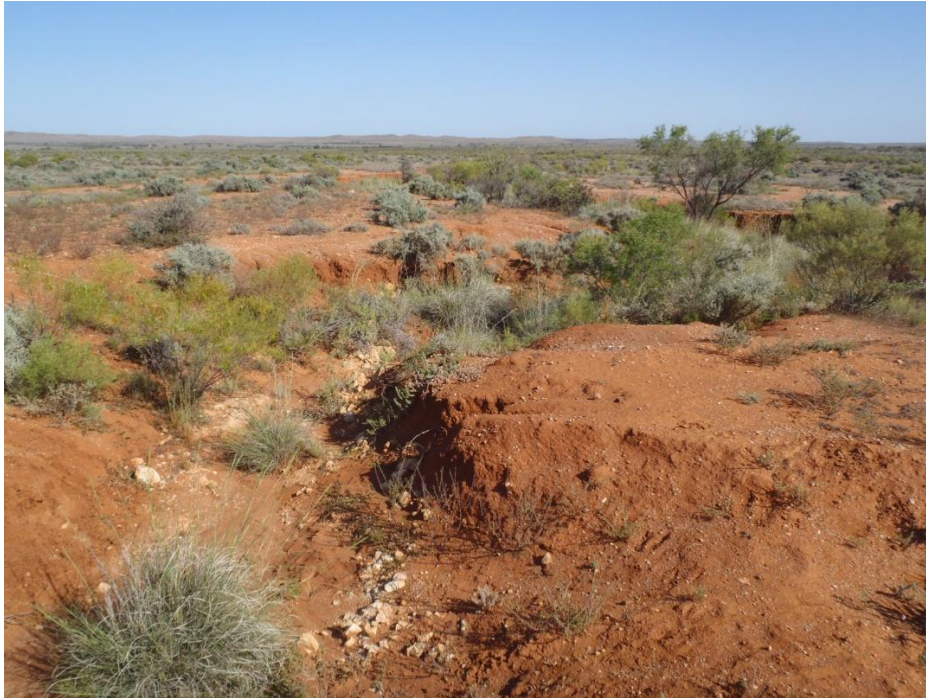
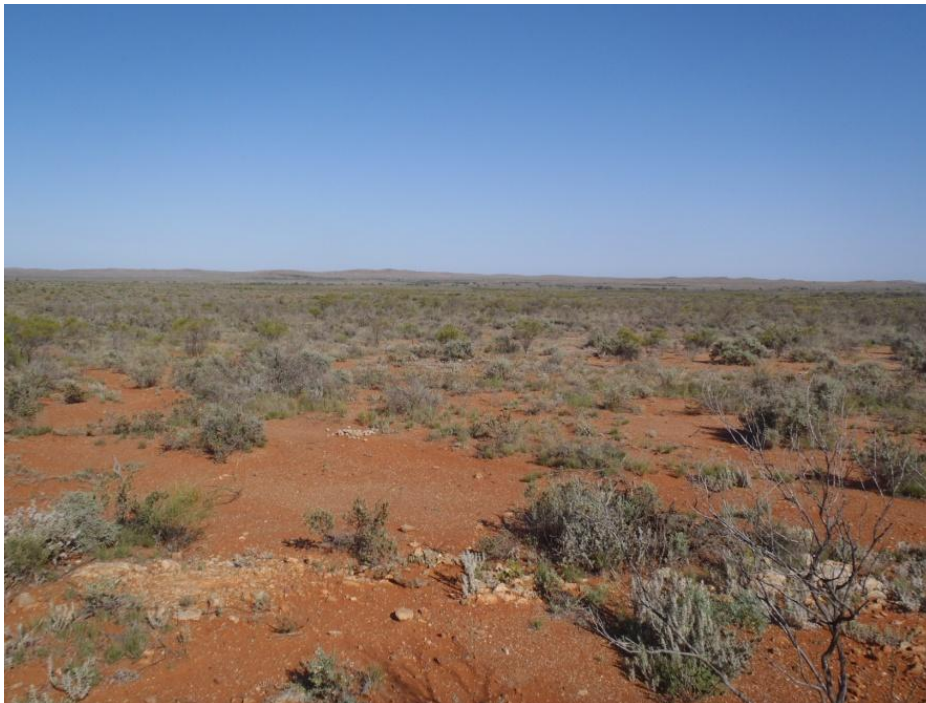
■ **Plate 2-7 Typical soils of the site**

■ **Plate 2-8 Typical soils of the site**

Soils found on the site are shown in **Plate 2-7** and **Plate 2-8**. The soils are considered moderately erodible, and increased erosion may occur where soils are not protected by vegetation. Gullying is evident where there is a lack of vegetation.
