# Coopers Gap

## Facade Sound Insulation Assessment Report

Client: AGL Energy Ltd

23-Aug-2016

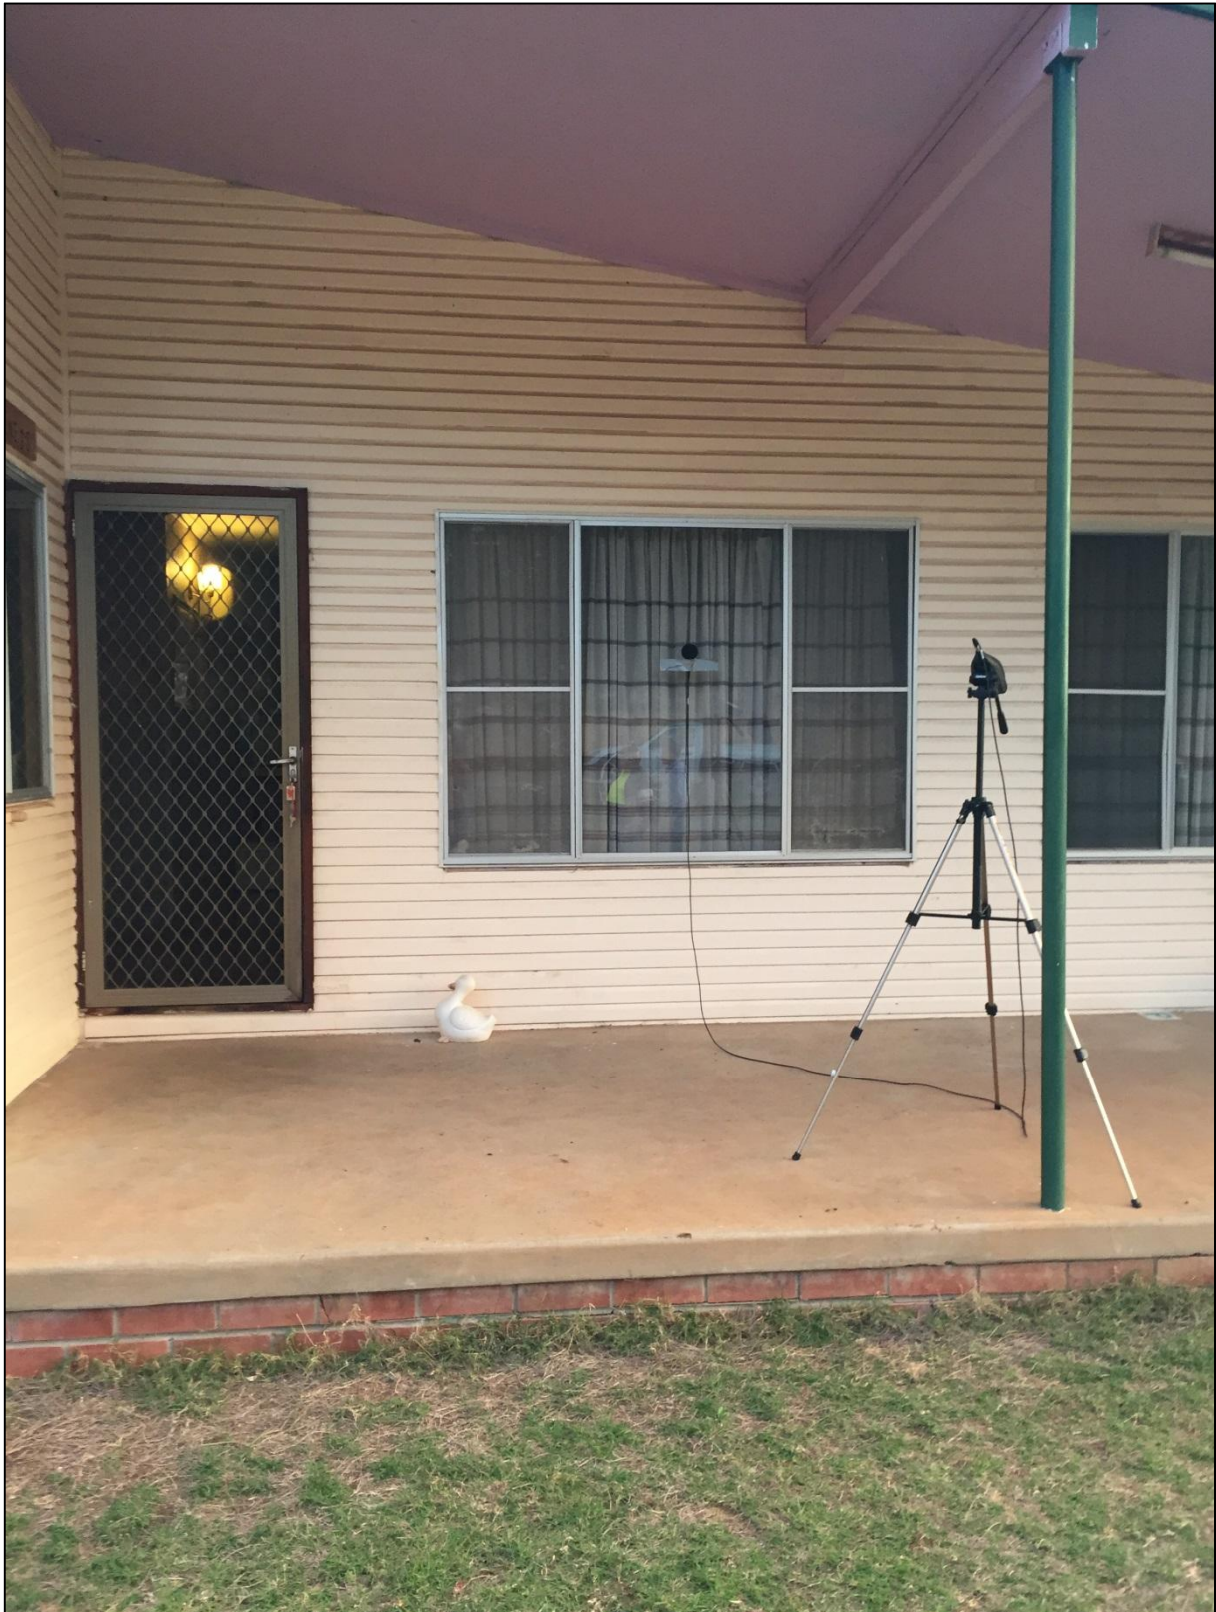
Figure 1 Example instrument microphone attached to the tested façade

Example test setup photos are shown in Figure 1 to Figure 4.

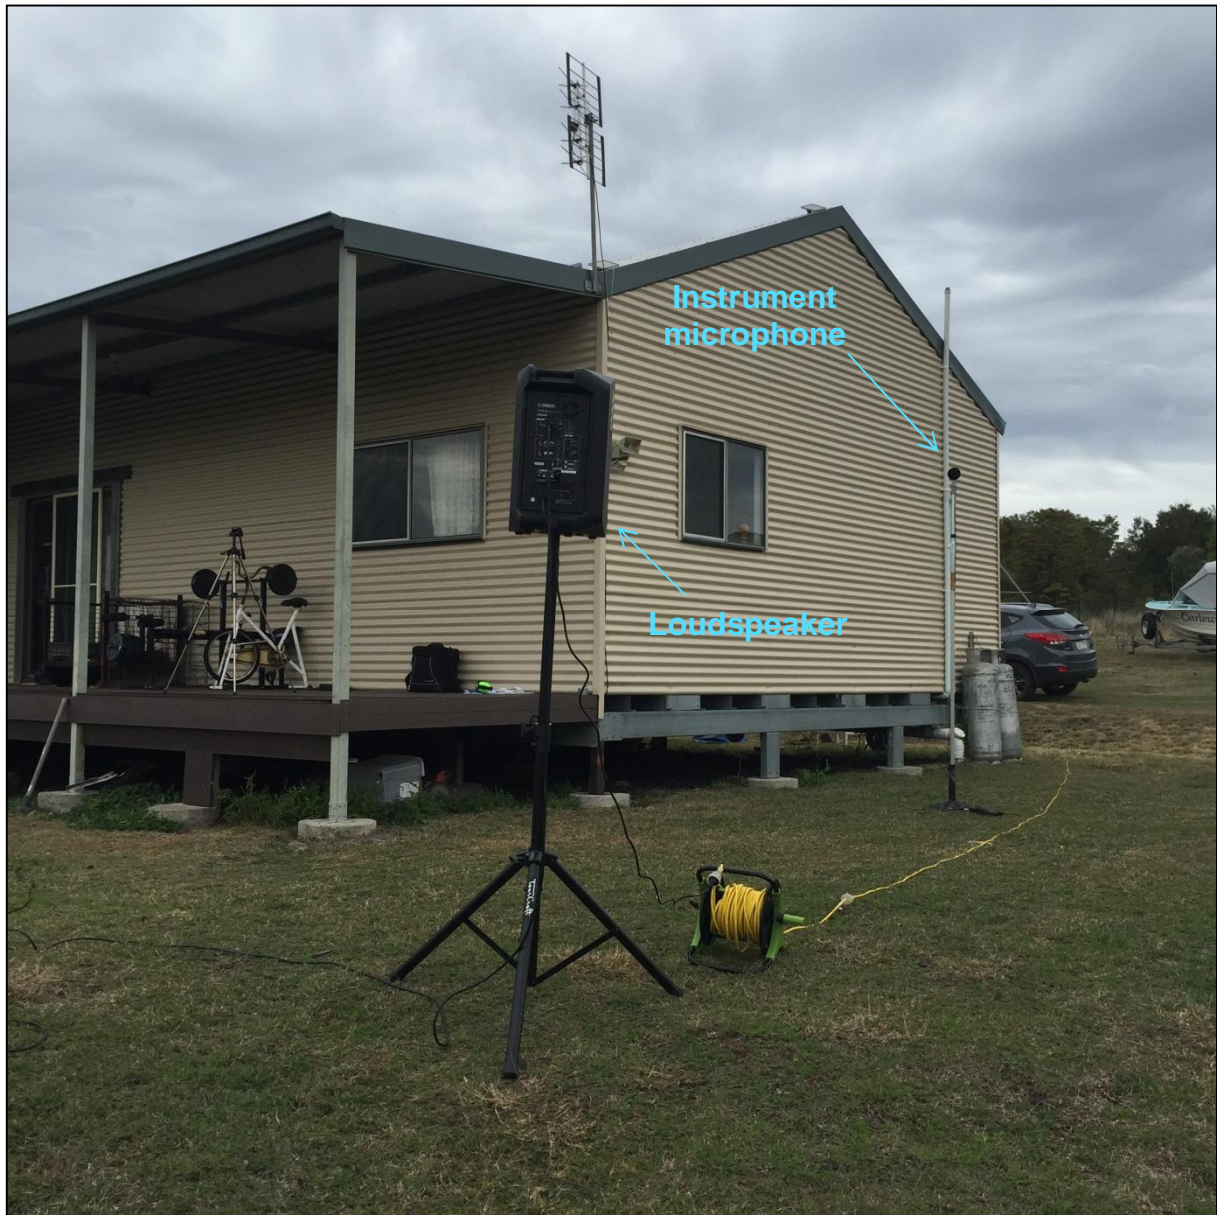
Figure 2 Example instrument microphone placed at 2m from façade and at 1.5m above finished floor level

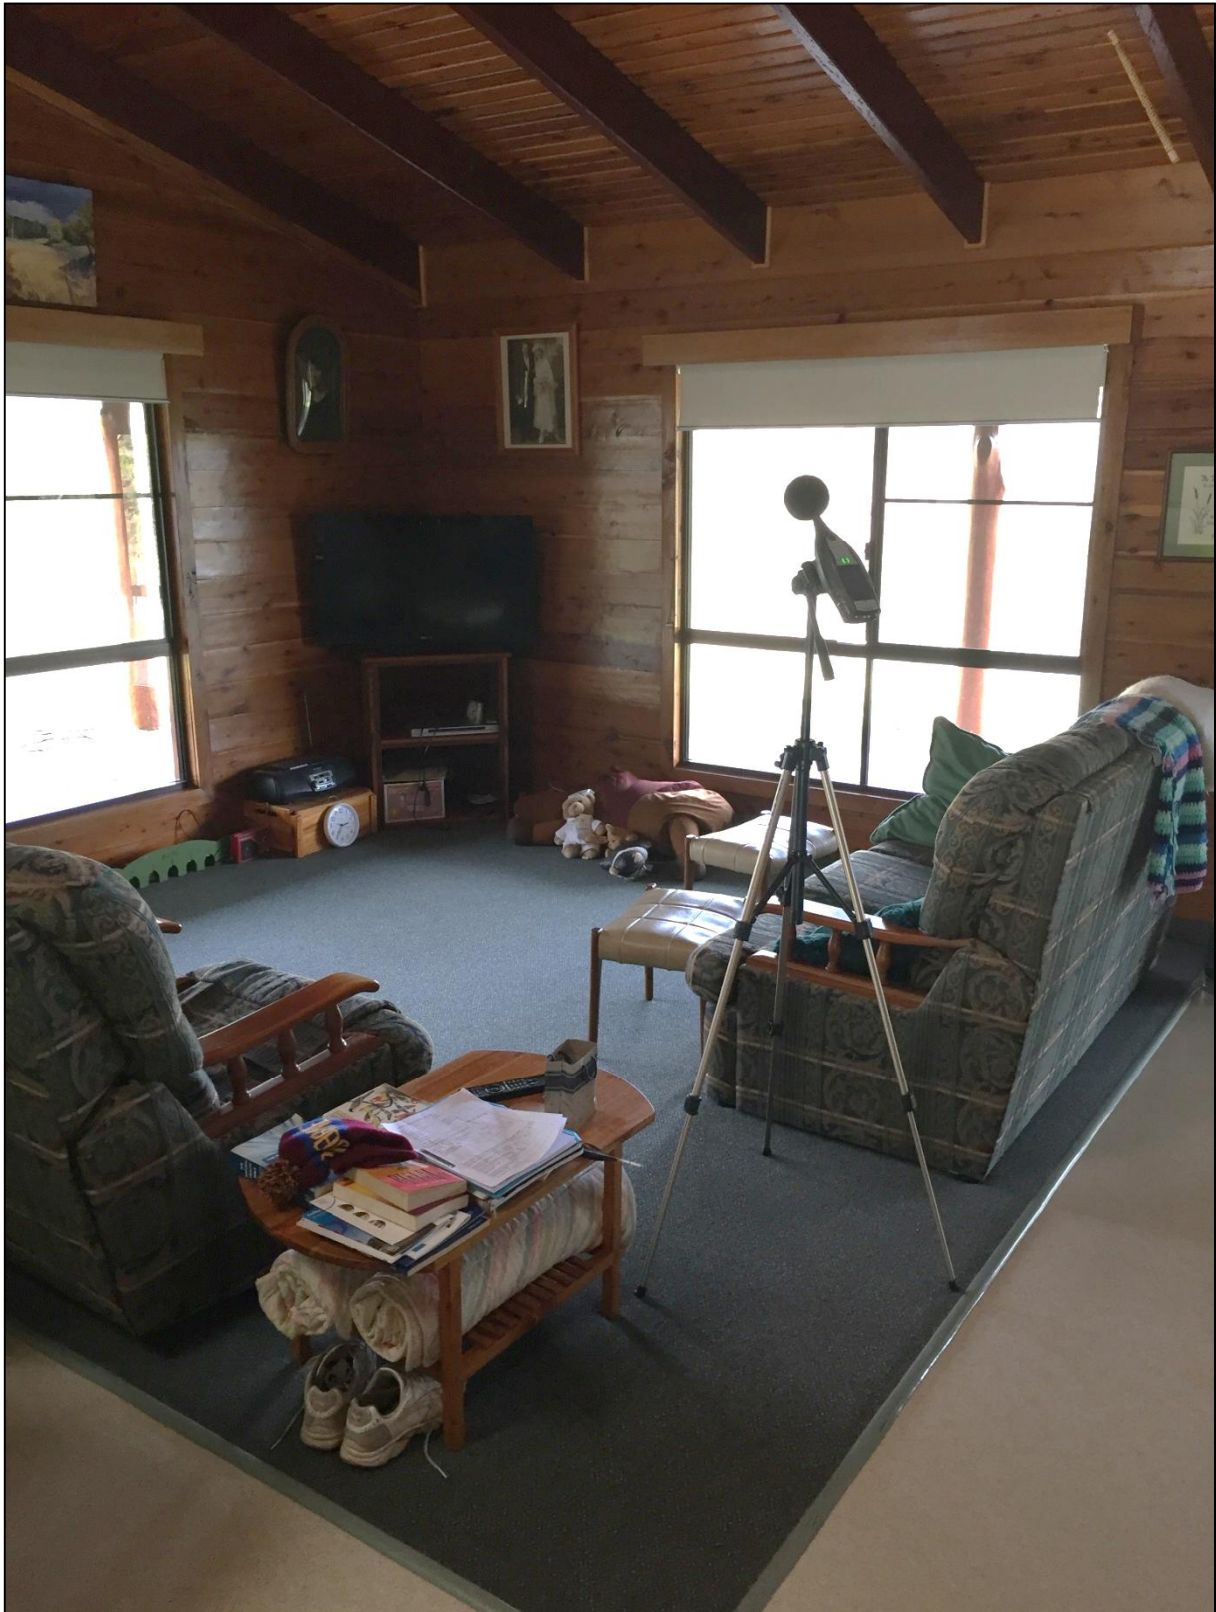
Figure 3 Example background noise measurement setup

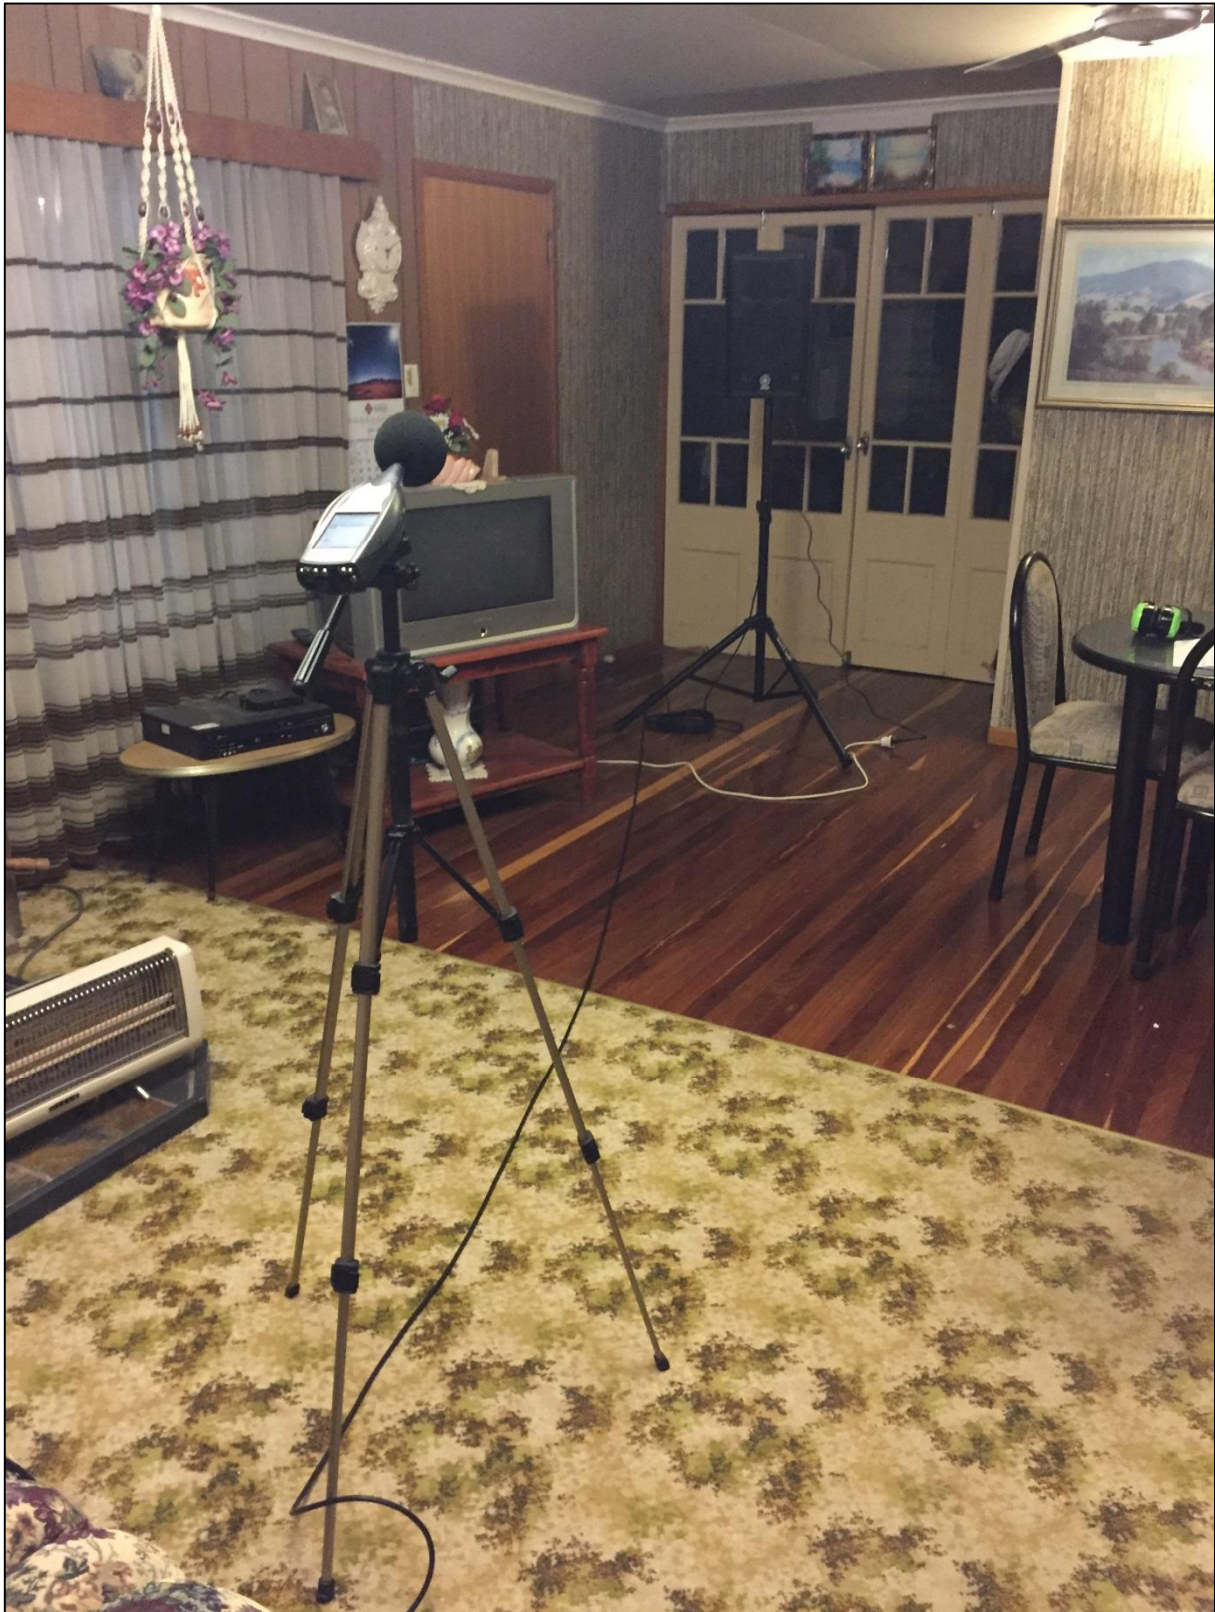
Figure 4 Example reverberation time measurement setup

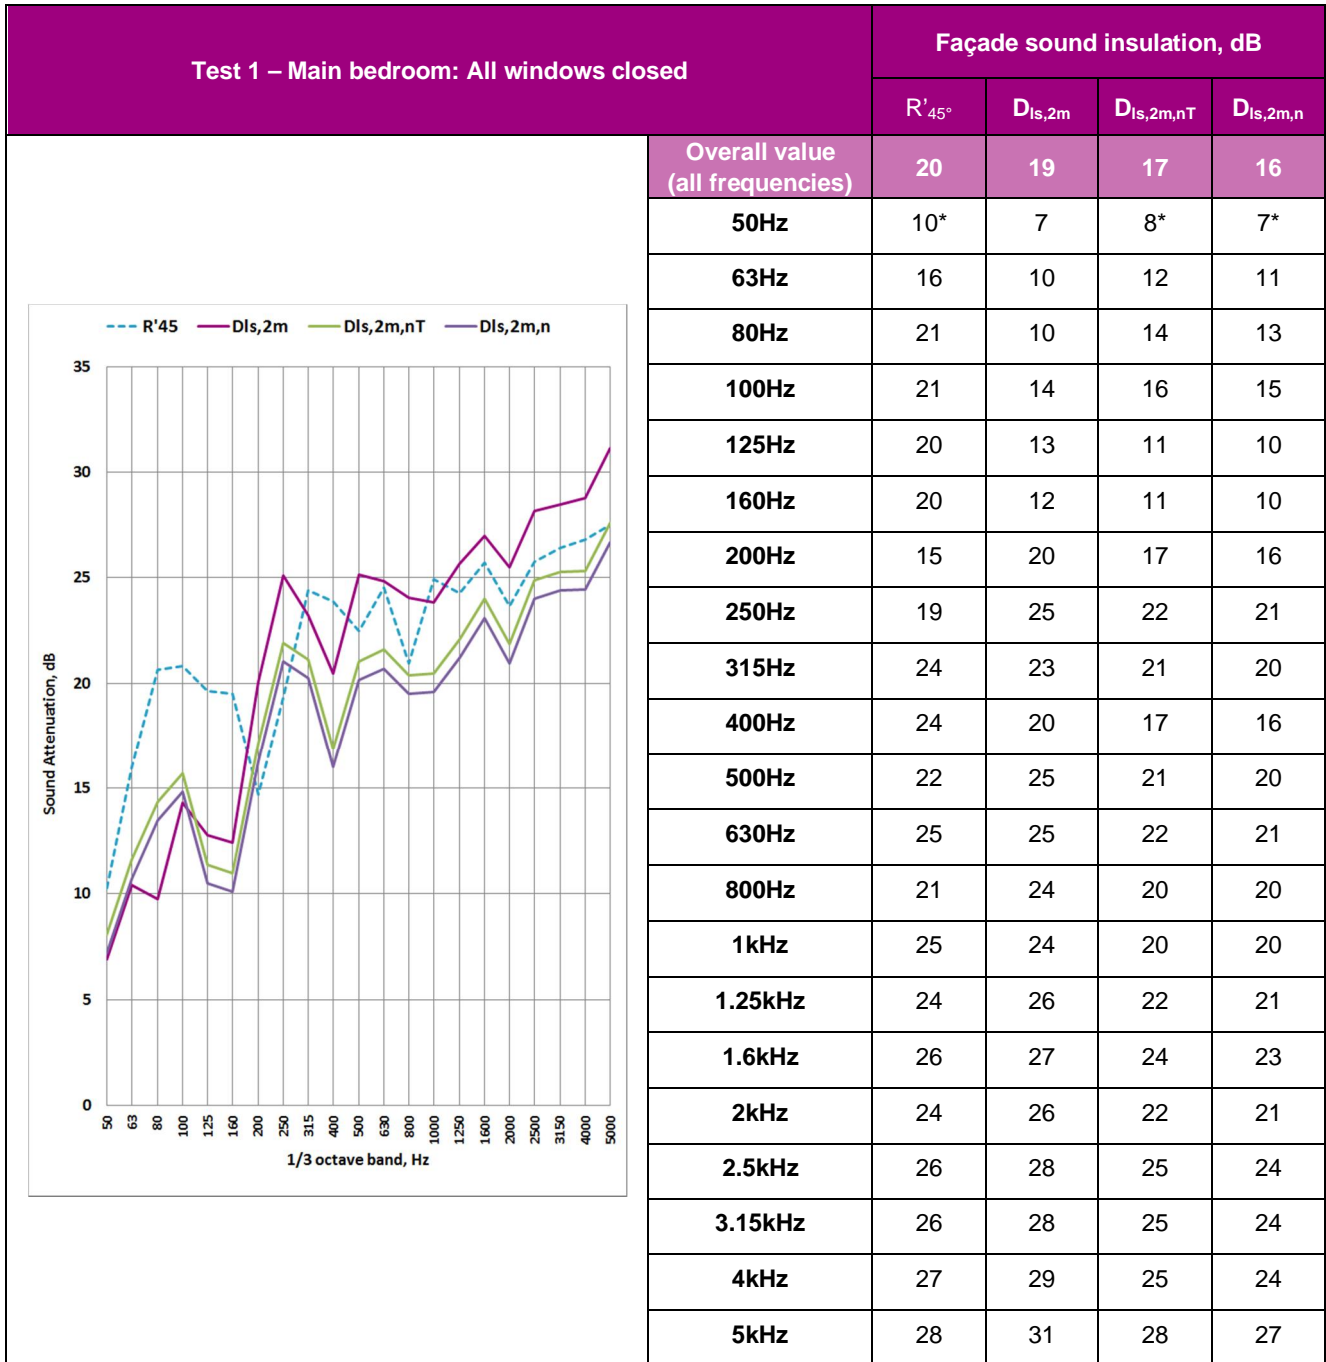
\*: Value calculated using extrapolated value of reverberation time, due to problems measuring reverberation in small volume room
