# Solar Flagships Program

## PRELIMINARY HYDROLOGIC ANALYSIS NYNGAN SOLAR PV PLANT (NORTHERN BLOCK)

- Revision 2
- 29 March 2011

AGL Energy Limited

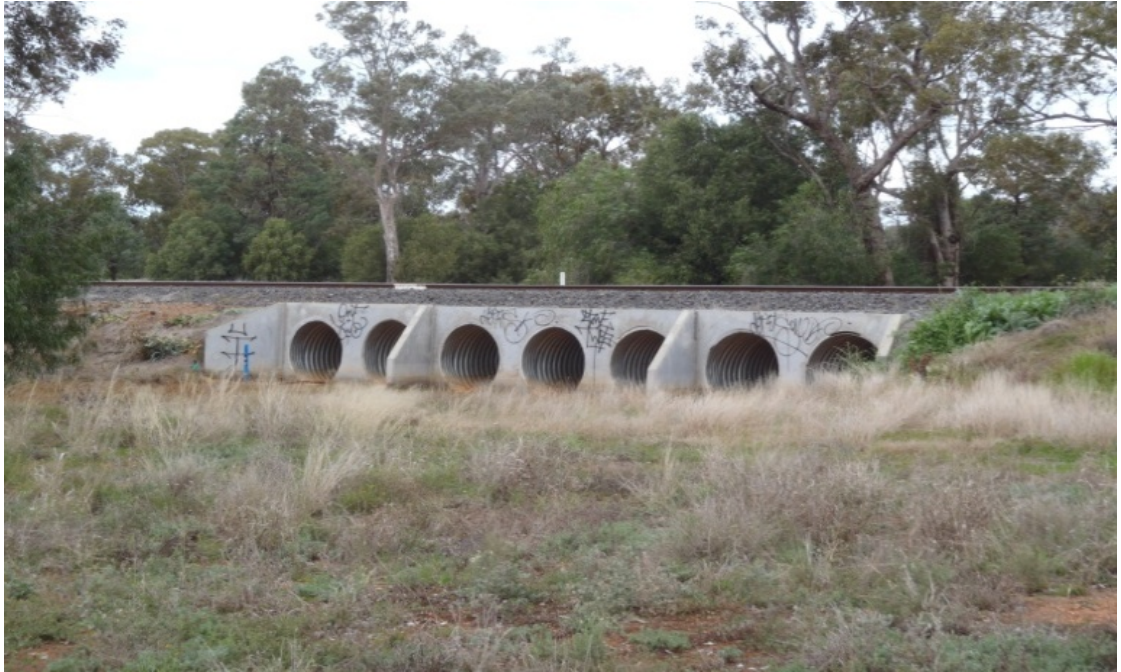
- **Figure 2.1 Whitbarrow Creek northern branch culverts under the Nyngan-Cobar Railway line**

- The culverts under the railway (twin 2.4 m box culverts) were replaced by Australian Rail Track Corporation (ARTC) with seven 1.5 m diameter (refer to **Figure 2.1**) Armco pipes after the 1980s flood and prior to the 1992 flood;

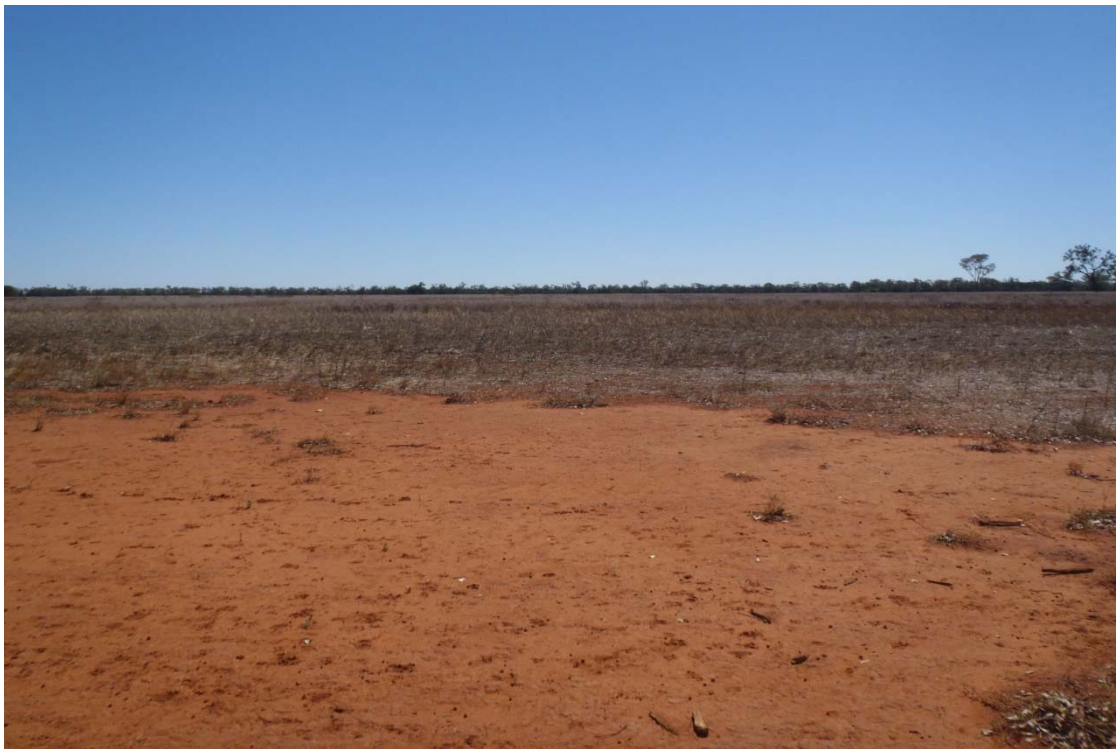
■ **Figure 2.3 Typical soils within the Nyngan property**

The successive site visits confirmed that throughout the property the soils are red/brown earths with no evidence of floodplain related soils. The red/brown earths are evident in **Figure 2.3**.
