### PROPERTY CONDITION SURVEY

Old Punt Road  
TOMAGO NSW

24 March 2015

AD1475

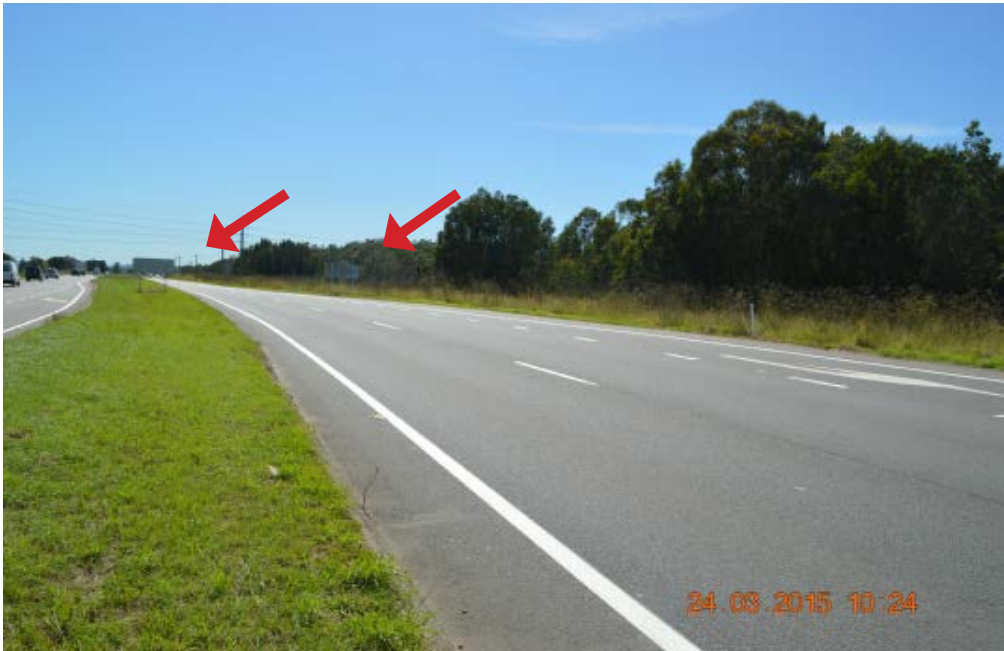
Refer to photo 18.

Showing new road signs.

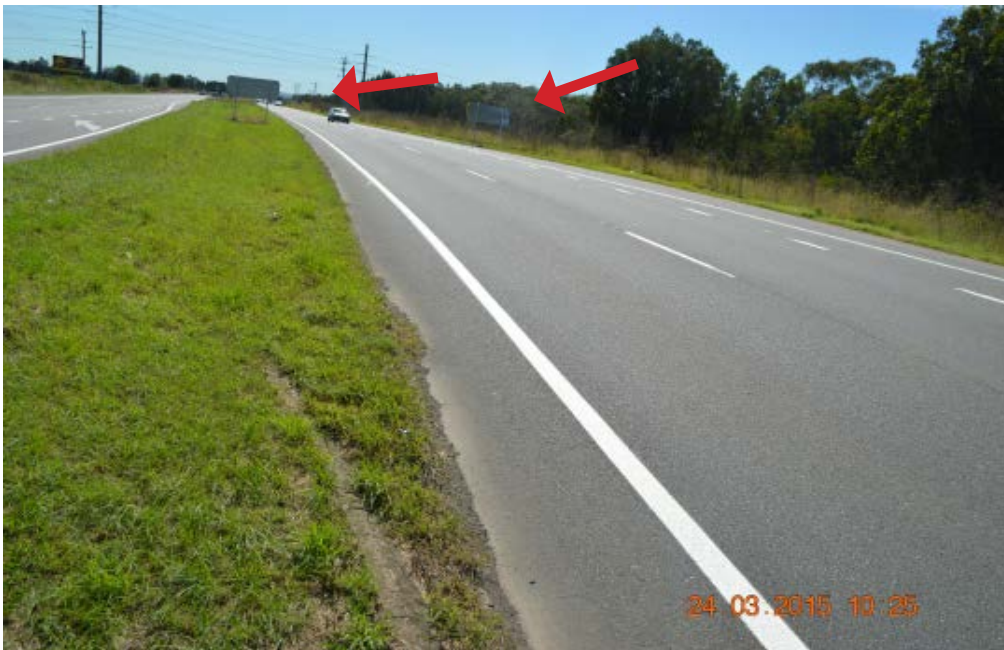
Refer to photo 19.

1. Showing new road signs. See photo 19-21.
2. Showing missing reflector post. See photo 27.
3. Showing replaced reflectors. See photo 29.
4. Showing repainted road lines. See photo 30.

Showing new road signs.

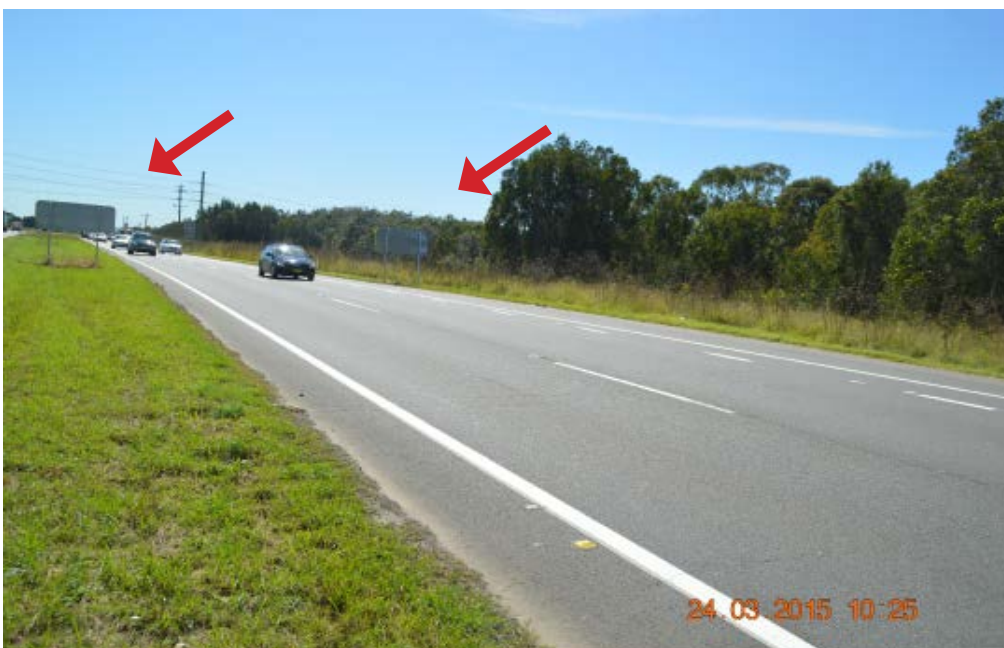
Showing new road signs.

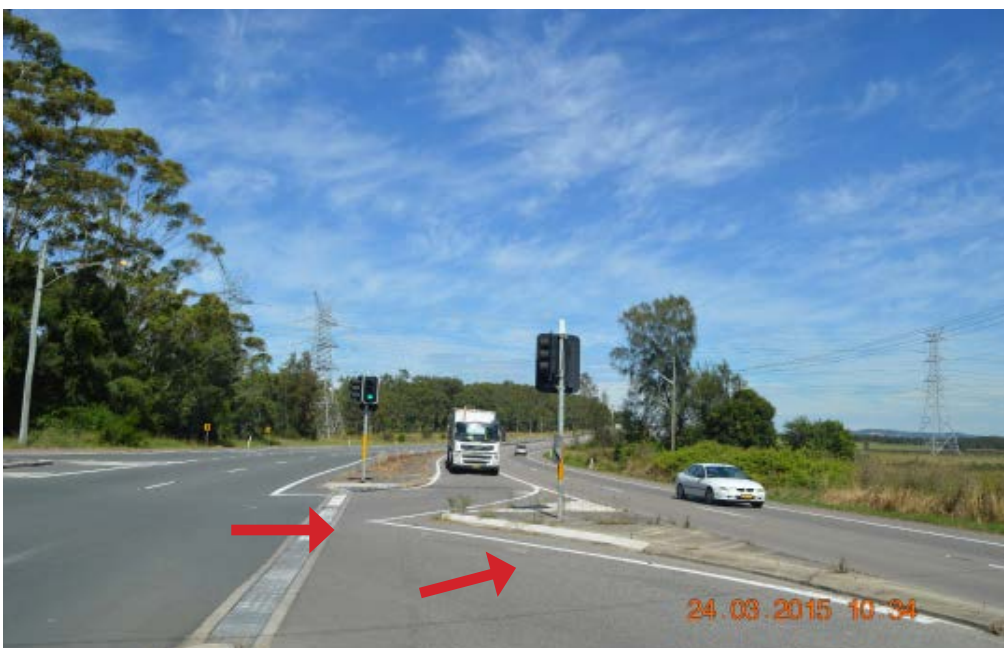
Refer to photo 30.

Showing repainted road lines.

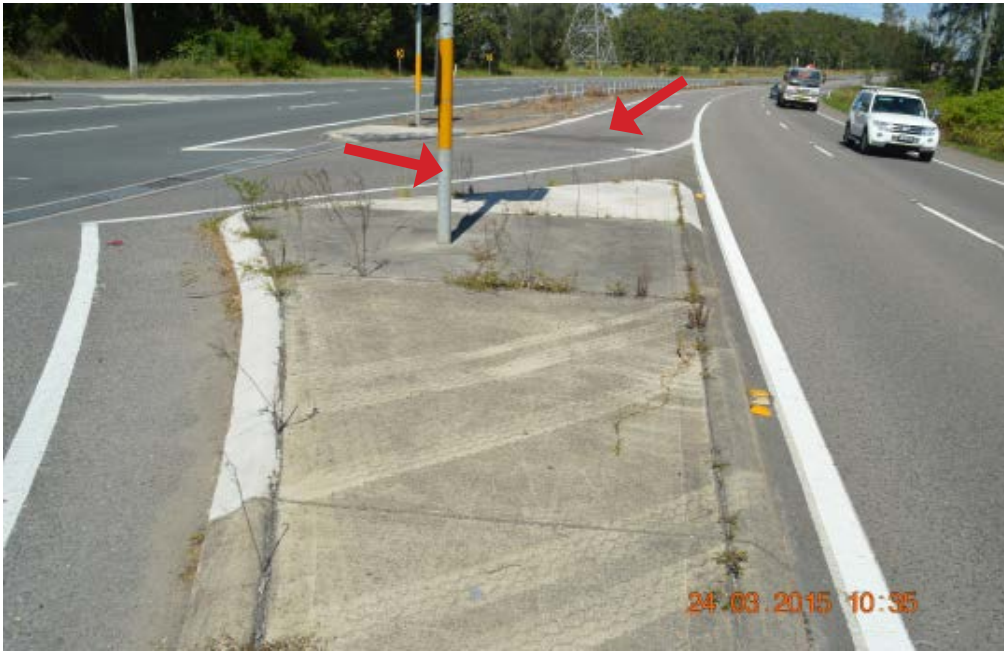
Refer to photo 31.

5. Showing altered road lines. See photo 31-33.
6. Showing missing reflectors. See photo 35.
7. Showing missing reflector post. See photo 37-38.
8. Showing missing reflector. See photo 39.

Showing altered road lines.

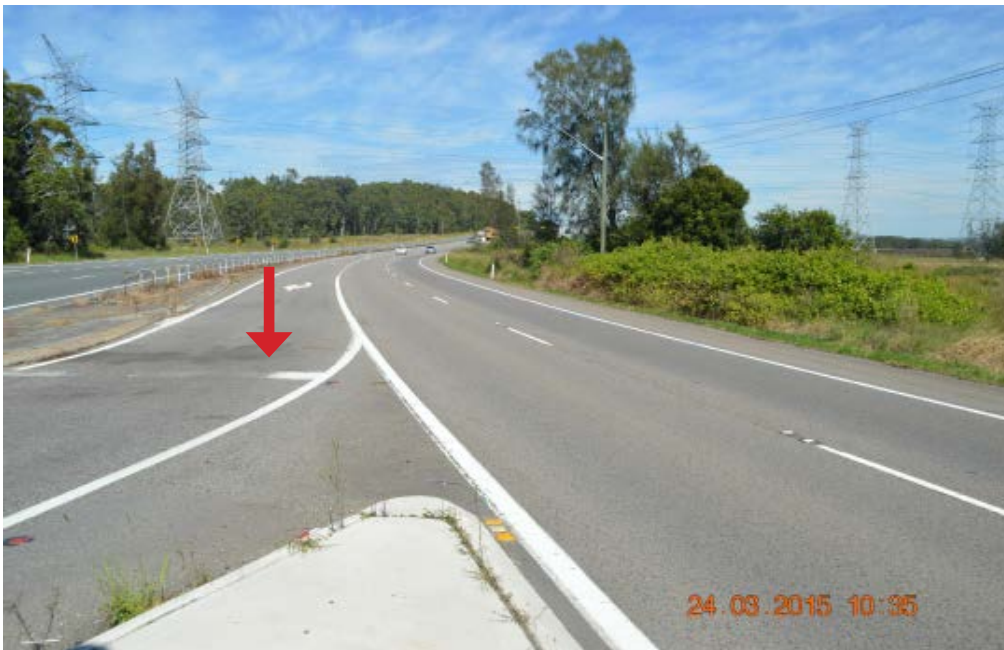
Refer to photo 32.

Showing altered road lines.

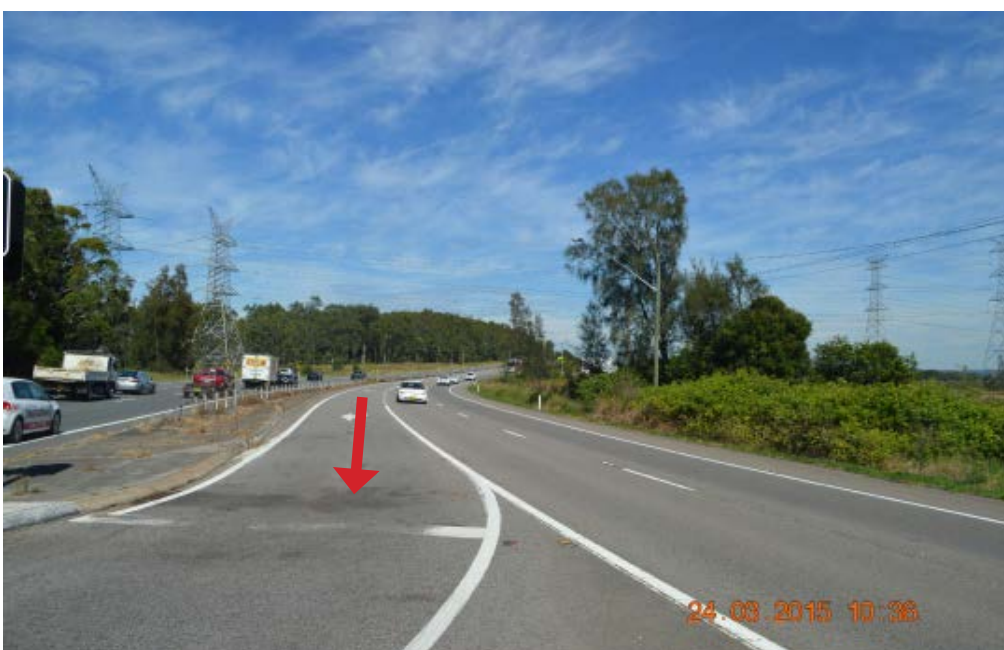
Refer to photo 32.

Showing altered road lines.

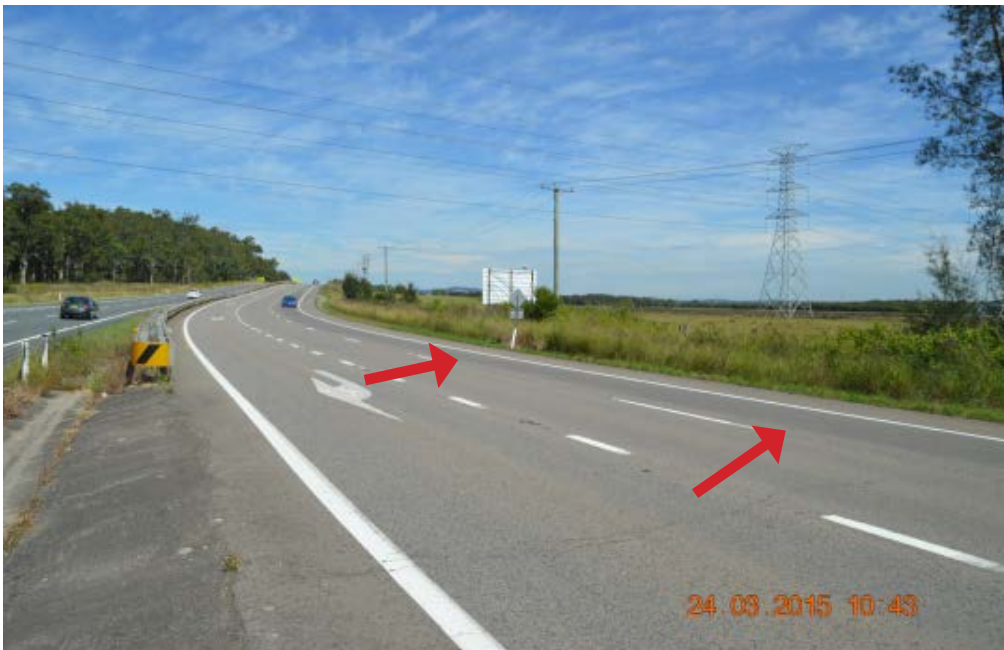
Refer to photo 43.

Showing altered sidelines.

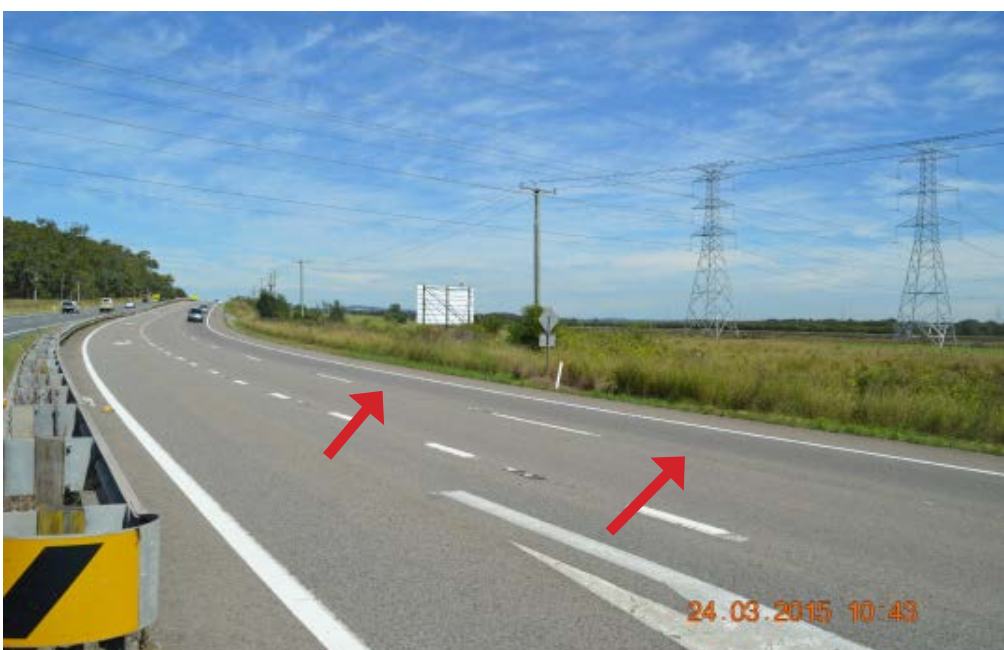
Refer to photo 45.

Showing altered sidelines.

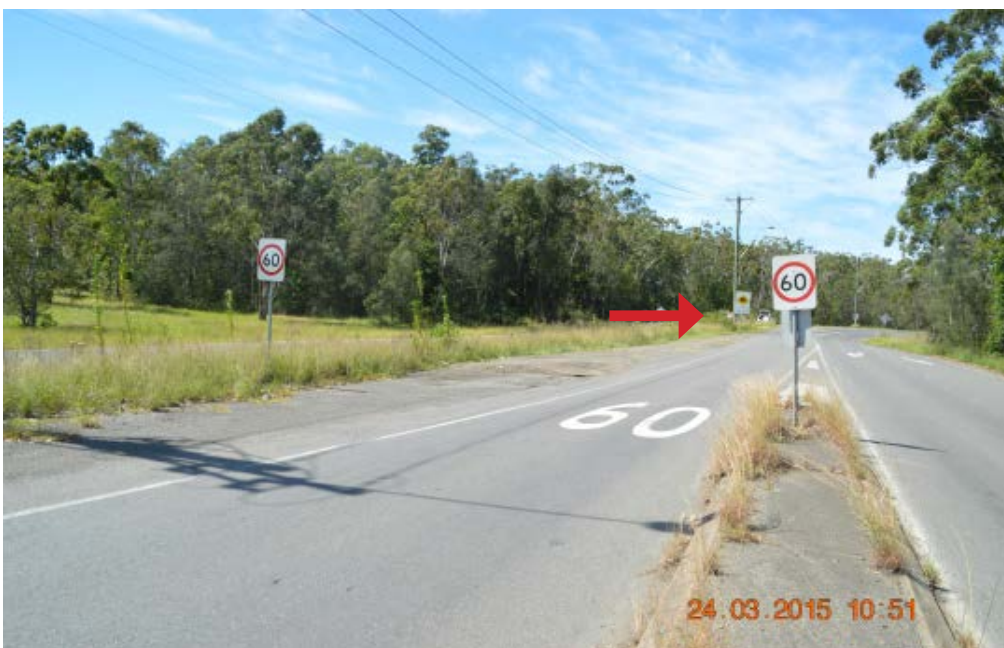
Refer to photo 69.

Speed signs on Old Punt Road near the intersection.

Showing additional road sign.

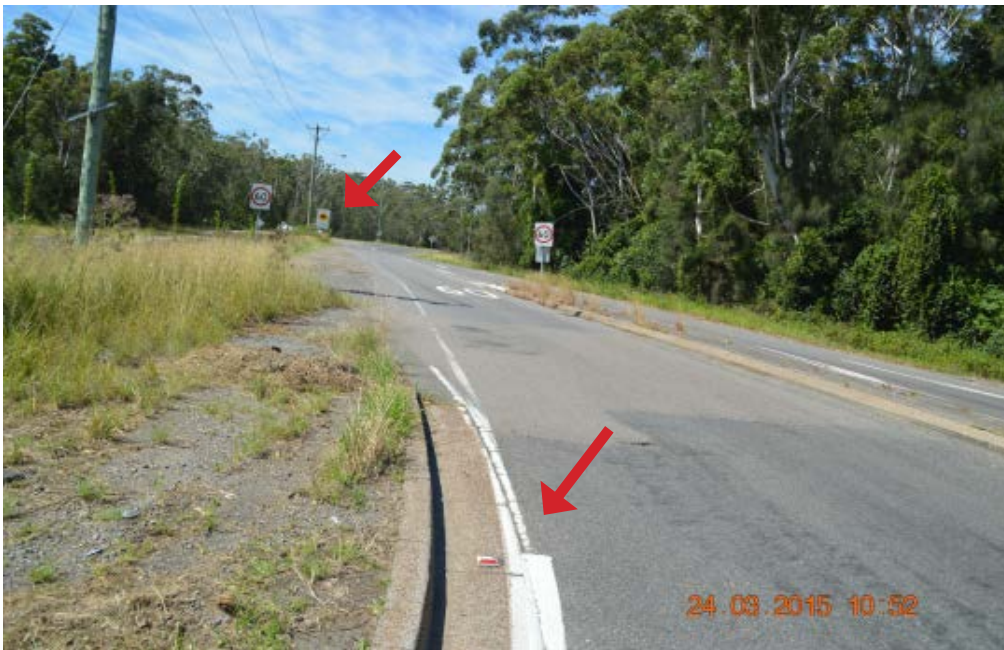
Refer to photo 71.

North side of Old Punt Road at 20 metres from the intersection with the Pacific Highway.

Showing additional reflector and road sign.

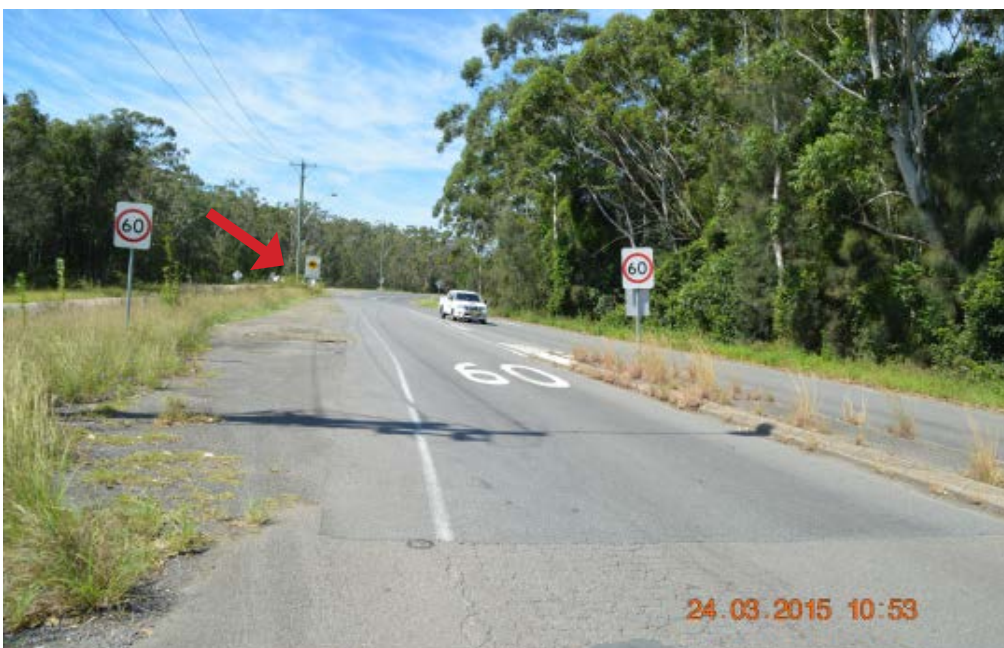
Refer to photo 72.

North side of Old Punt Road at 30 metres from the intersection with the Pacific Highway.

Showing additional road sign.

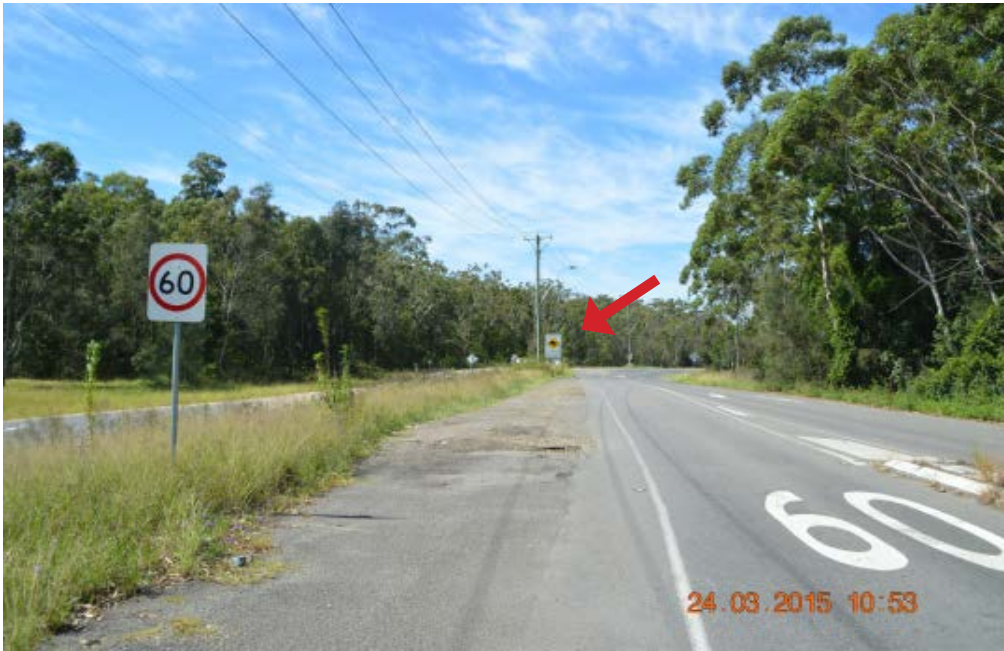
Refer to photo 73.

North side of Old Punt Road at 40 metres from the intersection with the Pacific Highway.

Showing additional road sign.

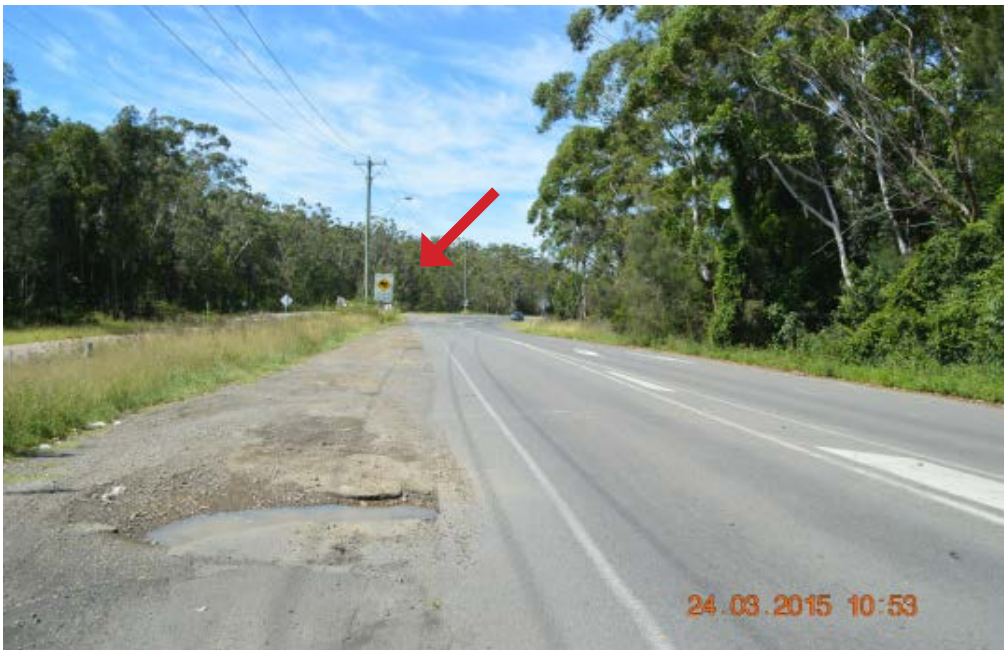
Refer to photo 74.

North side of Old Punt Road at 50 metres from the intersection with the Pacific Highway.

Showing additional road sign.

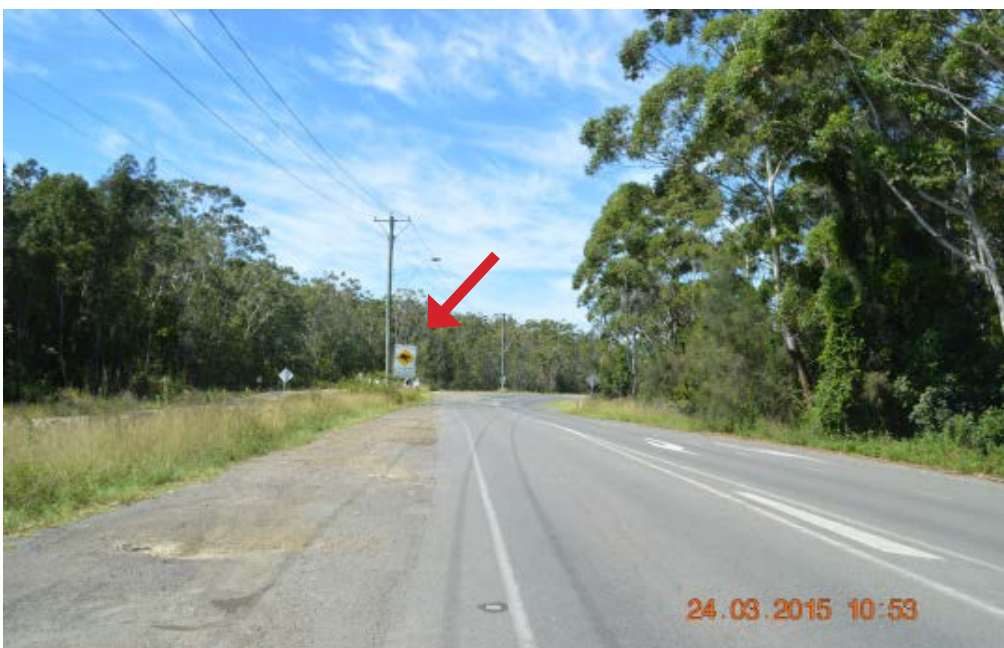
Refer to photo 75.

North side of Old Punt Road at 60 metres from the intersection with the Pacific Highway.

Showing additional road sign.

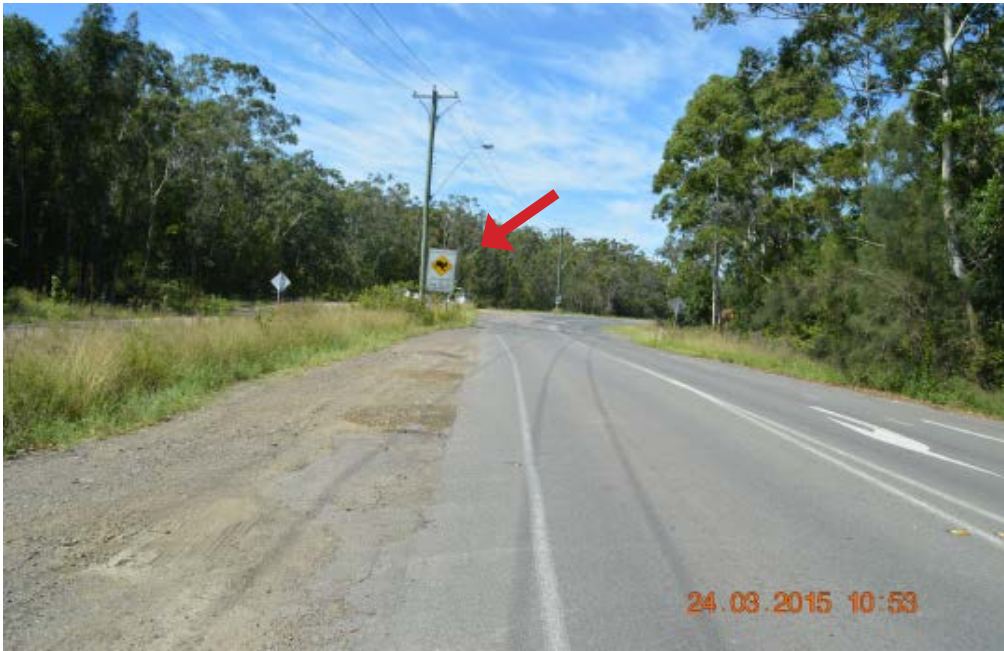
Refer to photo 76.

North side of Old Punt Road at 70 metres from the intersection with the Pacific Highway.

Showing additional road sign.

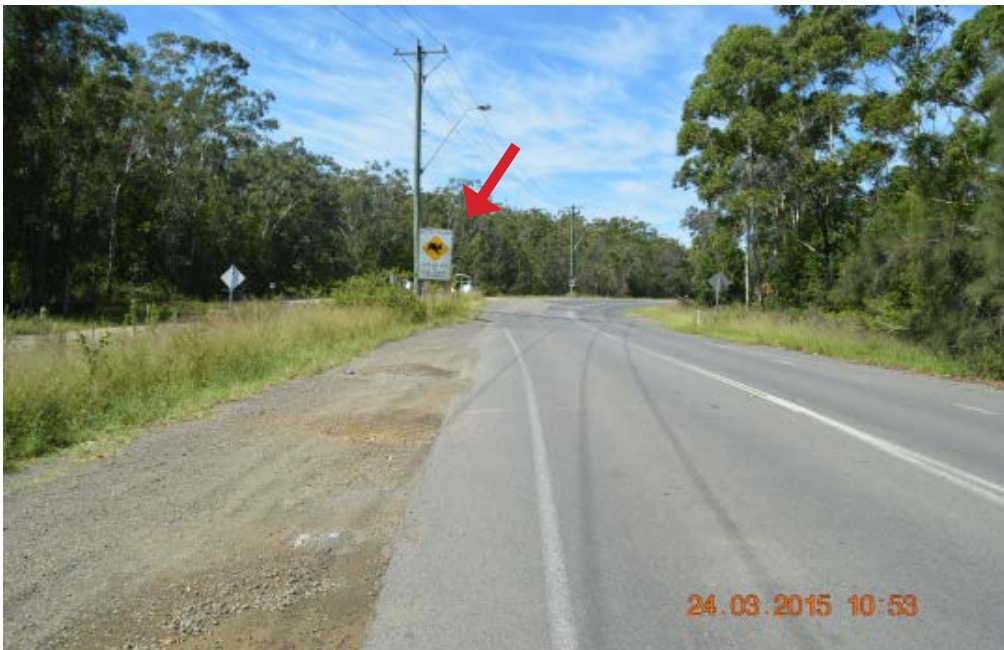
Refer to photo 77.

North side of Old Punt Road at 80 metres from the intersection with the Pacific Highway.

Showing additional road sign.

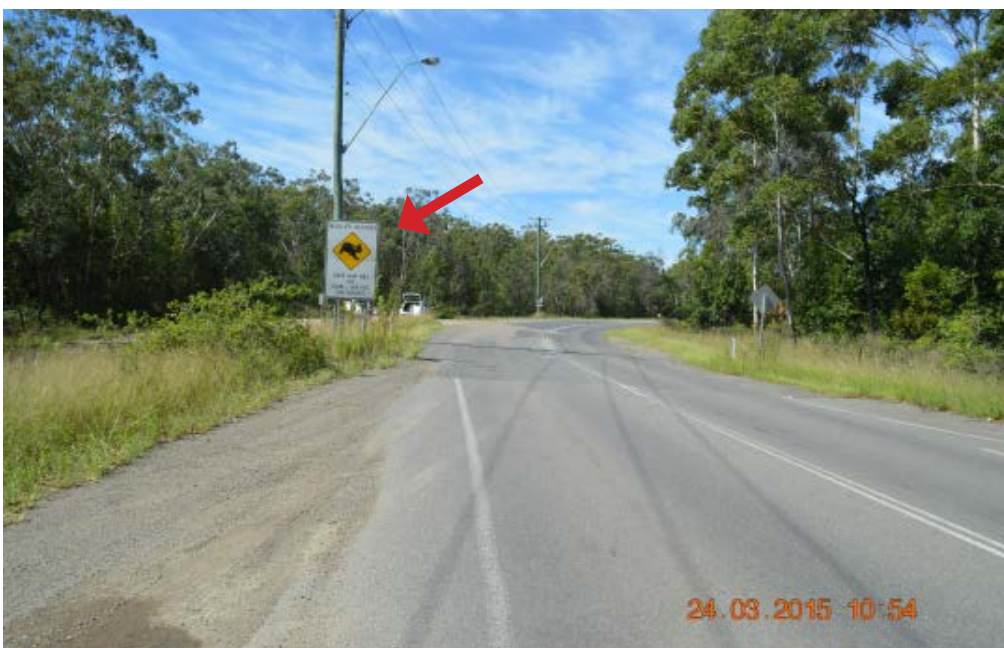
Refer to photo 78.

North side of Old Punt Road at 90 metres from the intersection with the Pacific Highway.

Showing additional road sign.

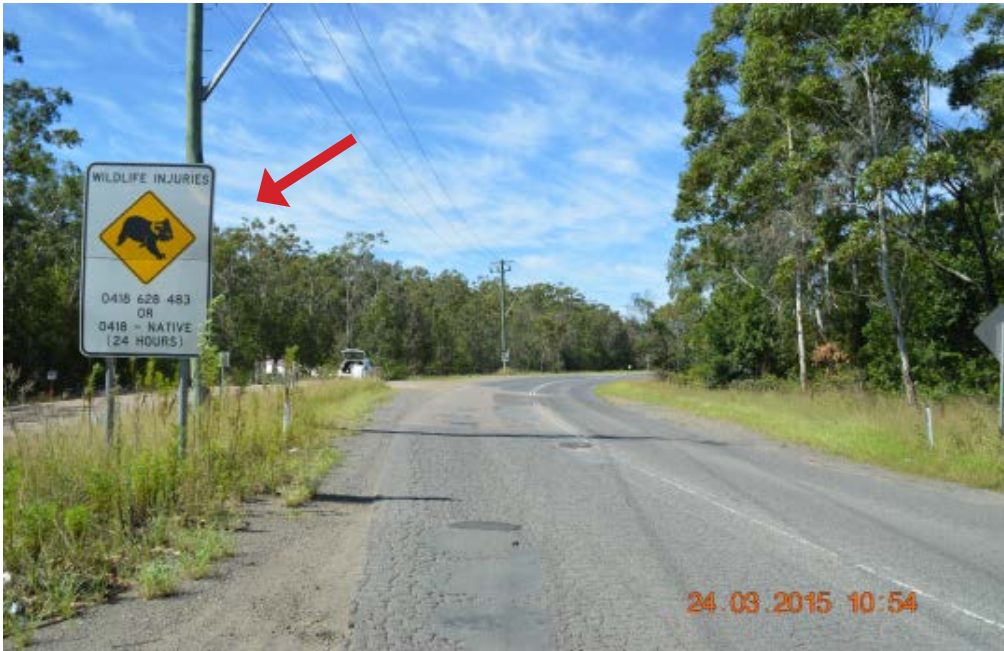
Refer to photo 79

North side of Old Punt Road at 100 metres from the intersection with the Pacific Highway.

Showing additional road sign.

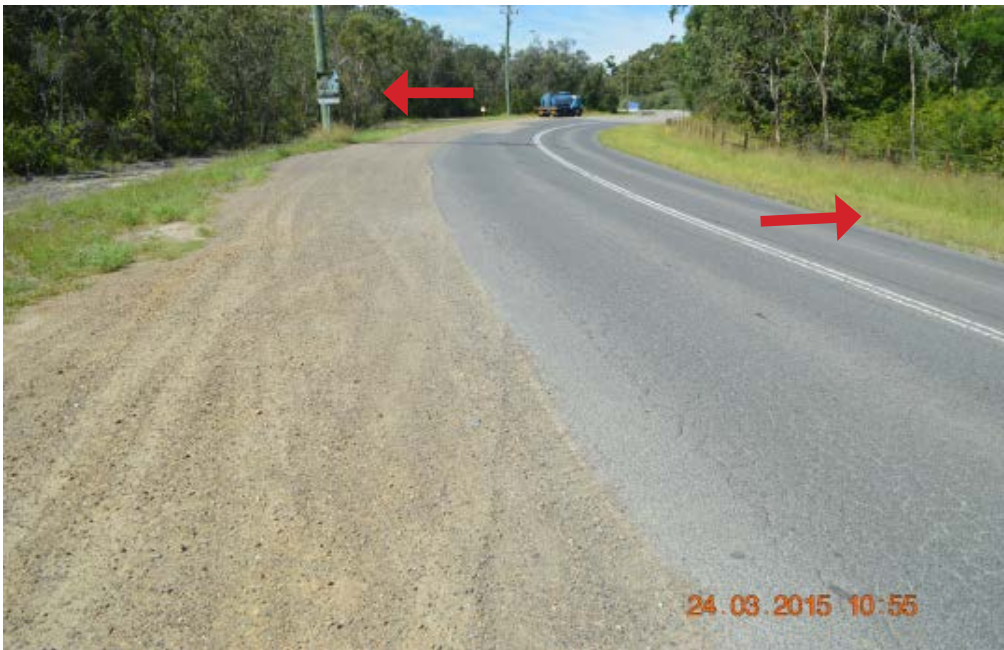
Refer to photo 86.

North side of Old Punt Road at 170 metres from the intersection with the Pacific Highway.

Showing additional road sign and missing reflector post.

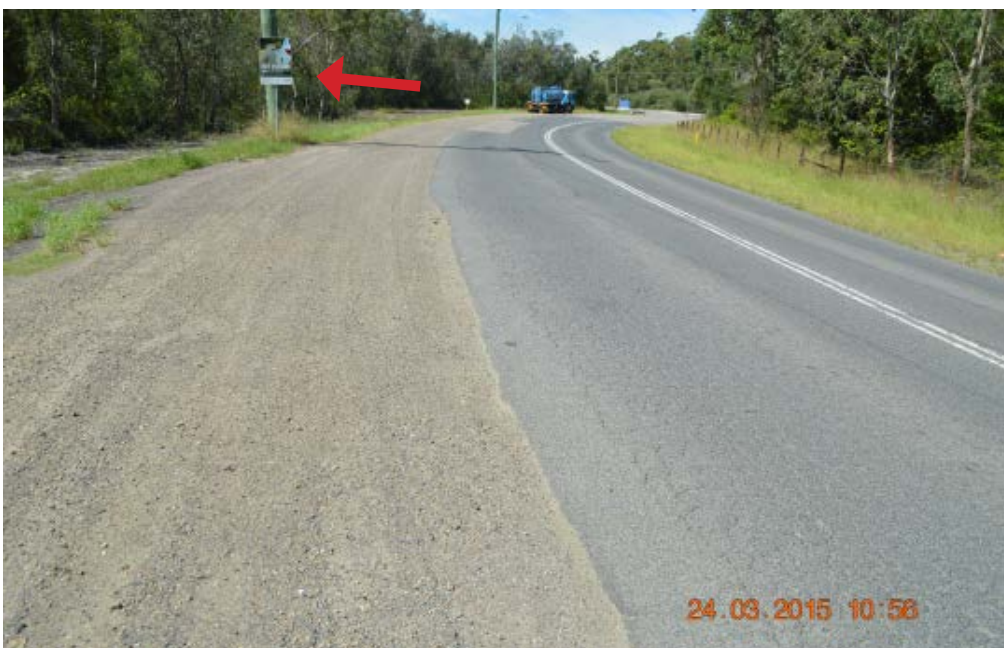
Refer to photo 87.

North side of Old Punt Road at 180 metres from the intersection with the Pacific Highway.

Showing additional road sign.

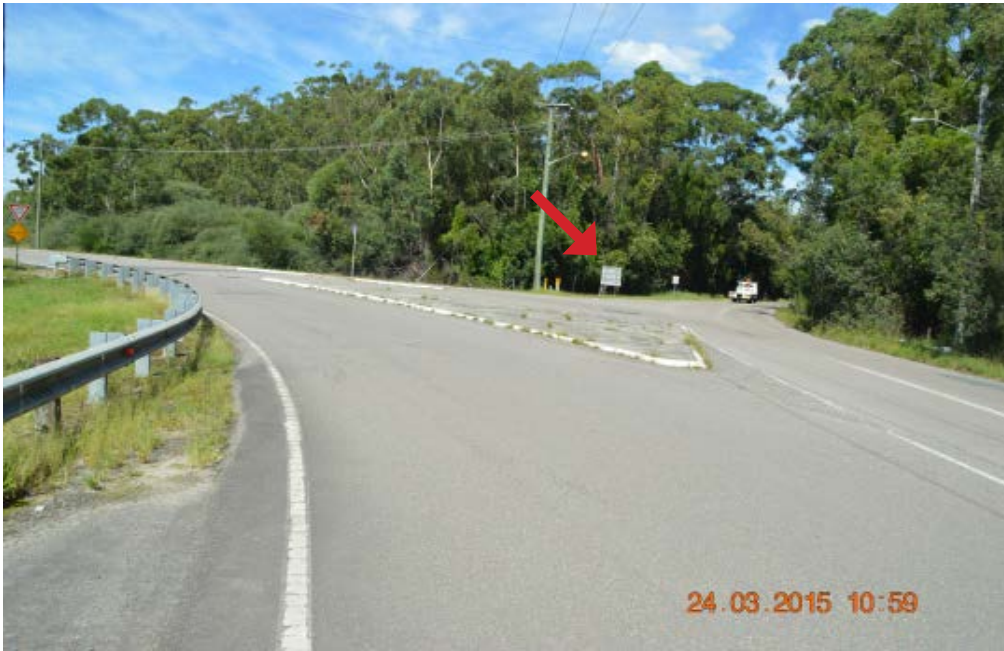
Refer to photo 100.

Showing replacement of road signs.

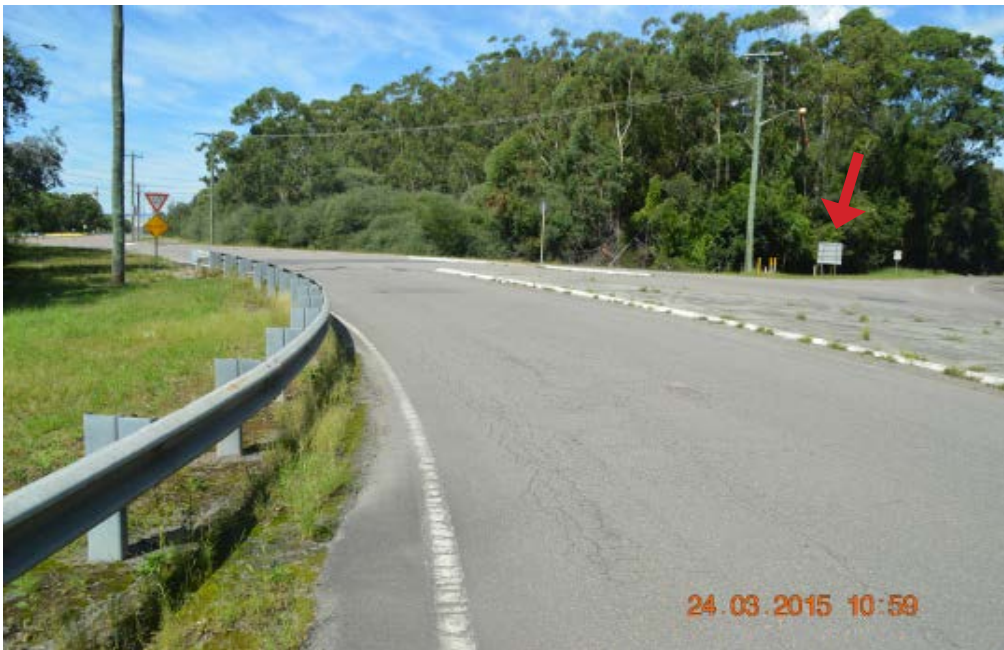
Refer to photo 101.

Showing replacement of road sign.

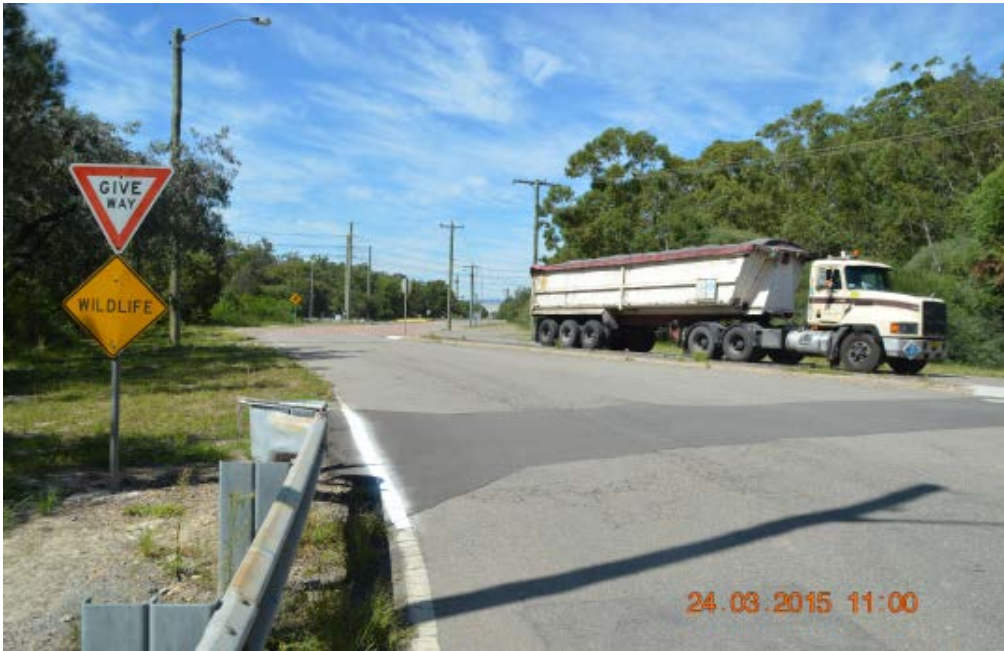
Refer to photo 103.

No changes noted.

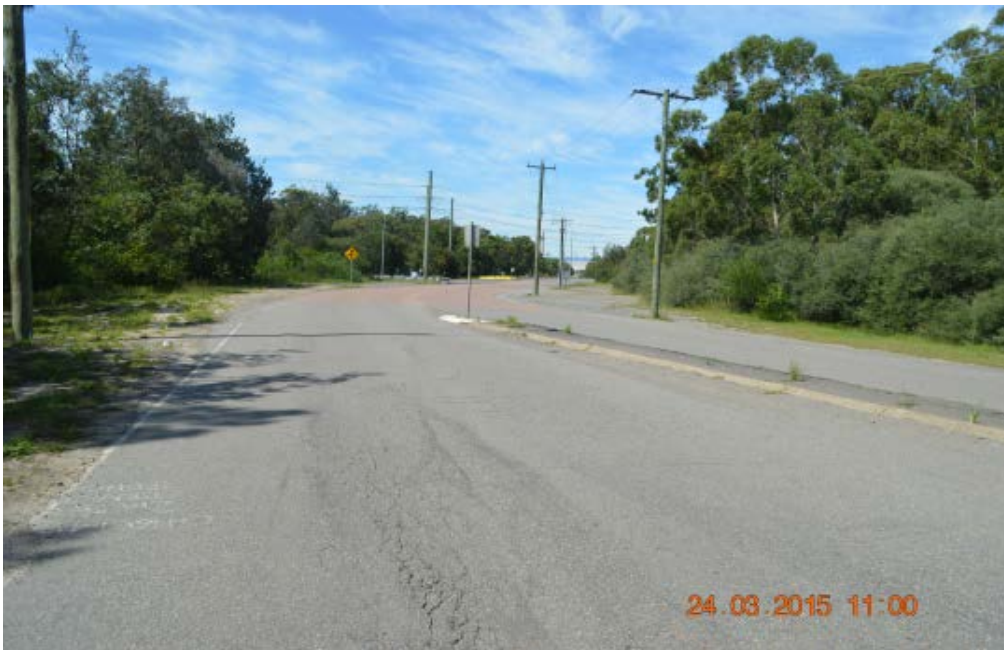
Refer to photo 104.

No changes noted.

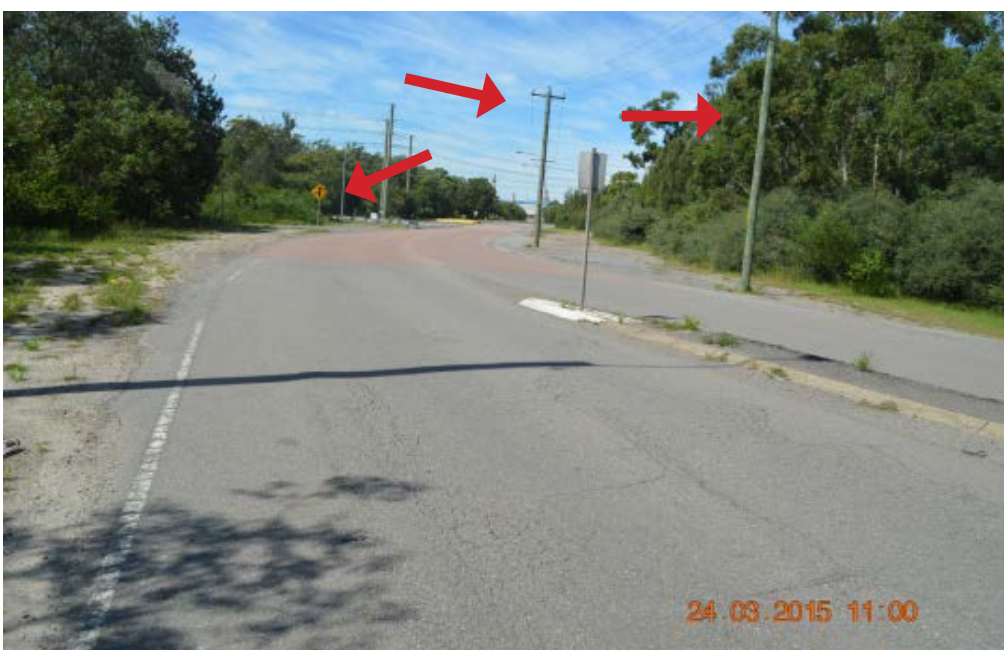
Refer to photo 105.

Showing additional road sign and power poles.

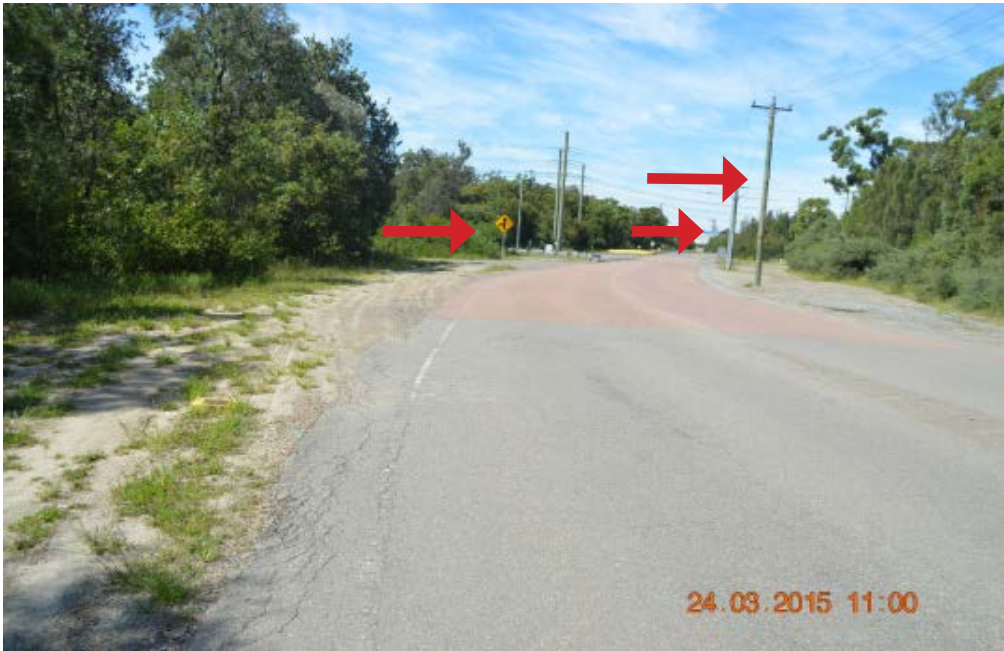
Refer to photo 106.

Showing additional road sign and power poles.

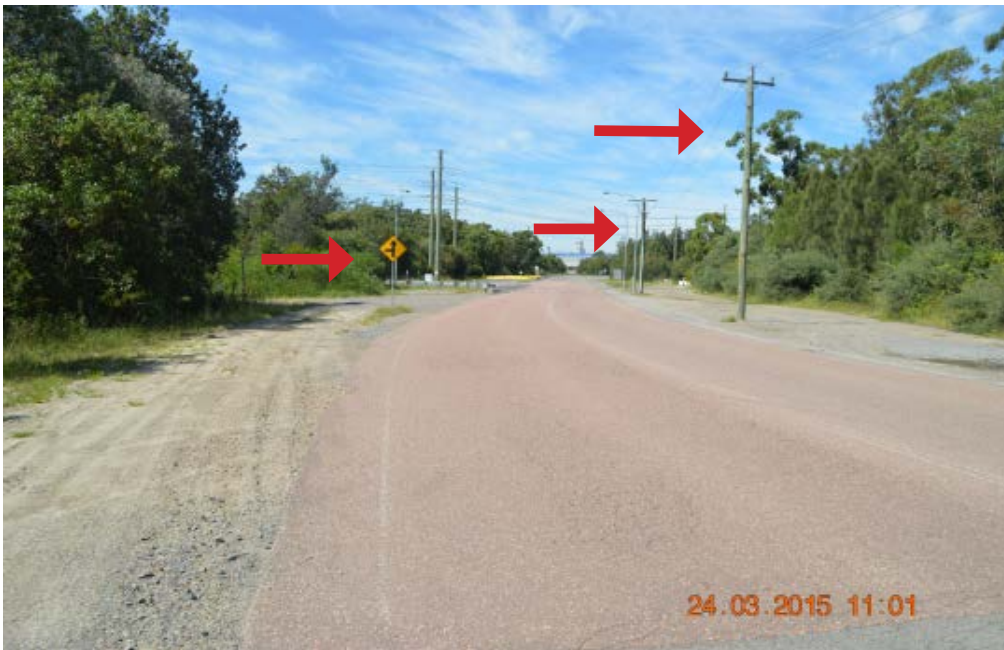
Refer to photo 107.

Showing additional road sign and power poles.

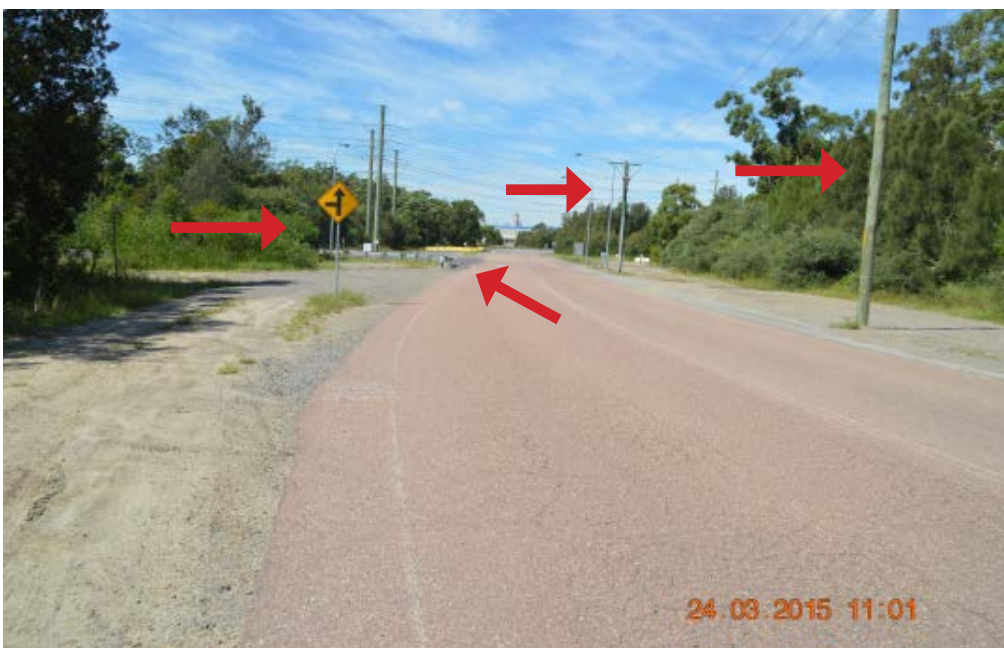
Refer to photo 108.

Showing additional power poles, street lights and side road.

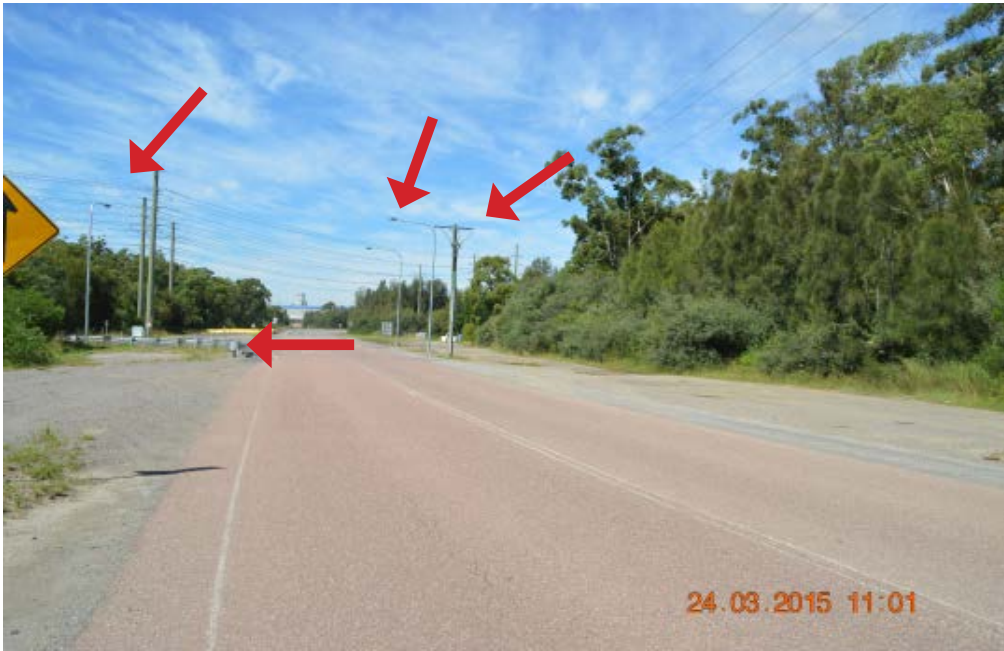
Refer to photo 109.

Showing additional power poles, street lights and side road.

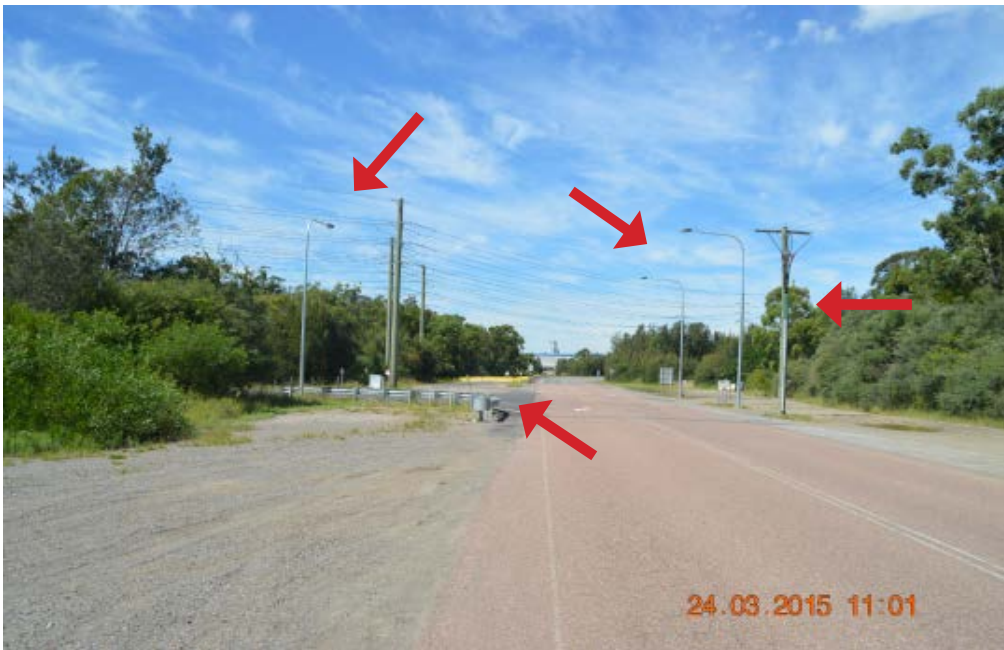
Refer to photo 110.

Showing additional power poles, street lights and side road.

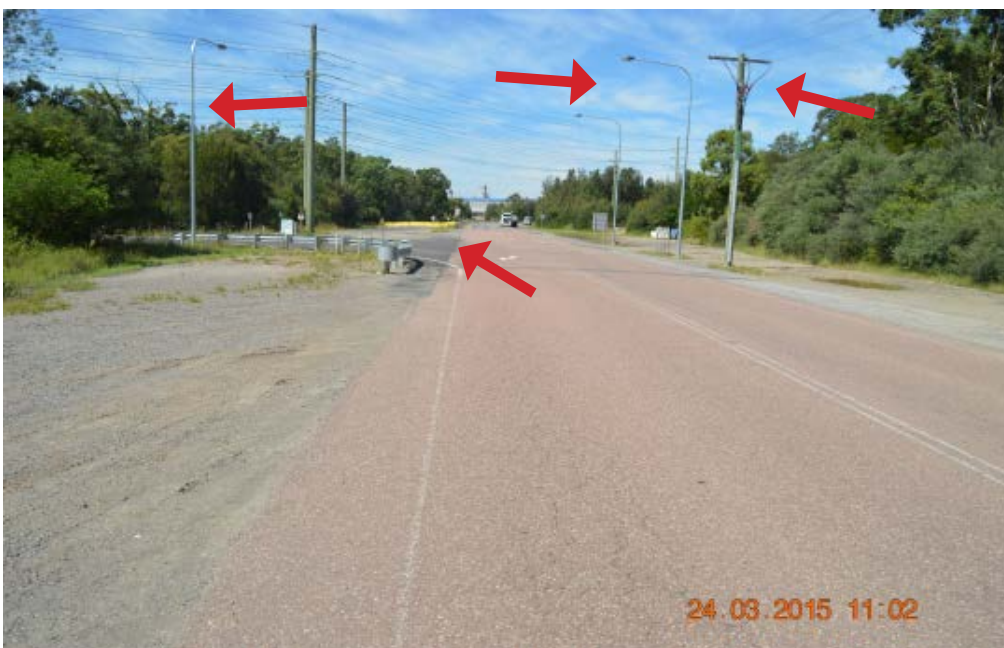
Refer to photo 111.

Showing additional power poles, street lights and side road.

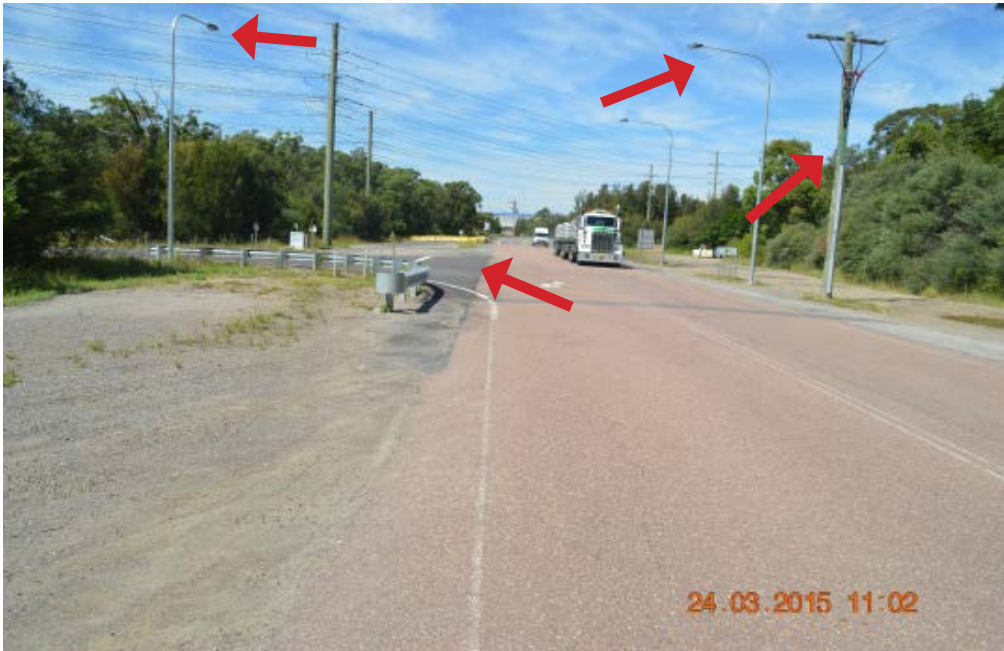
Refer to photo 112.

Showing additional power pole, street lights, and side road.

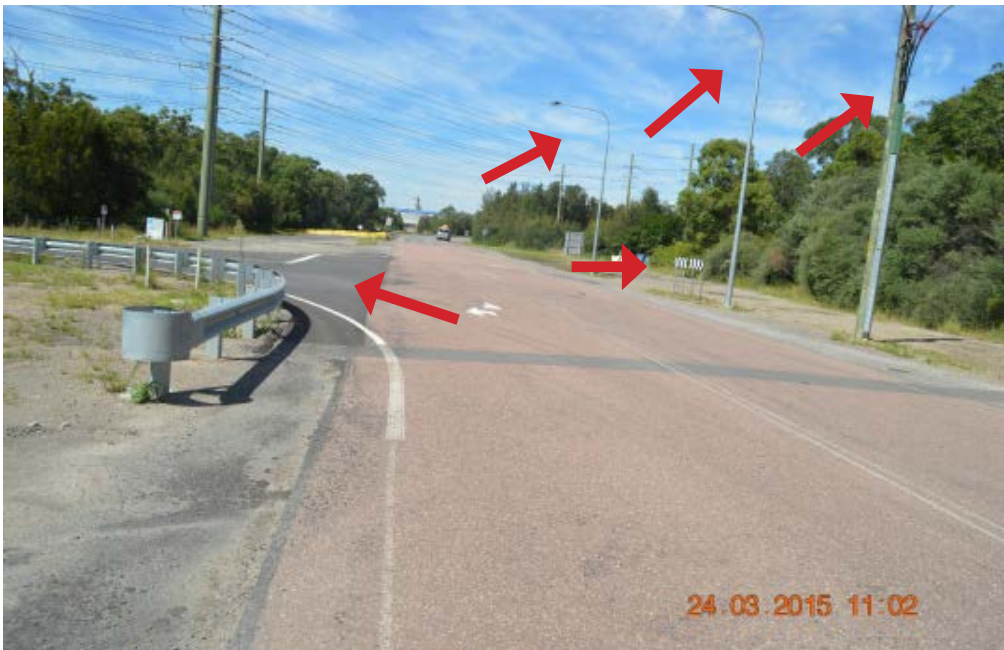
Refer to photo 113.

Showing additional street lights, road signs and side road.
