### PROPERTY CONDITION SURVEY

Old Punt Road  
TOMAGO NSW

24 March 2015

AD1475

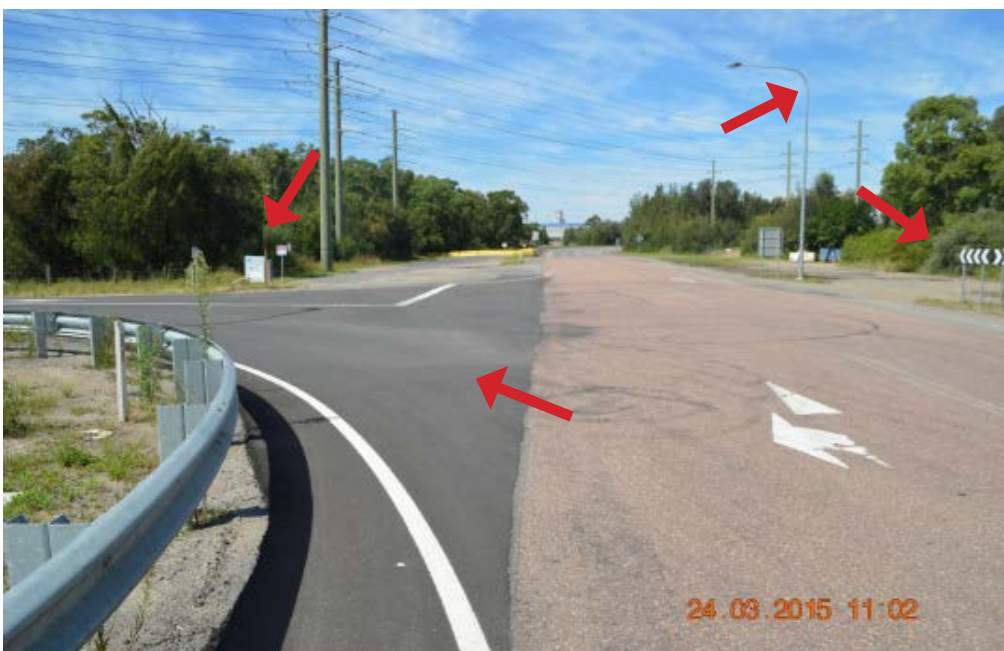
Refer to photo 115.

Showing additional street lights, road signs and side road.

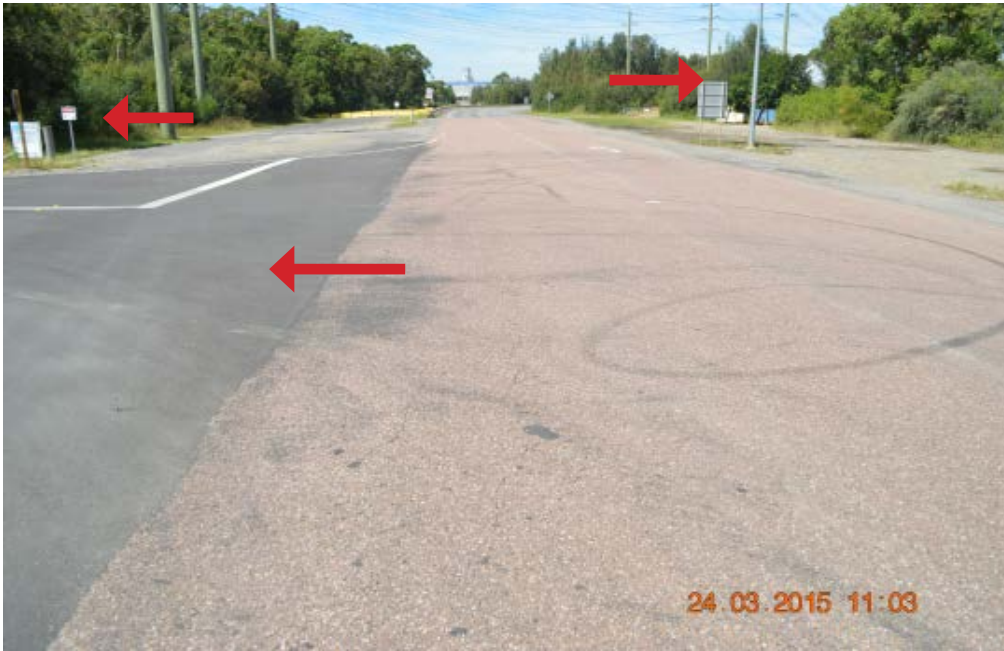
Refer to photo 116.

Showing additional street light, road signs and side road.

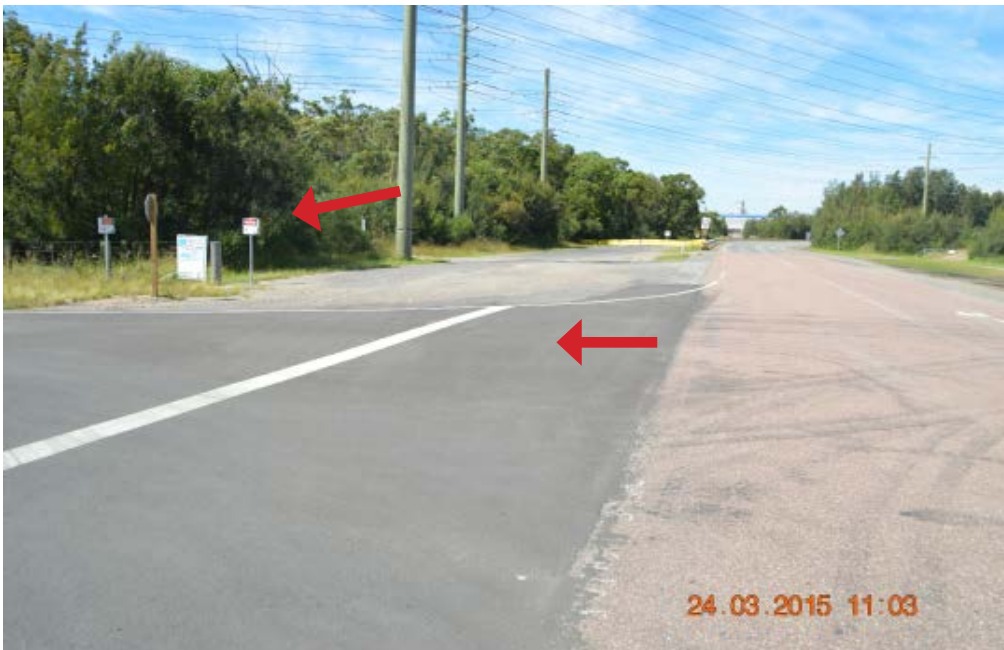
Refer to photo 116.

Showing additional side road and sign posts.

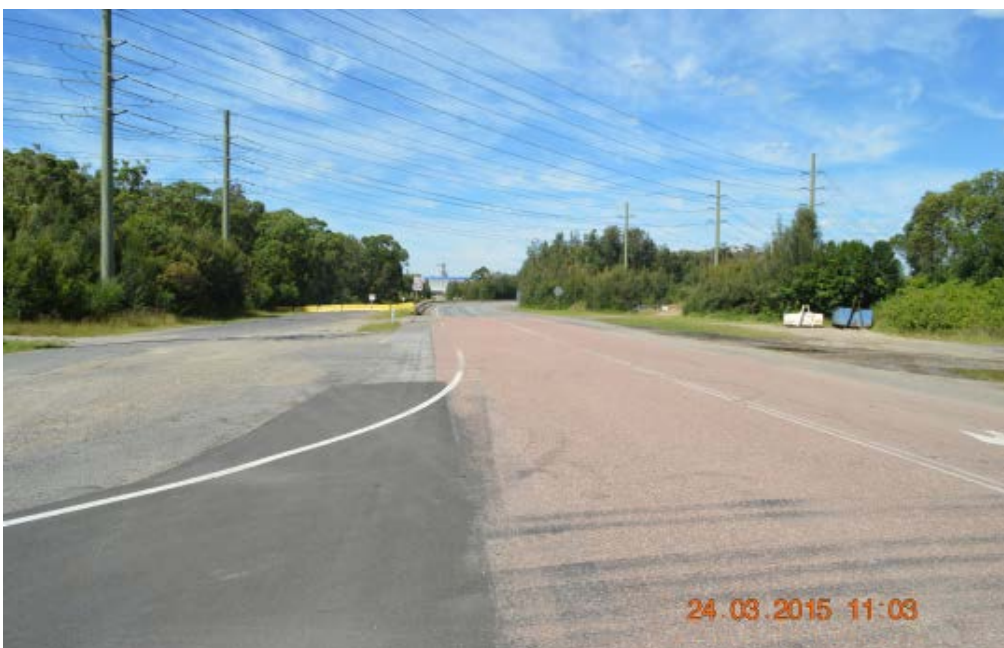
Refer to photo 117.

No changes noted.

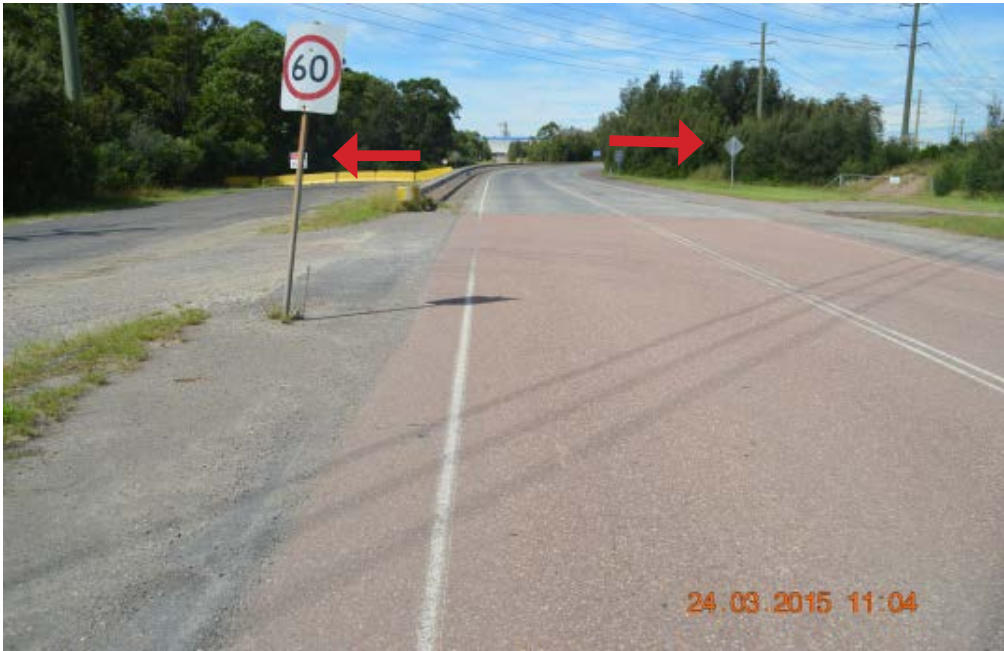
Refer to photo 121.

Showing new sign posts.

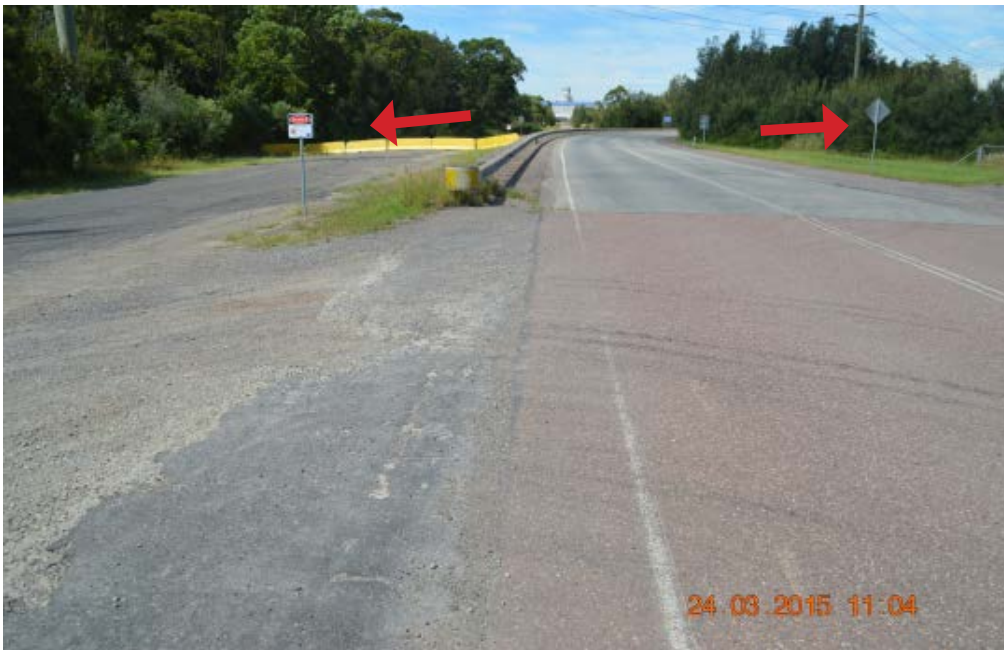
Refer to photo 122.

Showing new sign posts.

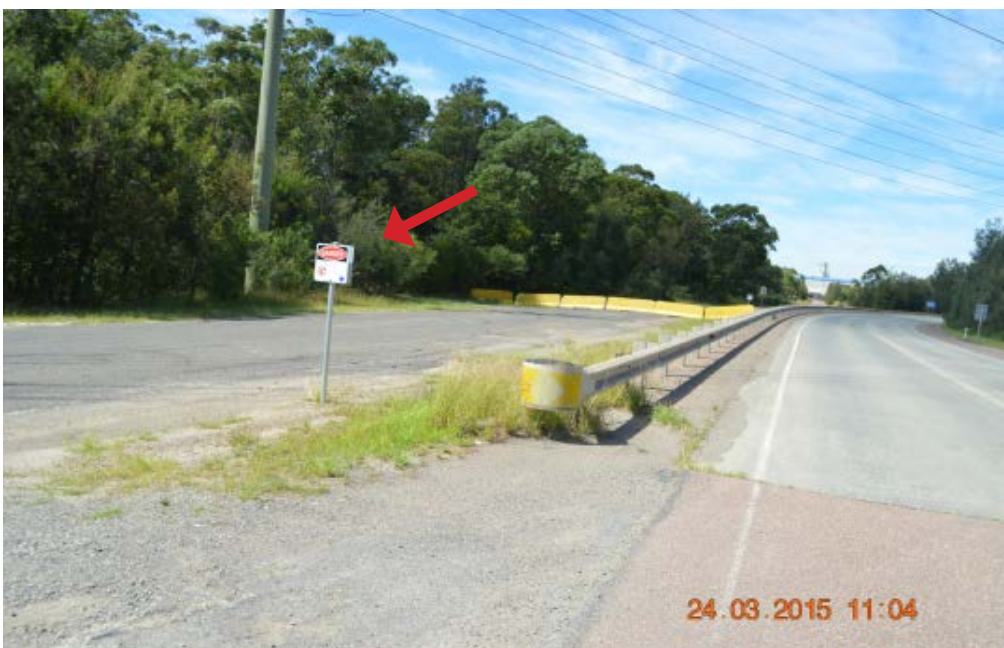
Refer to photo 122.

Showing new sign post.
