AGL Macarthur

Bushfire Mitigation Plan 2023-2024

AGL Energy AEL Reference: ML MC FI 02 (Rev 5.0)

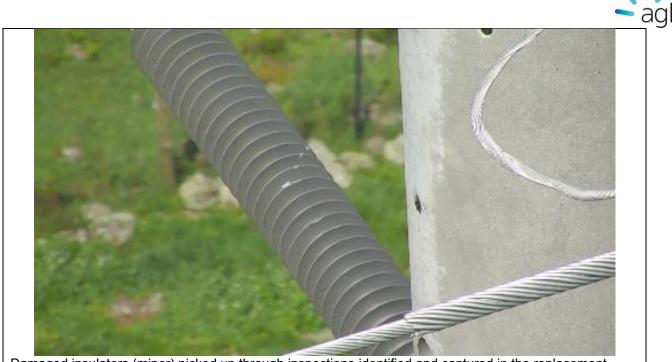
17.6. Engineered Solutions

Since the initial construction of Macarthur wind farm in 2013, the only engineered solution relating to bushfire mitigation and overhead lines and easements has been the replacement of 132kV polymer line insulators damaged by fauna. An engineering design was completed on all 140 line insulators resulting in insulators being replaced with ceramic insulators in 2016 (18of), 2019 (16of) and 2023 (8of). Inspection programs have been ongoing to understand the condition of the insulators and AGL are preparing a replacement program that inlcudes a further 9of priority polymer insulators.

Damaged insulators (minor) picked up through inspections identified and captured in the replacement program (2020).
