## AGL Macarthur

### Bushfire Mitigation Plan 2024-2025

AGL Energy AEL Reference: ML MC FI 02 (Rev 6.0)

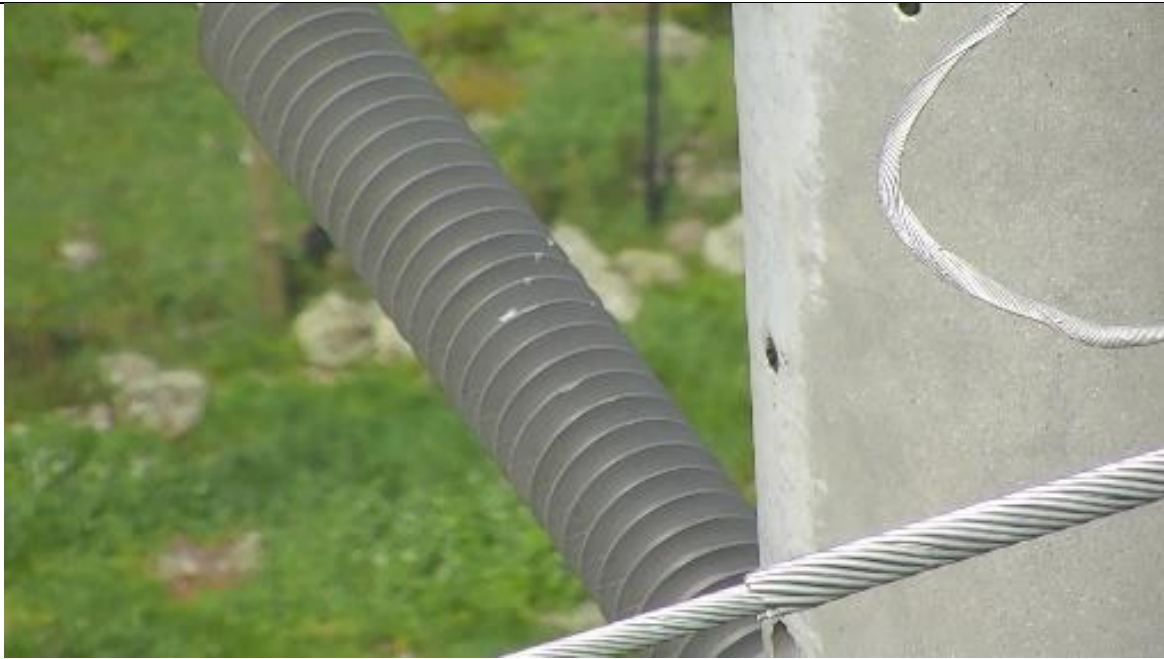
Damaged insulators (minor) picked up through inspections identified and captured in the replacement program (2020).

Since the initial construction of Macarthur wind farm in 2013, the only engineered solution relating to bushfire mitigation and overhead lines and easements has been the replacement of 132kV polymer line insulators damaged by fauna. An engineering design was completed on all 140 line insulators resulting in insulators being replaced with ceramic insulators in 2016 (18of), 2019 (16of) and 2023 (8of). Inspection programs have been ongoing to understand the condition of the insulators and AGL are preparing a replacement program that includes a further 9of priority polymer insulators.
