## **AGL Macarthur**

### **Bushfire Mitigation Plan 2024-2025**

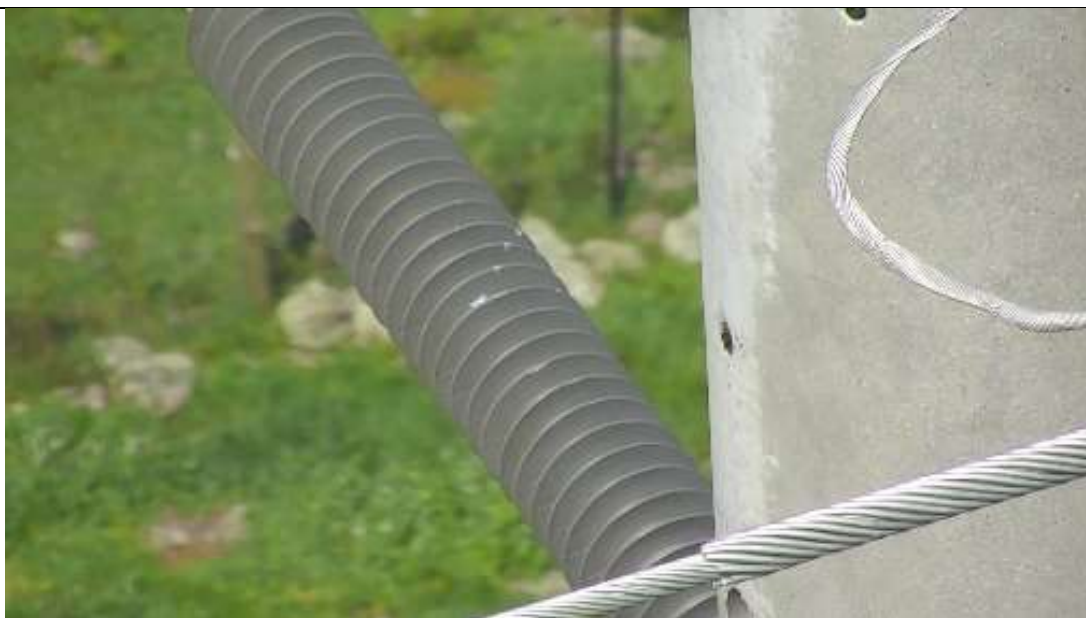
Damaged insulators (minor) picked up through inspections identified and captured in the replacement program (2020).

Since the initial construction of Macarthur wind farm in 2013, the only engineered solution relating to bushfire mitigation and overhead lines and easements has been the replacement of 132kV polymer line insulators damaged by fauna. An engineering design was completed on all 140 line insulators resulting in insulators being replaced with ceramic insulators in 2016 (18of), 2019 (16of) and 2023 (8of). Inspection programs have been ongoing to understand the condition of the insulators and AGL are preparing a replacement program that includes a further 9of priority polymer insulators.
