Bushfire Assessment Report

Bushfire Assessment

**Broken Hill Battery Energy
Storage System**

**74-84 Pinnacles Place,
Broken Hill**

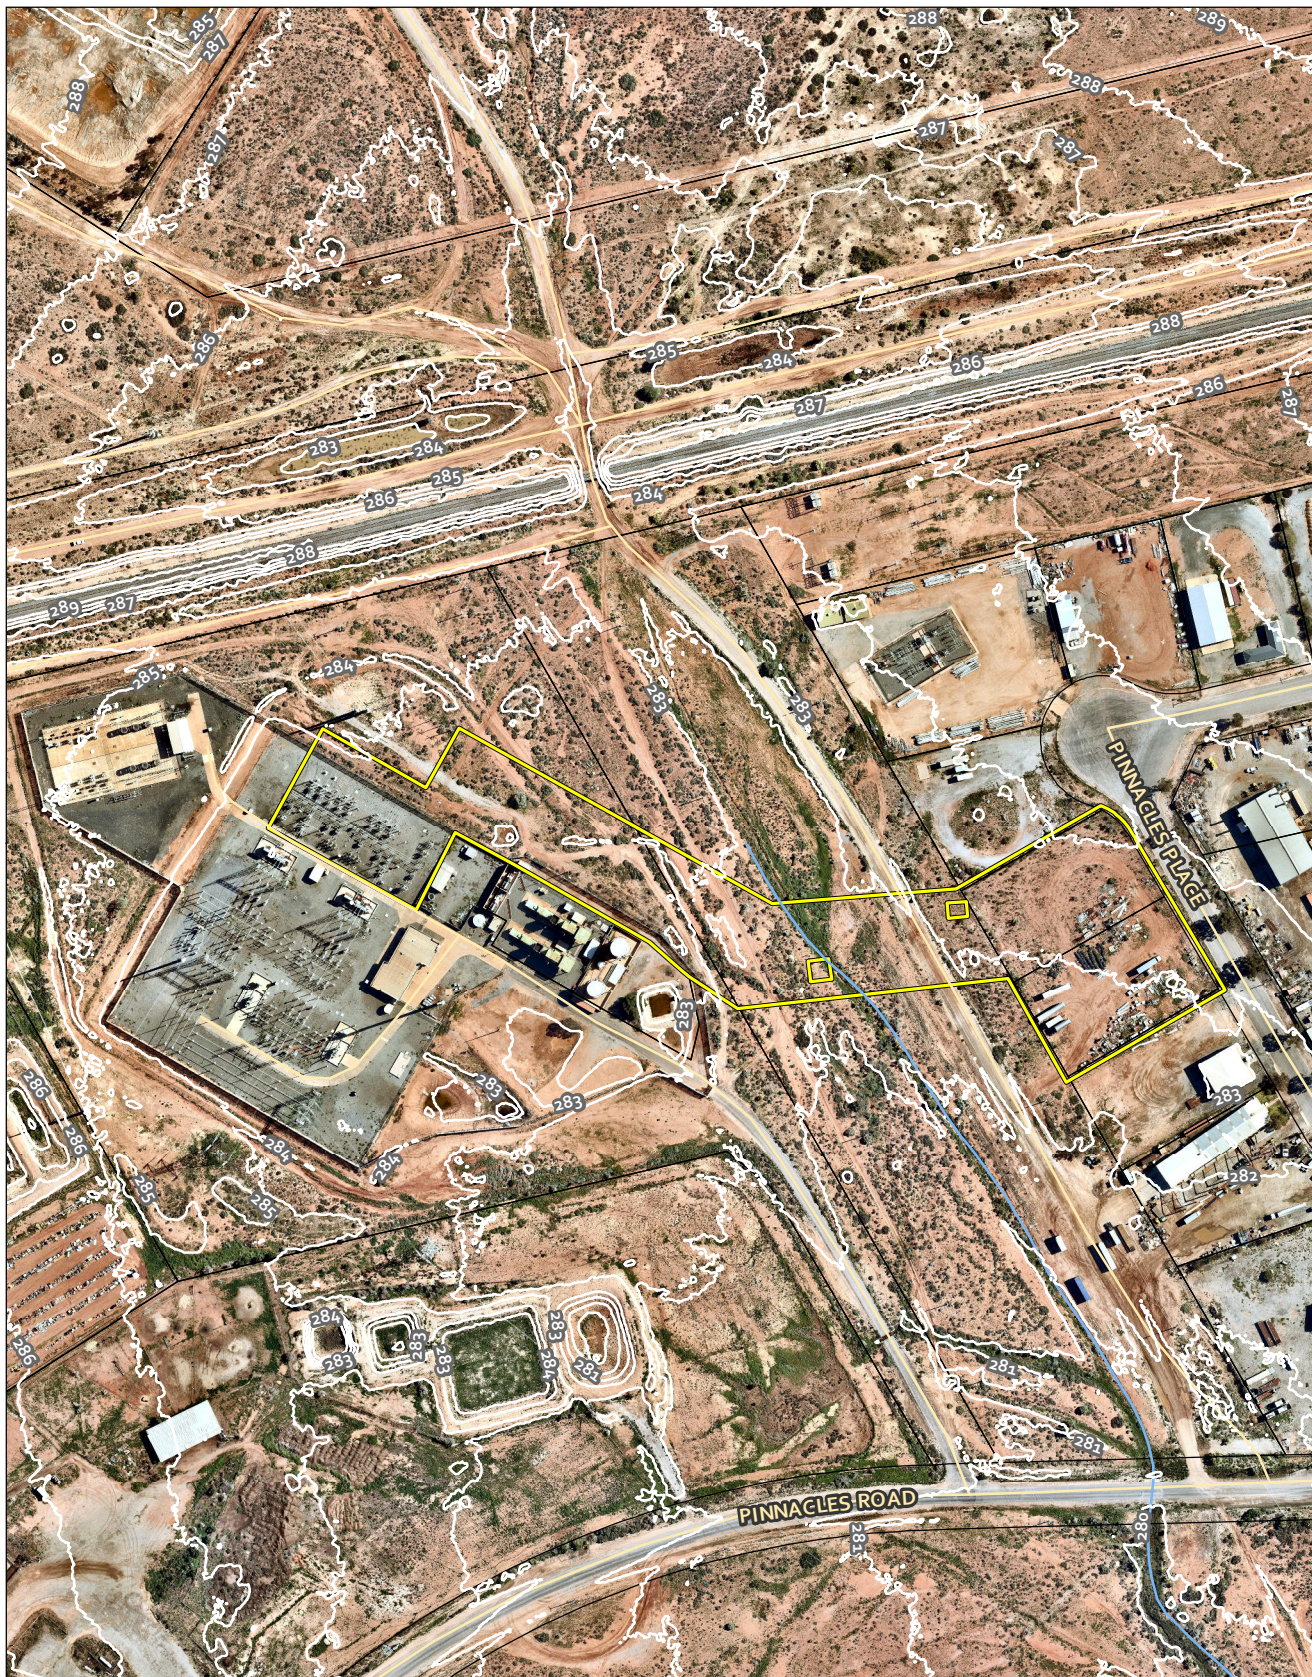
Figure 4: Slope

Figure 4 shows the pattern of the terrain within and surrounding the Project Area. The land is essentially flat consisting of an arid gibber plain. The land slopes gently to the west into a drainage line within Lot 7302. The gradient is less than 1.5 degrees and, therefore, falls within the PBP slope class of 'downslope 0-5 degrees'.
