Newcastle Gas Storage Facility

**6 Monthly Construction Compliance Report:
28 August 2013 to 27 February 2014**

For AGL

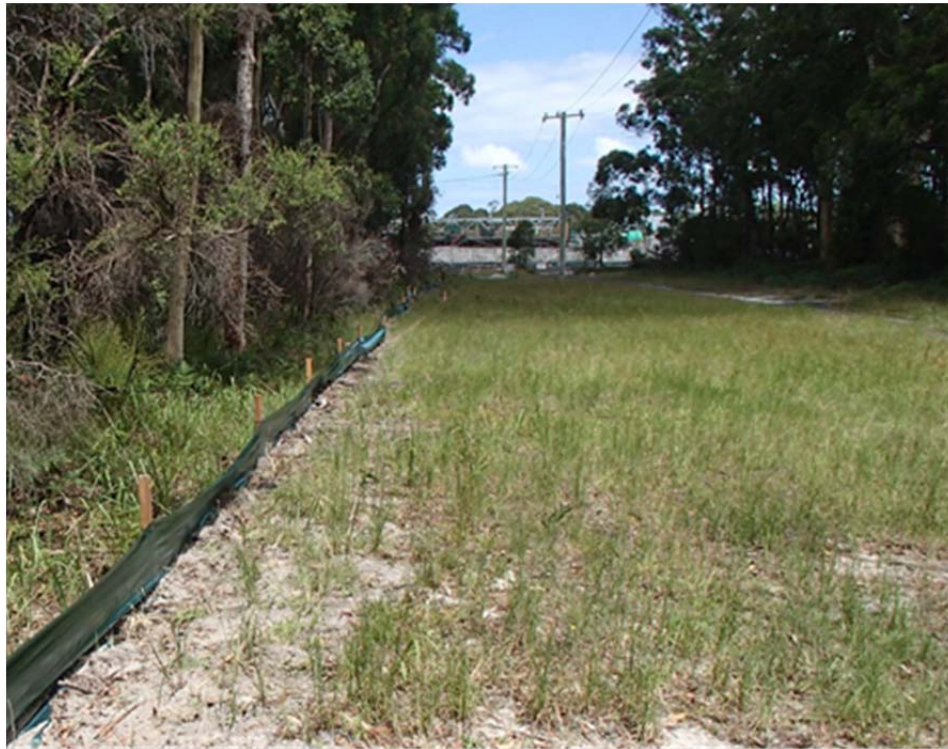
Photograph 4.1 Silt fencing installed along the Ausgrid easement

Refer to *Photograph 4.1* for an example of silt fencing along the AusGrid easement in preparation for trenching works installed by PowerServe.
