## Appendix D: Photomontages

### Photomontage V14 Pic's Paddock

## Photomontage V15 Barrier Highway Crossing

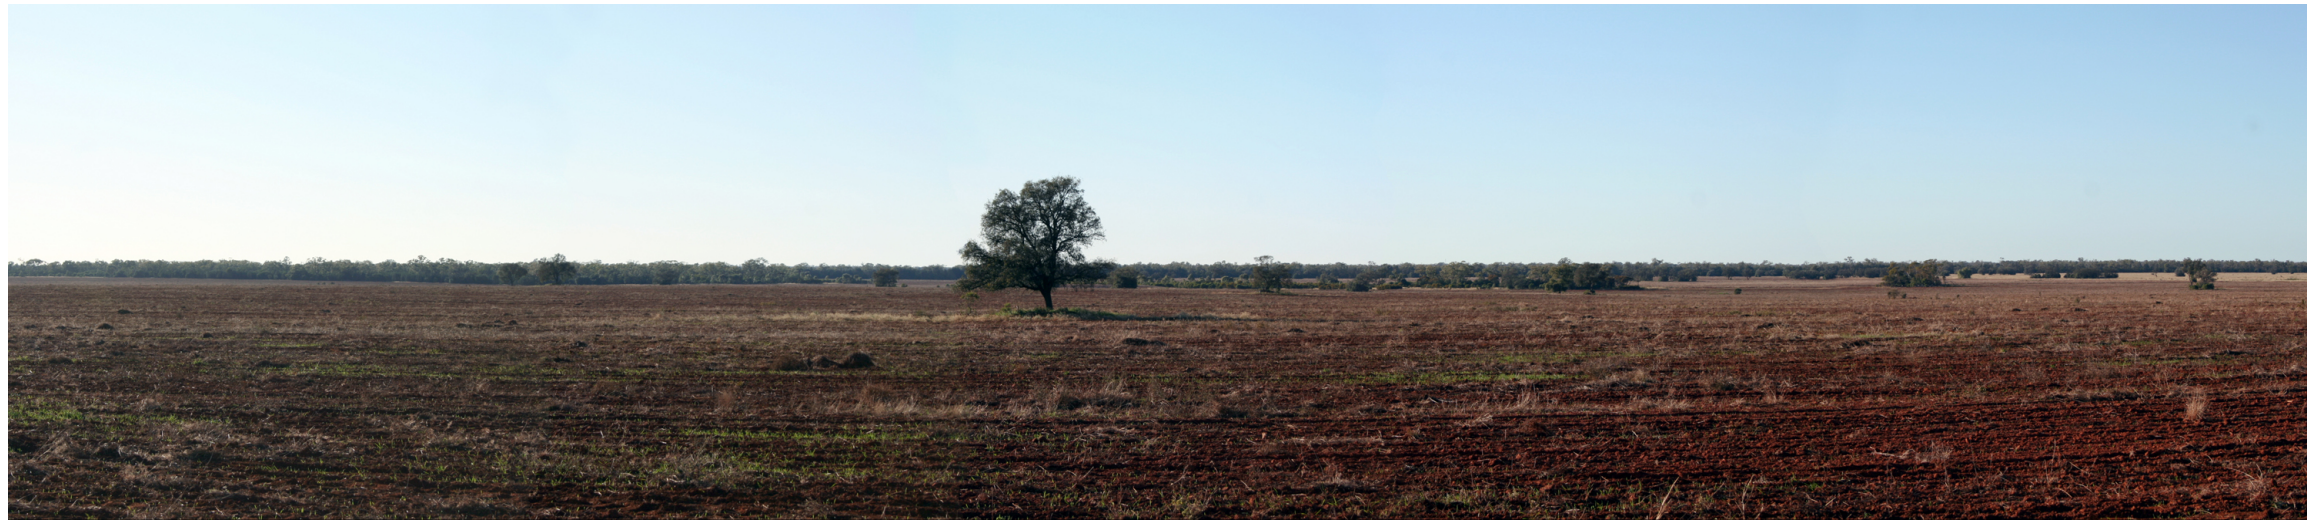
Existing conditions (above)

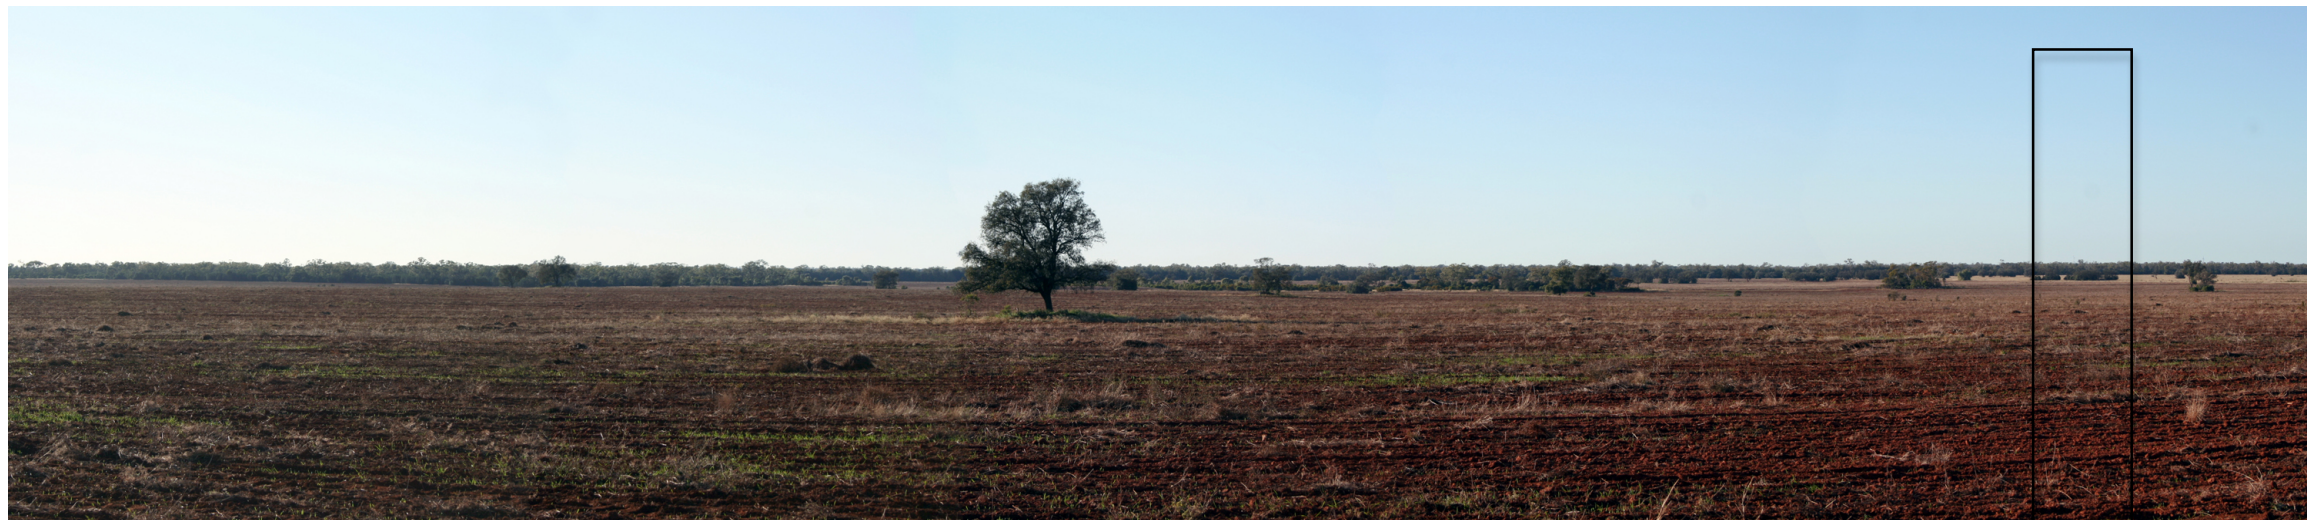
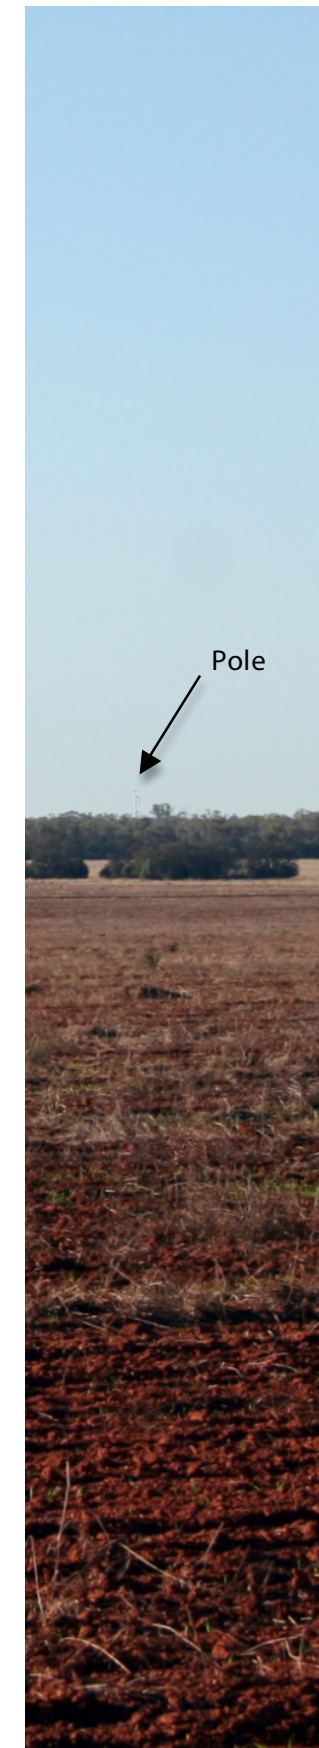
With proposed transmission line (above) and enlarged view showing one pole (right)

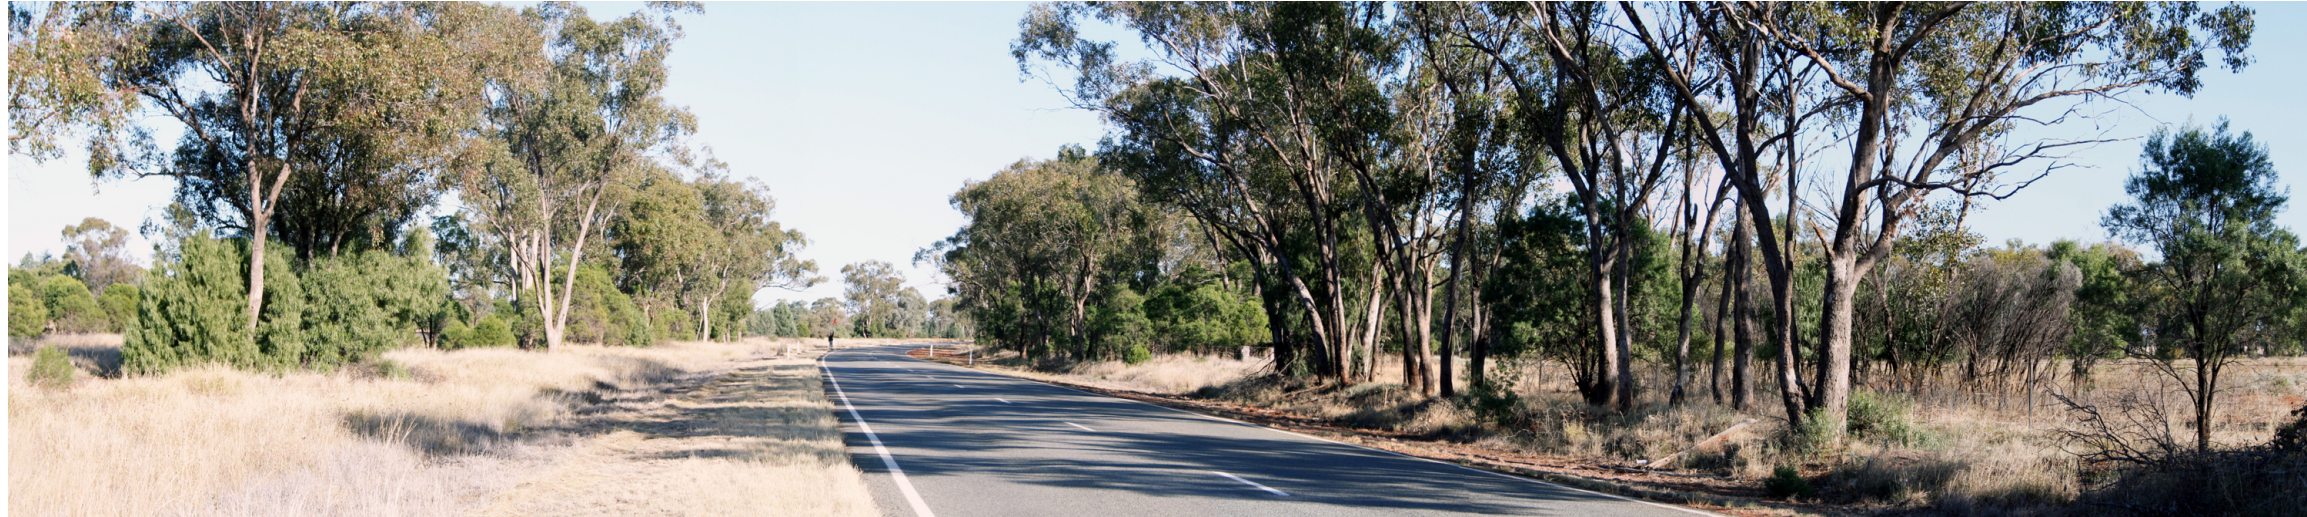
Existing conditions (above)

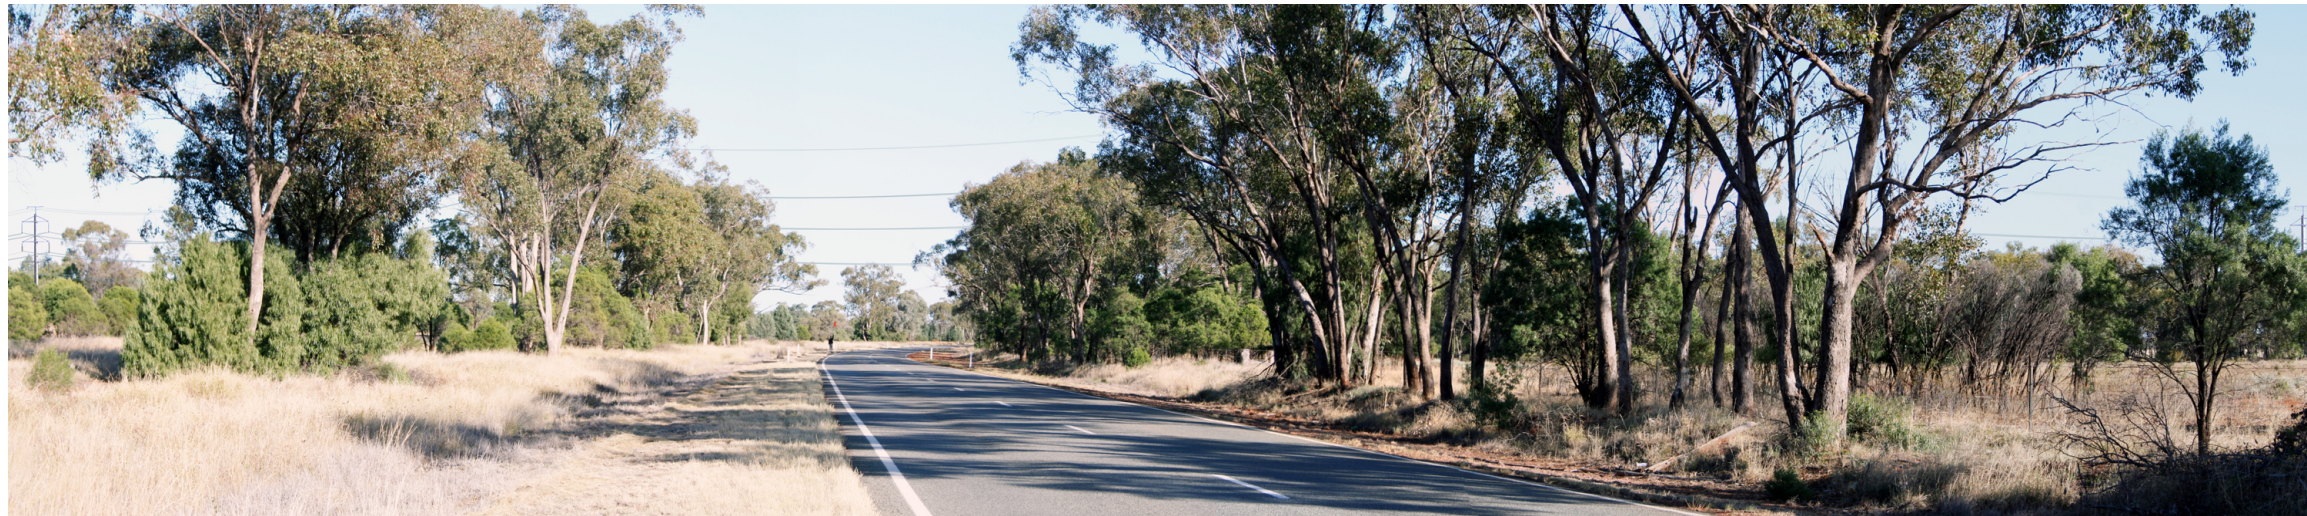
With proposed transmission line crossing highway using 26m high poles on both sides of road (above)

Note: photomontage does not show removal of vegetation.
