### PROPERTY CONDITION SURVEY

Old Punt Road  
TOMAGO NSW

24 March 2015

AD1475

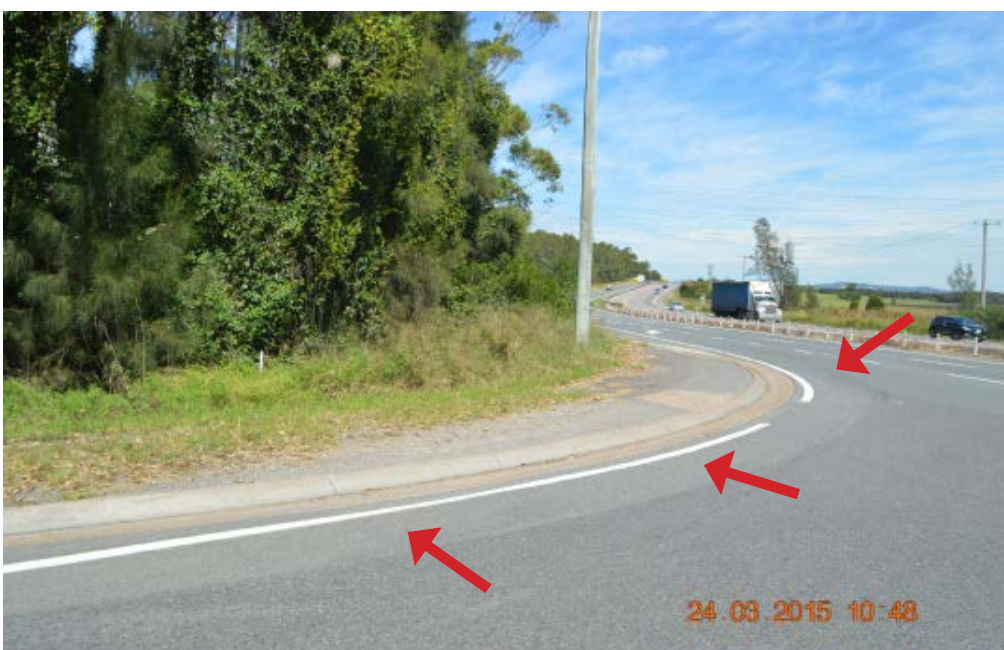
Refer to photo 60.

Footpath, paving kerb and gutter on the south east side of Pacific Highway at the intersection with Old Punt Road.

Showing repainted sidelines.

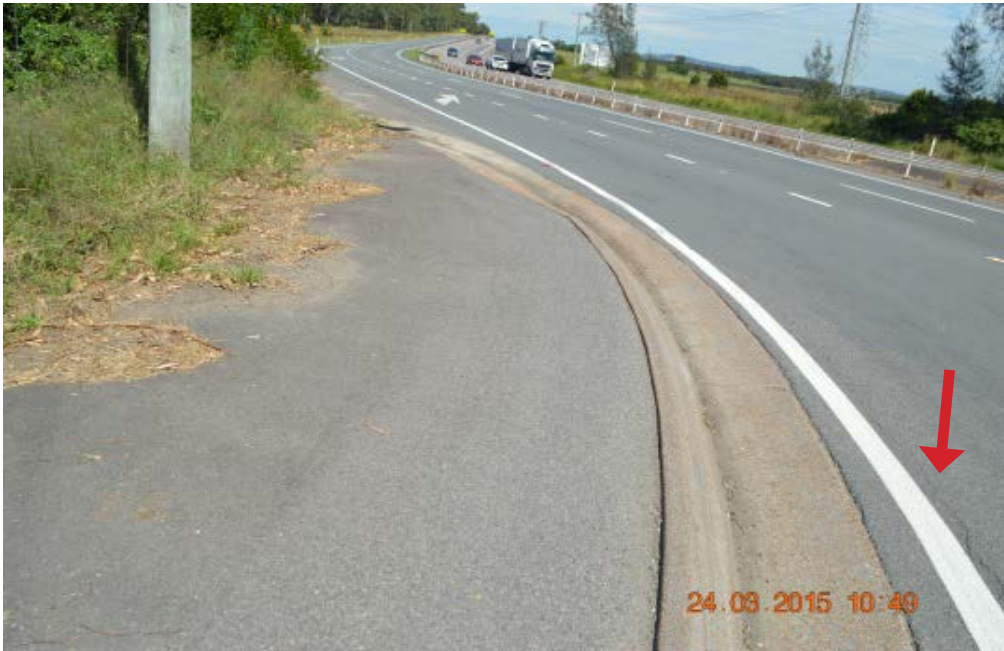
Refer to photo 61.

Footpath, paving kerb and gutter on the south east side of Pacific Highway at the intersection with Old Punt Road.

Showing repainted side lines.

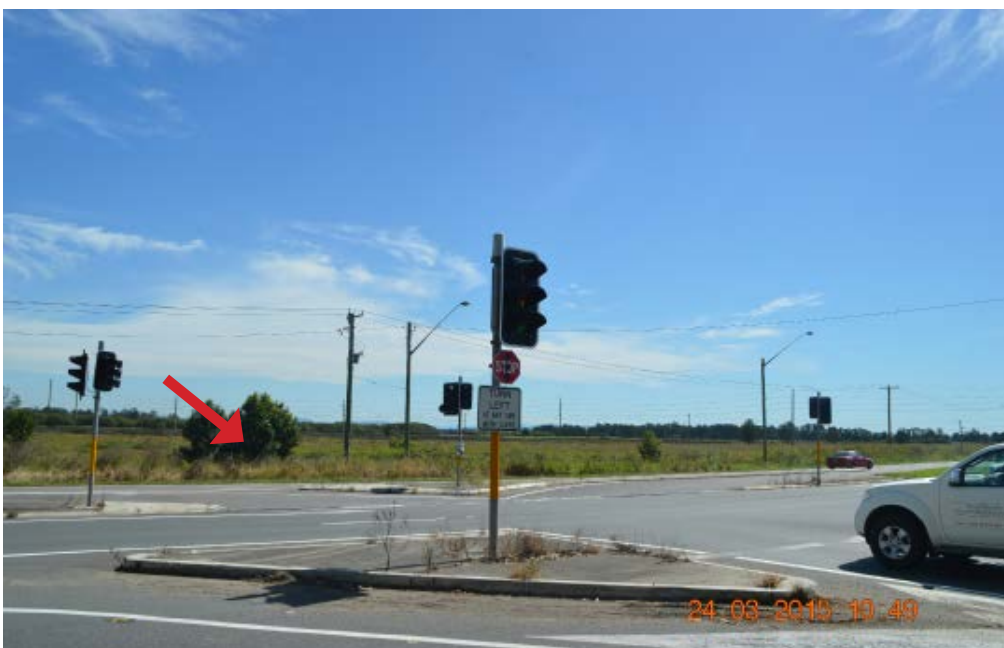
Refer to photo 63.

Traffic signals on the south side the intersection.

Showing missing hazard marker.

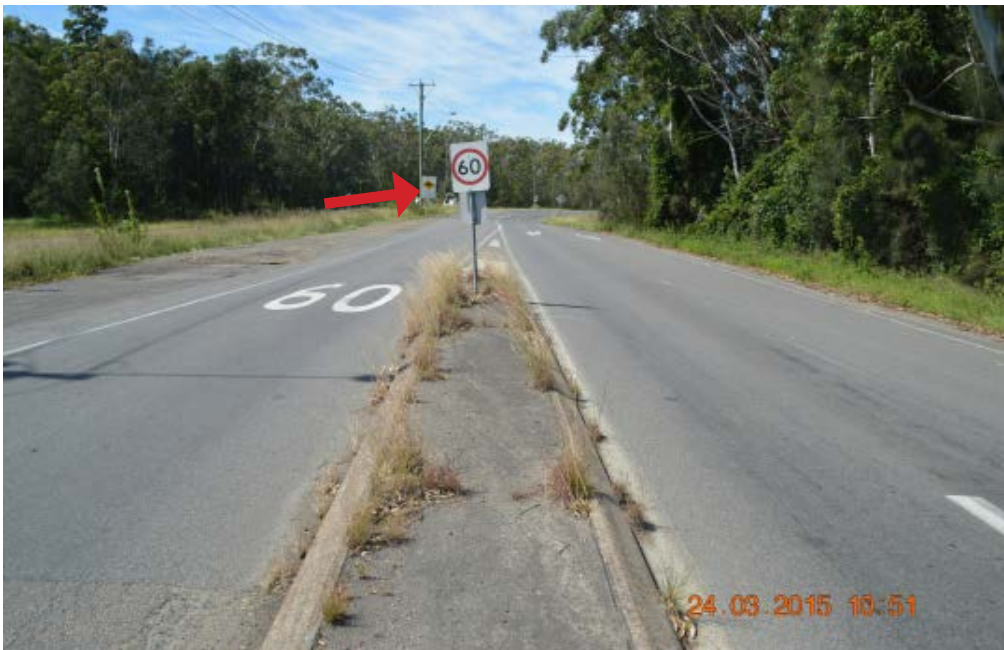
Refer to photo 68.

Island on Old Punt Road near the intersection with Pacific Highway.

Showing additional road sign.

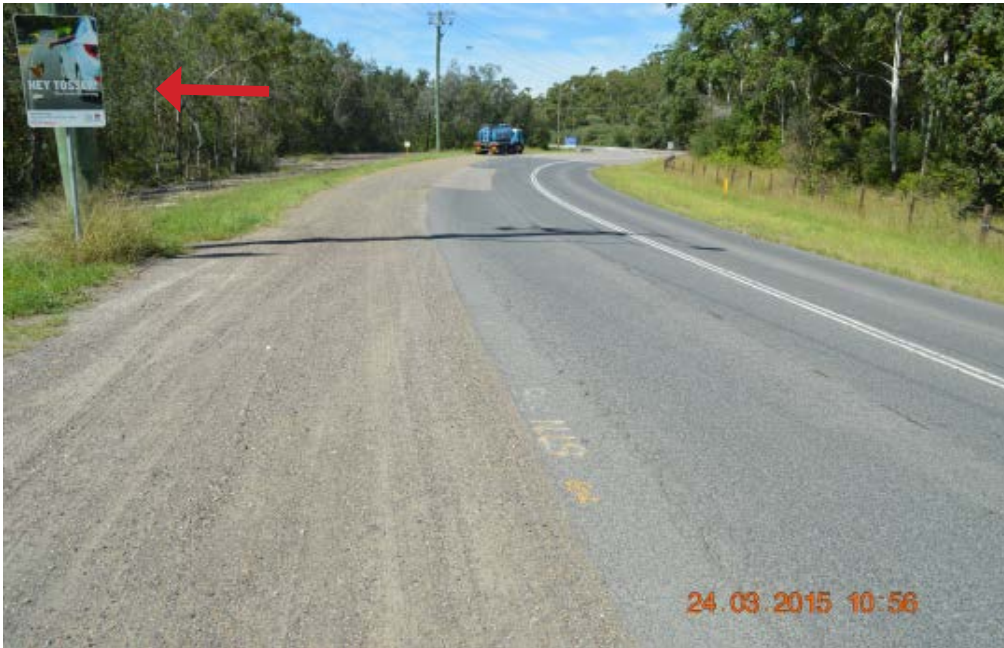
Refer to photo 88.

North side of Old Punt Road at 190 metres from the intersection with the Pacific Highway.

Showing additional road sign.

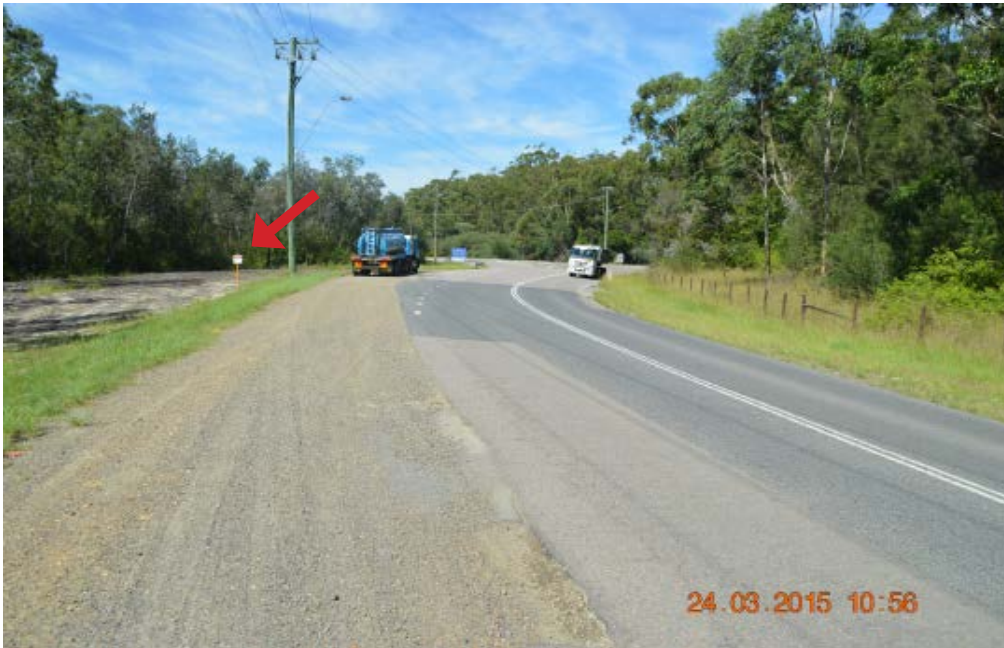
Refer to photo 91.

North side of Old Punt Road at 220 metres from the intersection with the Pacific Highway.

Showing additional road sign.

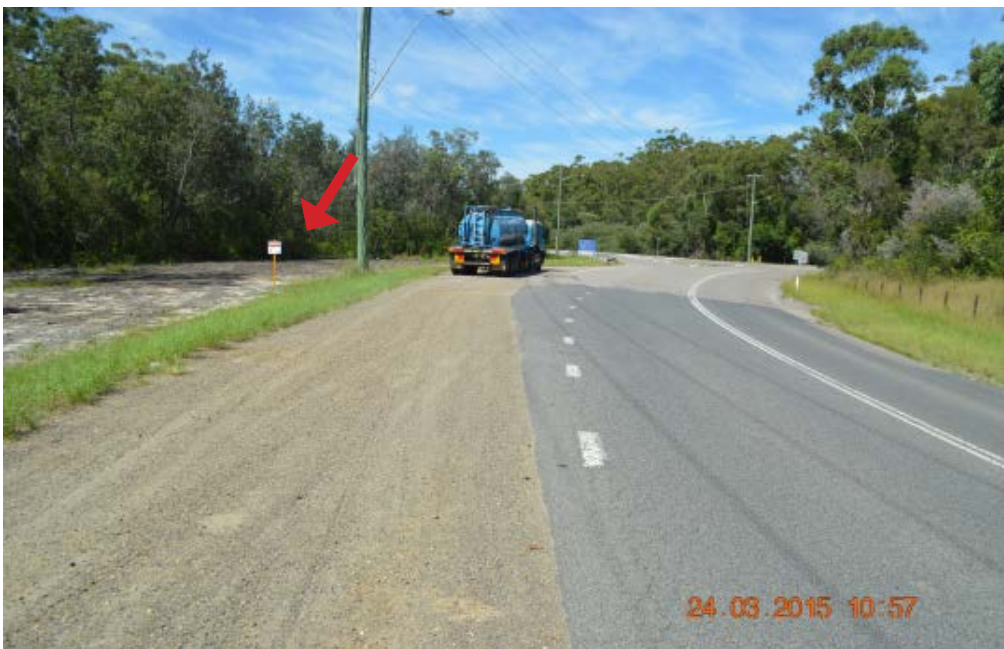
Refer to photo 92.

North side of Old Punt Road at 230 metres from the intersection with the Pacific Highway.

Showing additional road sign.

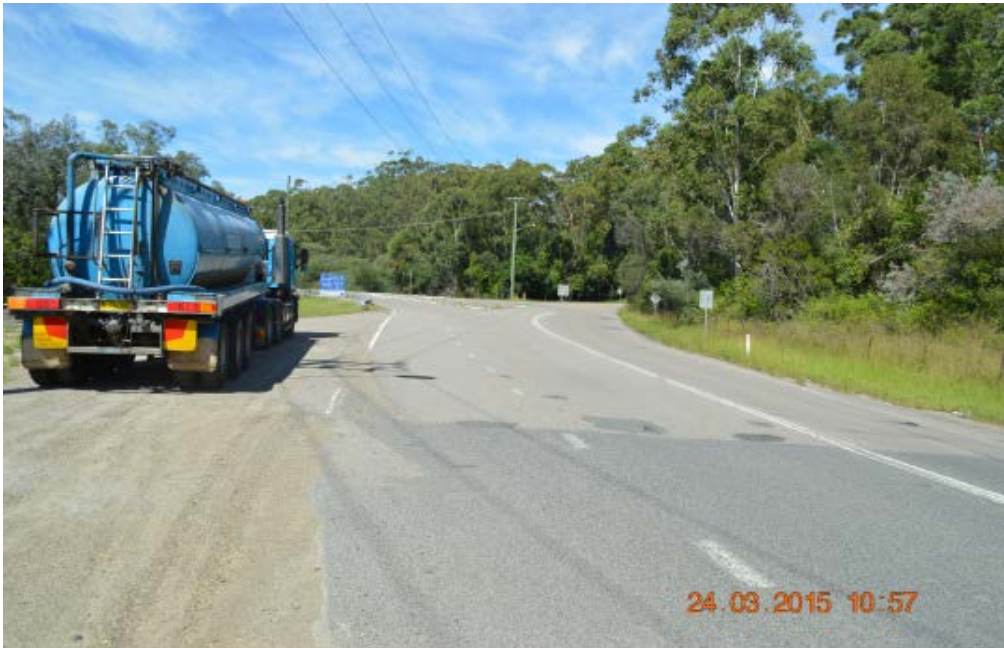
Refer to photo 94.

No changes noted.

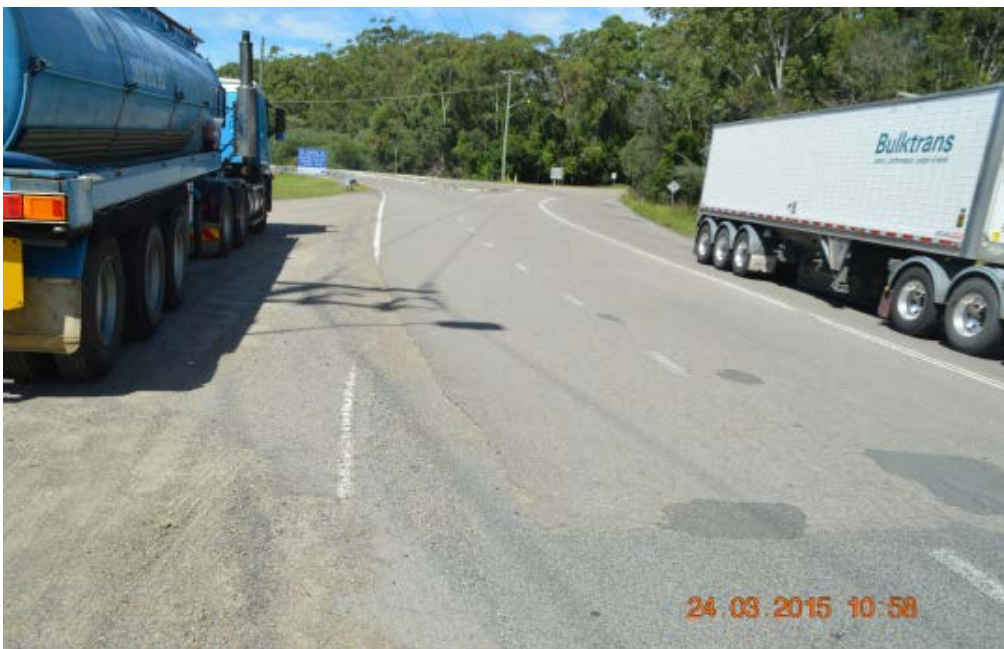
Refer to photo 95.

No changes noted.

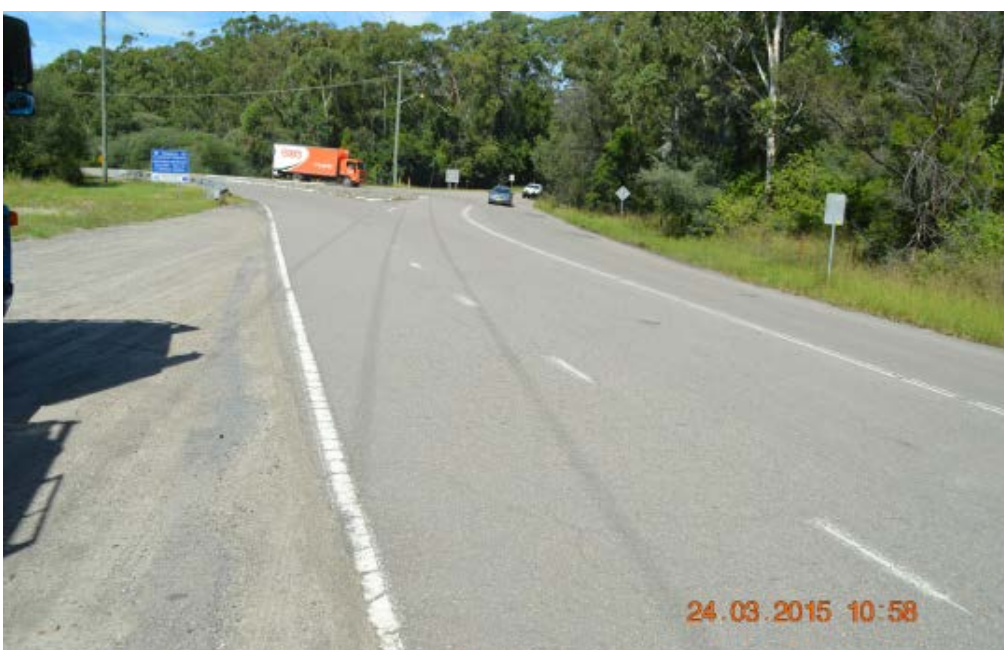
Refer to photo 96.

No changes noted.

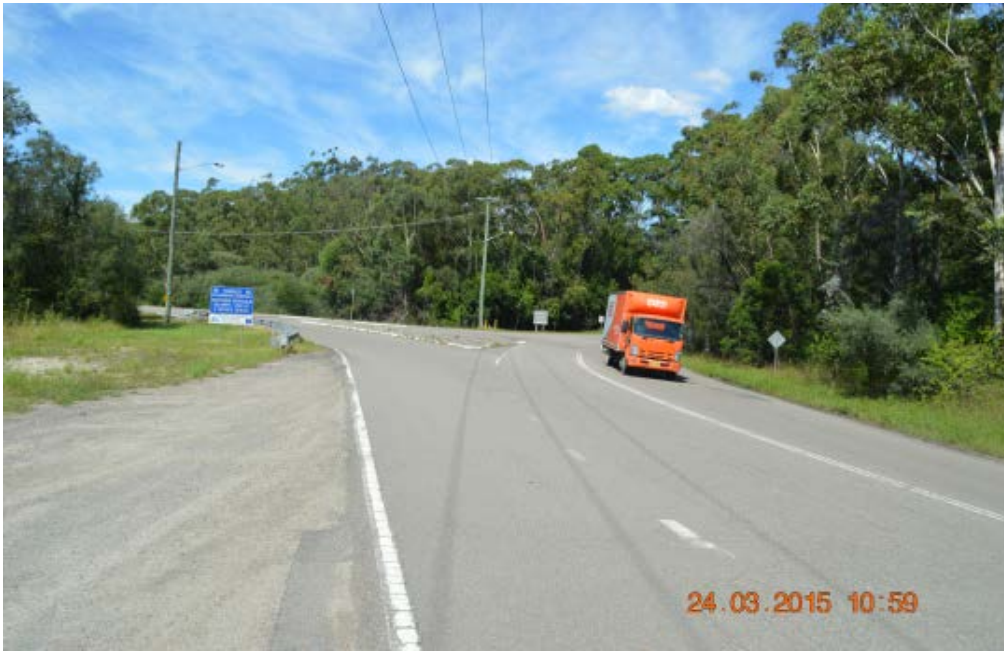
Refer to photo 97.

No changes noted.

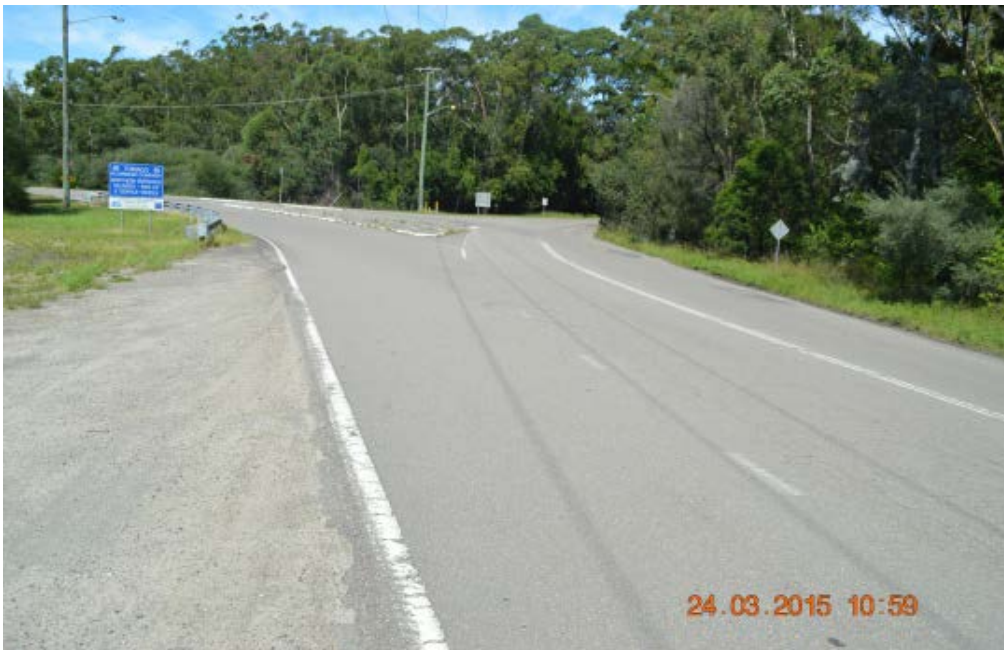
Refer to photo 98.

No changes noted.

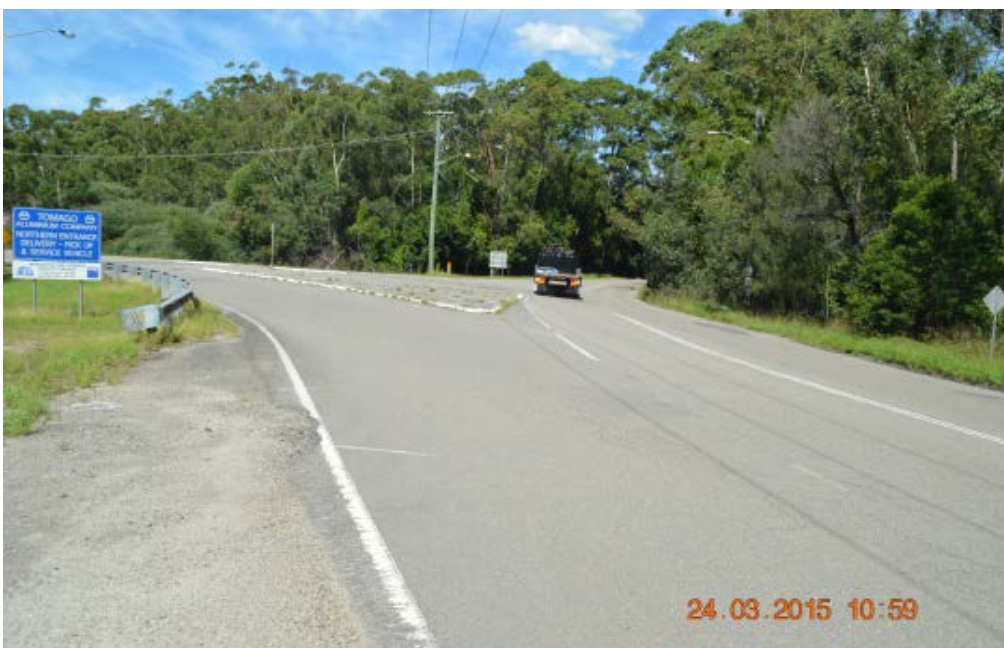
Refer to photo 99.

No changes noted.

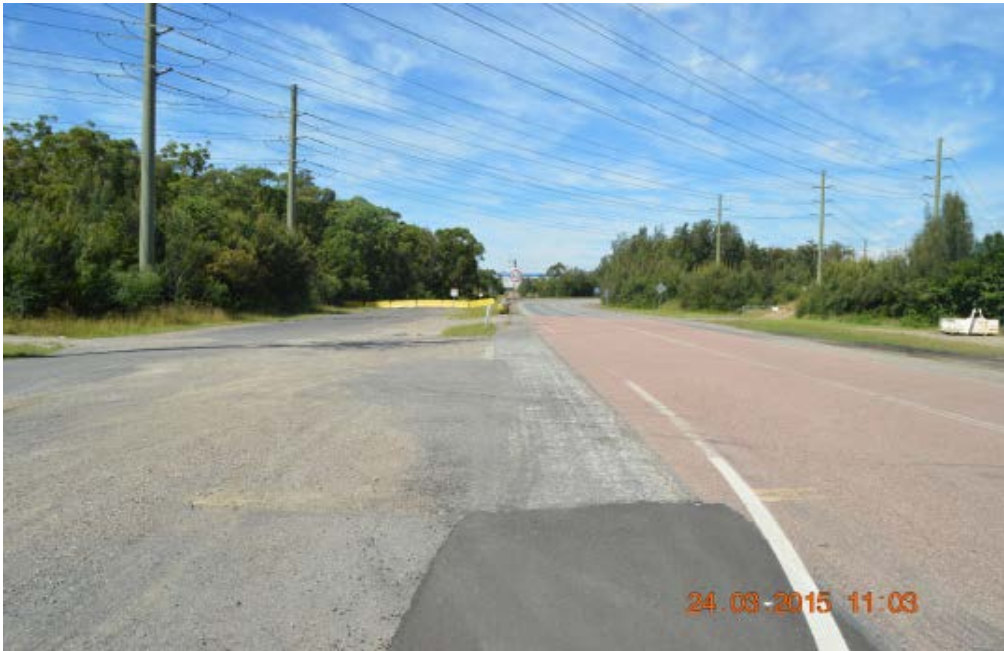
Refer to photo 118.

No changes noted.

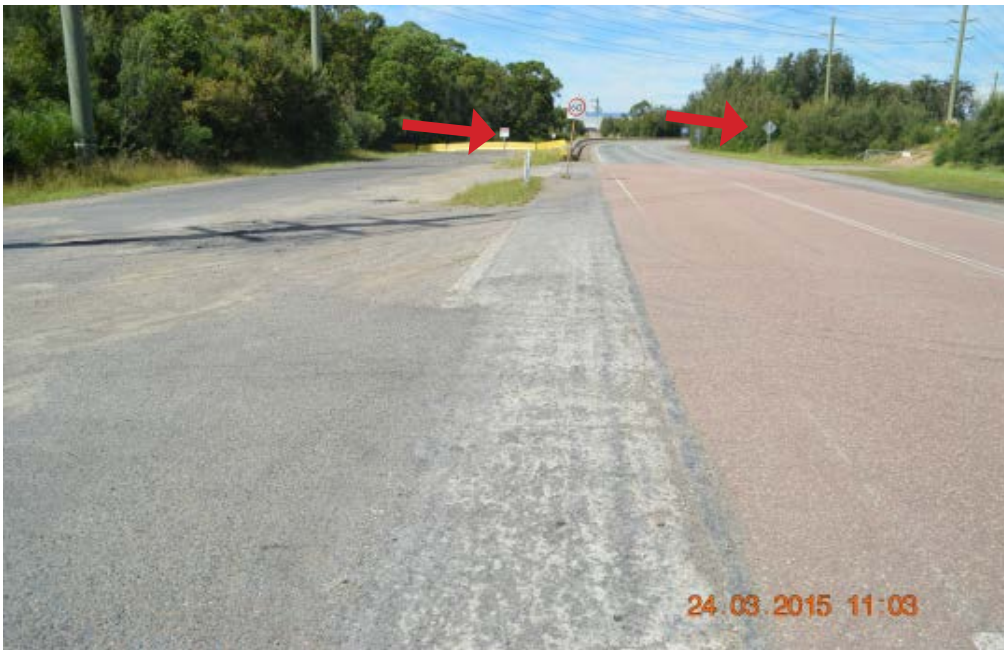
Refer to photo 119.

Showing new sign posts.

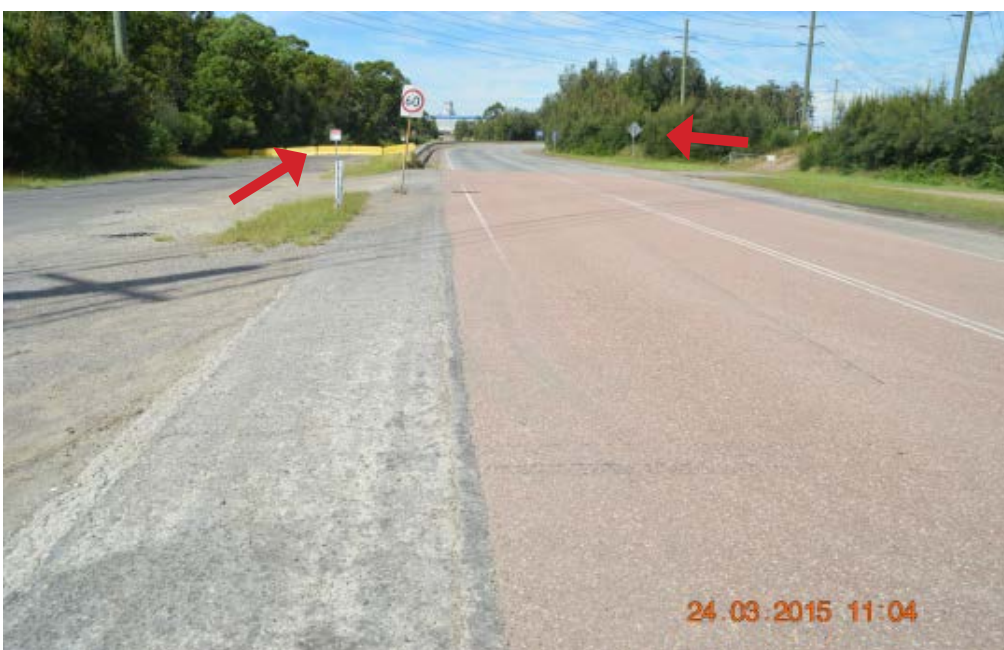
Refer to photo 120.

Showing new sign posts.

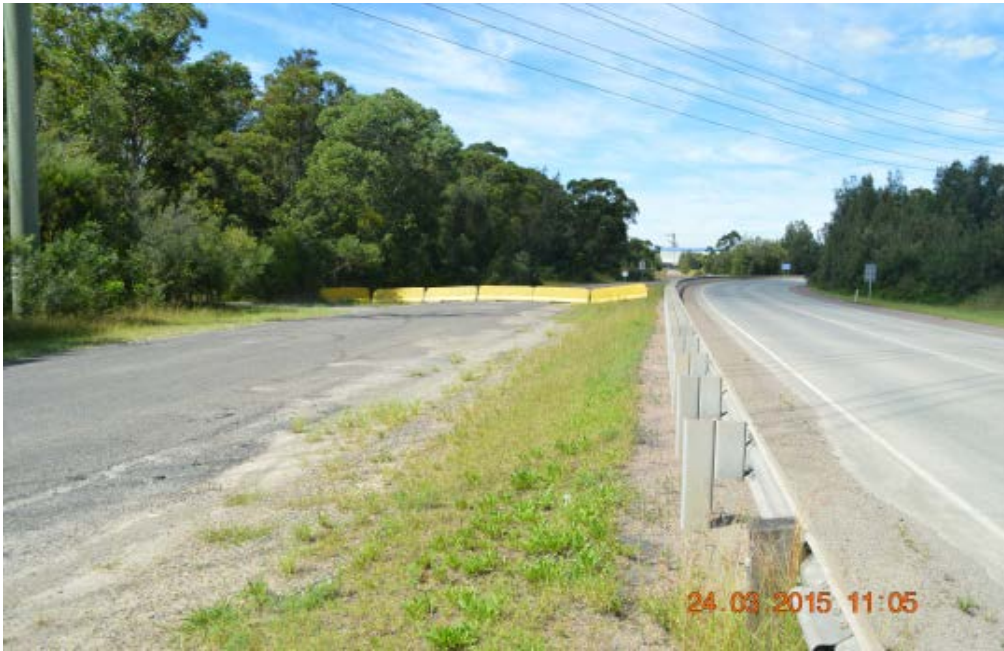
Refer to photo 123.

No changes noted.

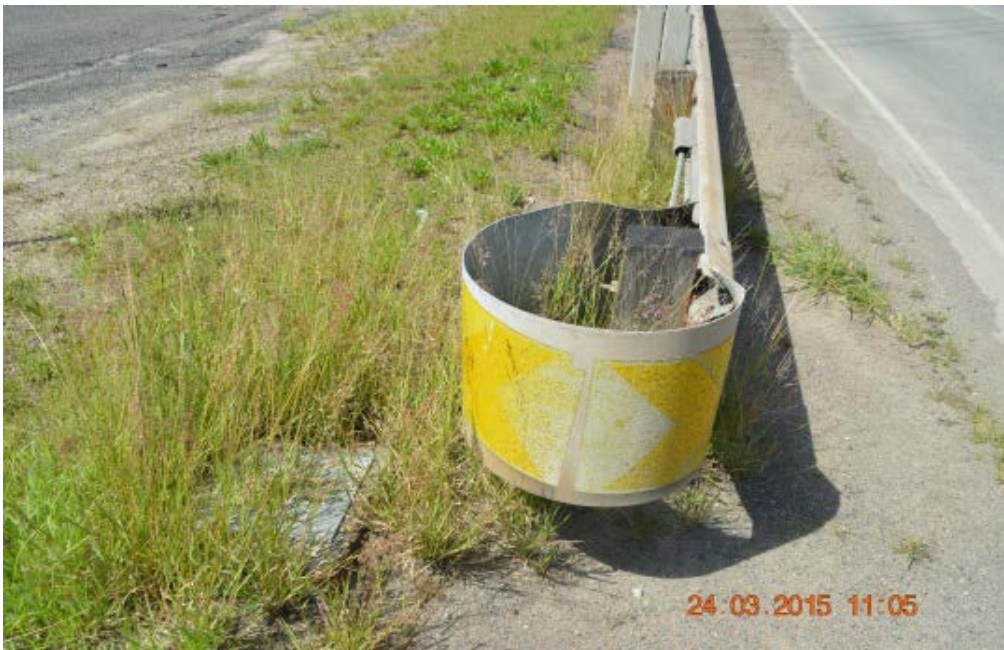
Refer to photo 125.

No changes noted.

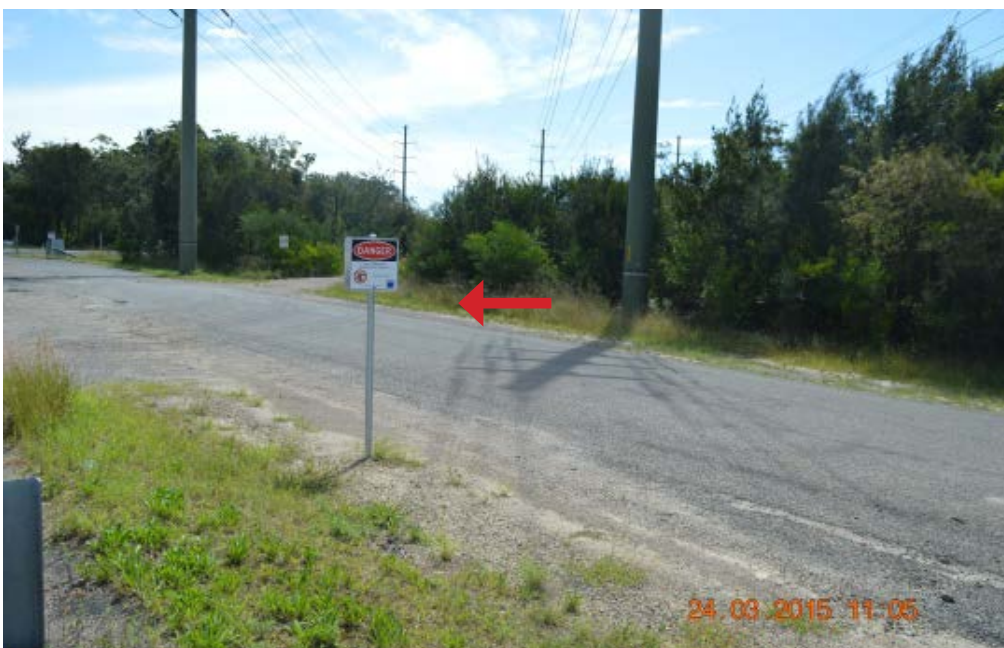
Refer to photo 126.

Showing new warning sign.

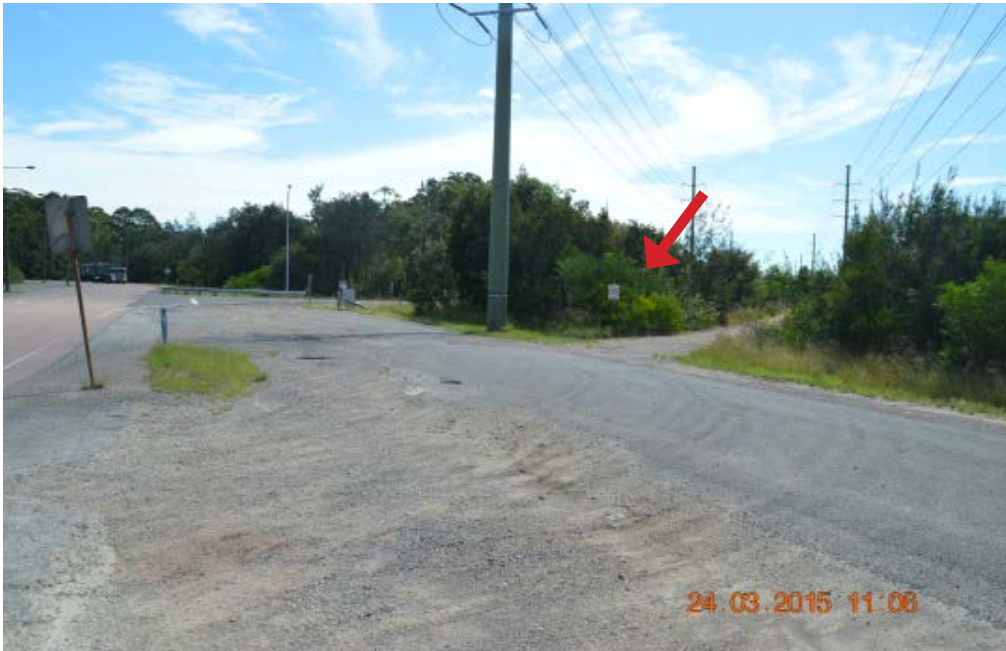
Refer to photo 127.

Showing new road sign.

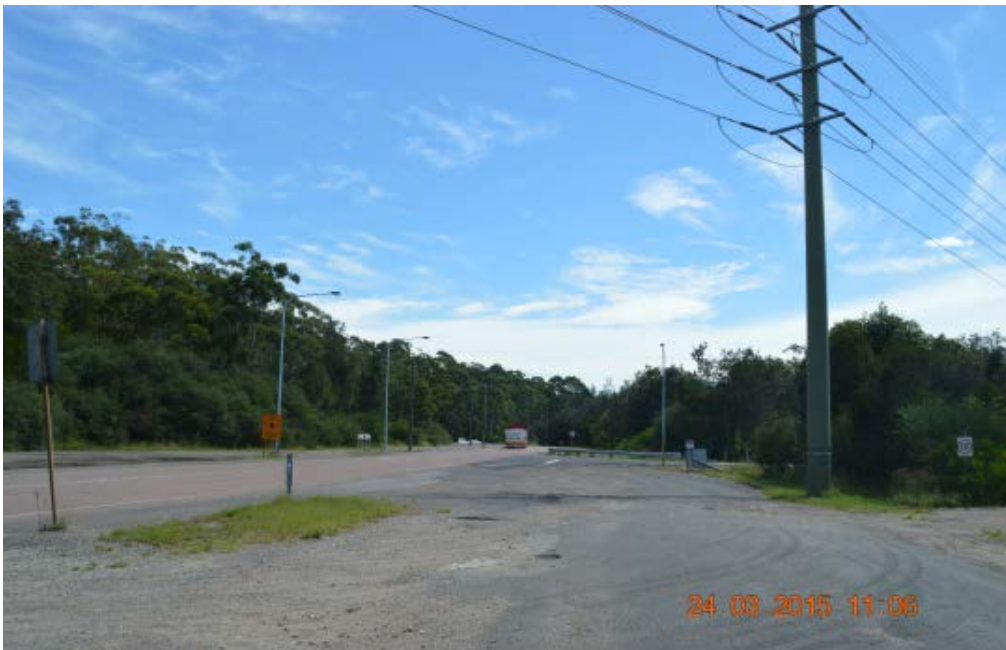
Refer to photo 128.

No changes noted.

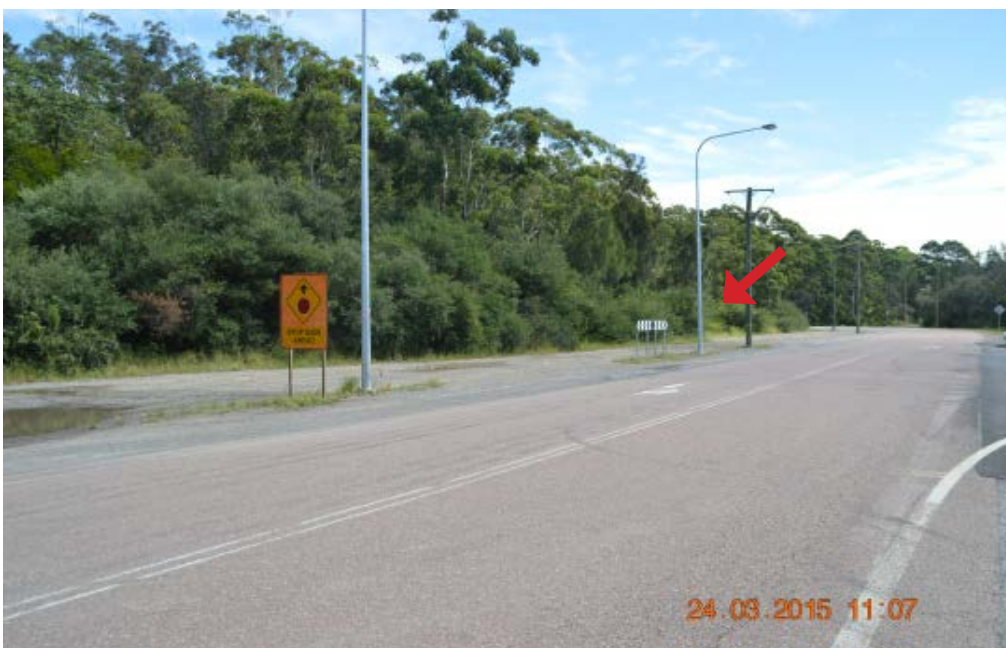
Refer to photo 129.

Showing new hazard sign.

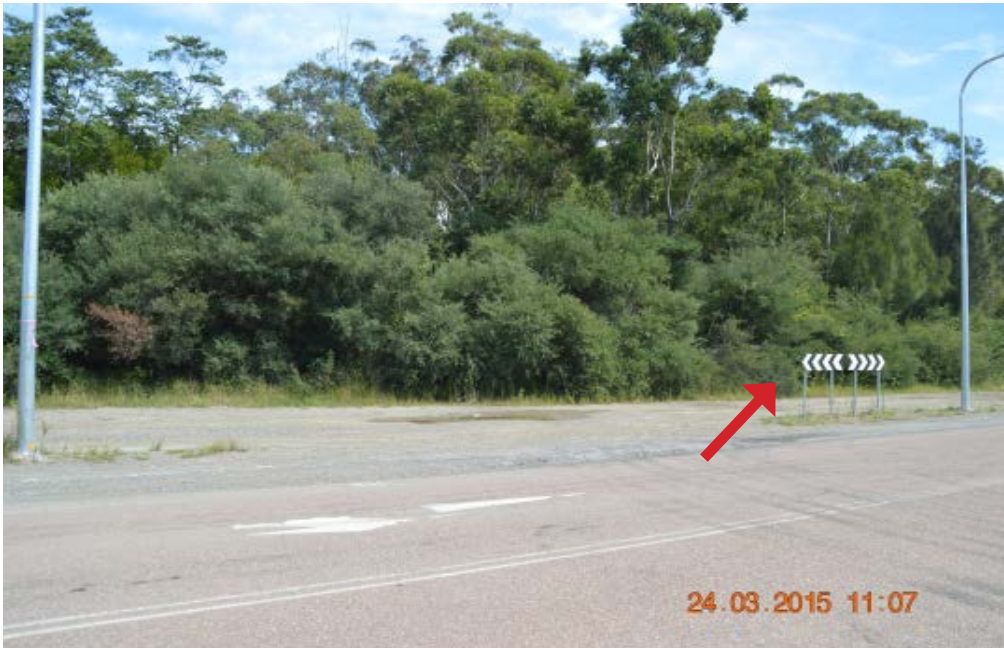
Refer to photo 130.

Showing new hazard sign.

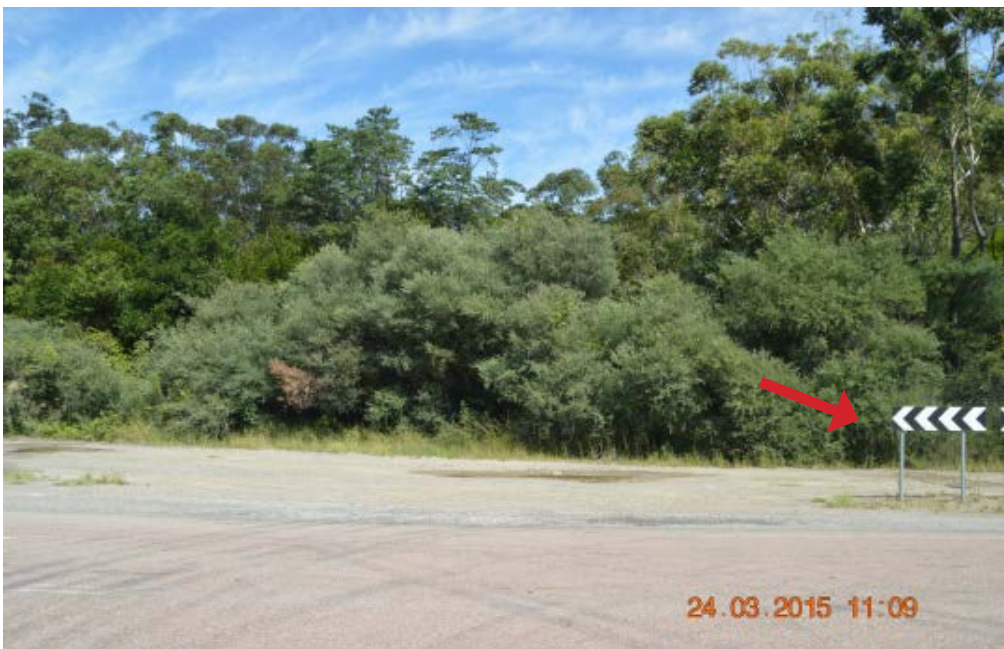
Refer to photo 130.

Showing new hazard sign.

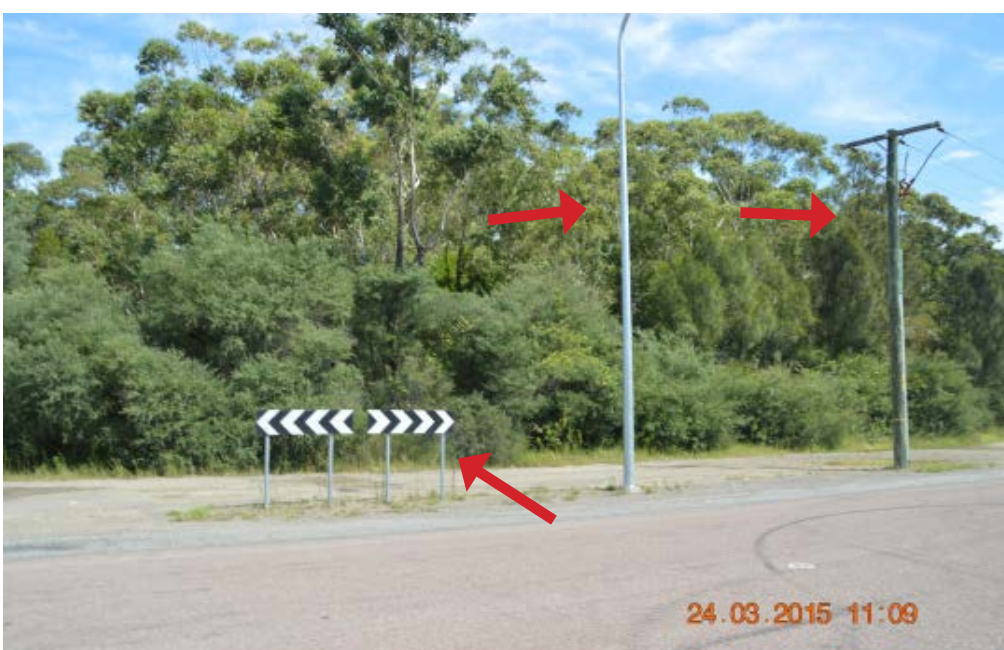
Refer to photo 132.

Showing new hazard sign, street light and power pole.

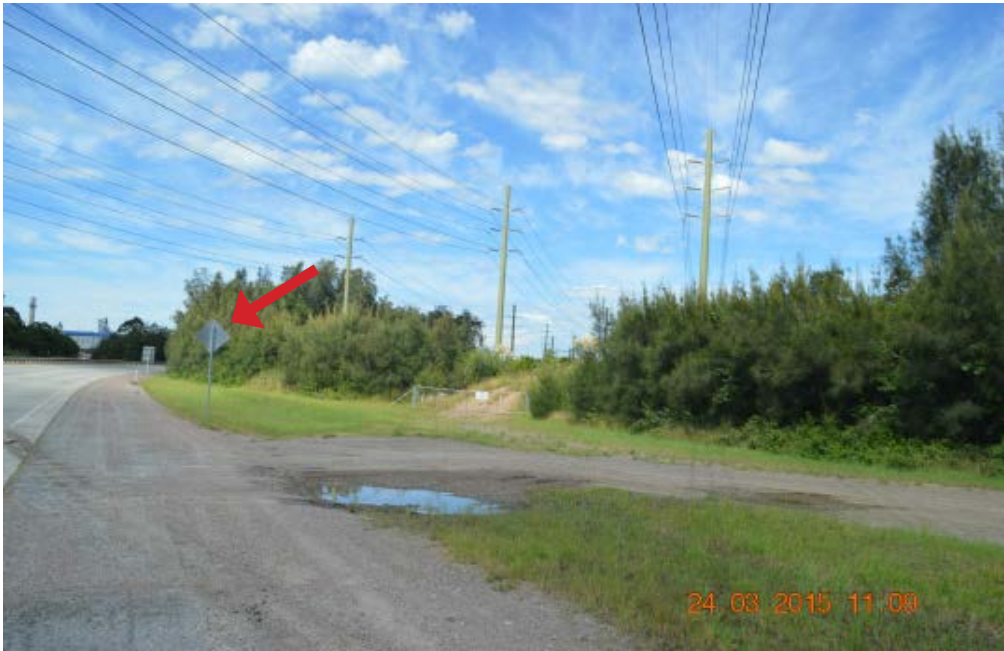
Refer to photo 133.

Showing additional road sign.

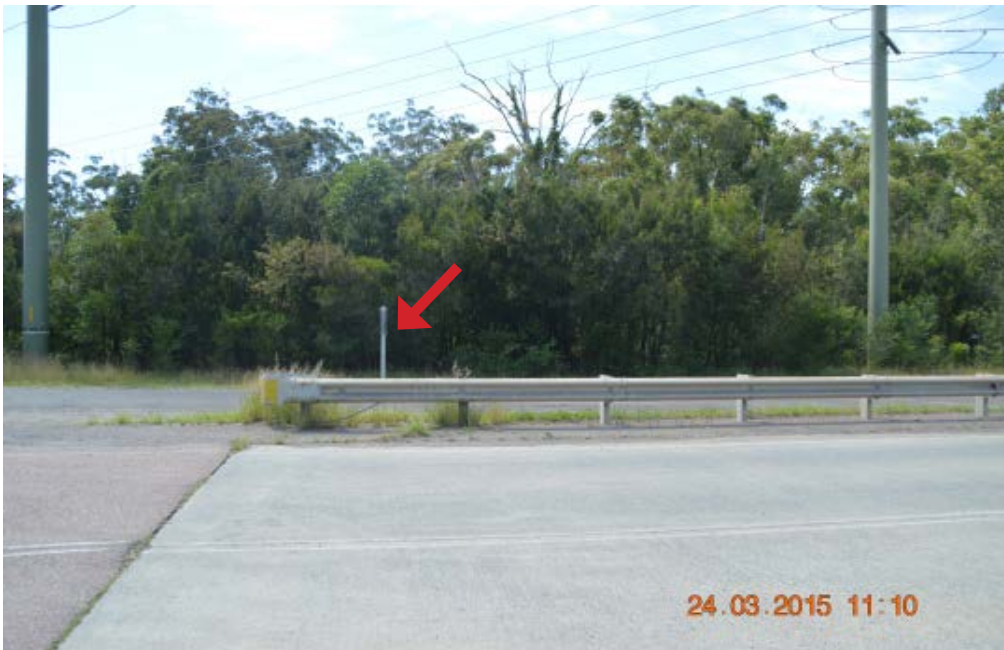
Refer to photo 134.

Guard rail on the north side of the road.

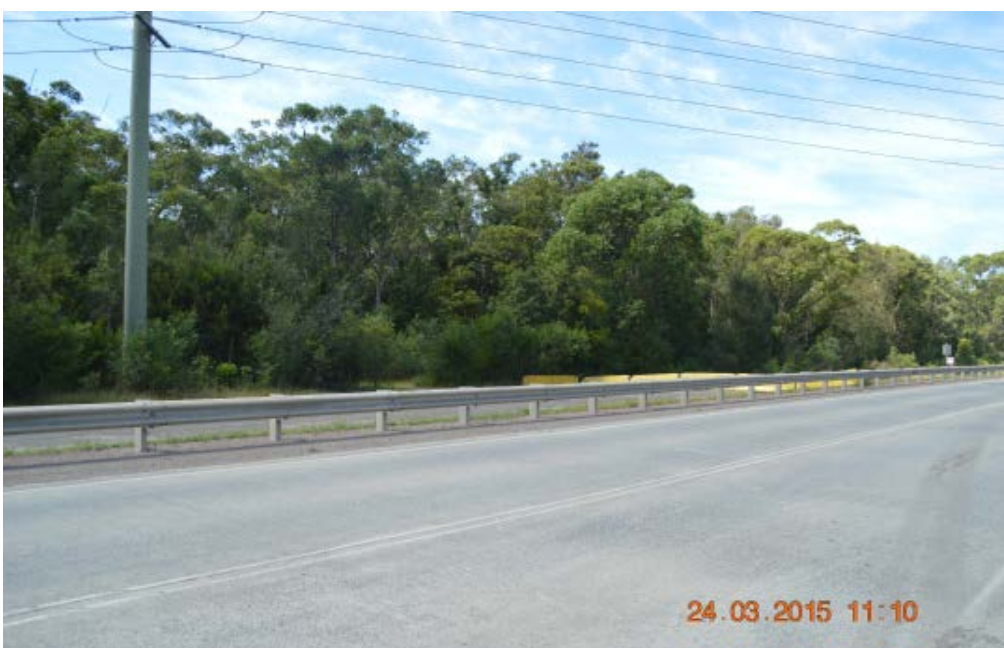
Showing additional road sign.

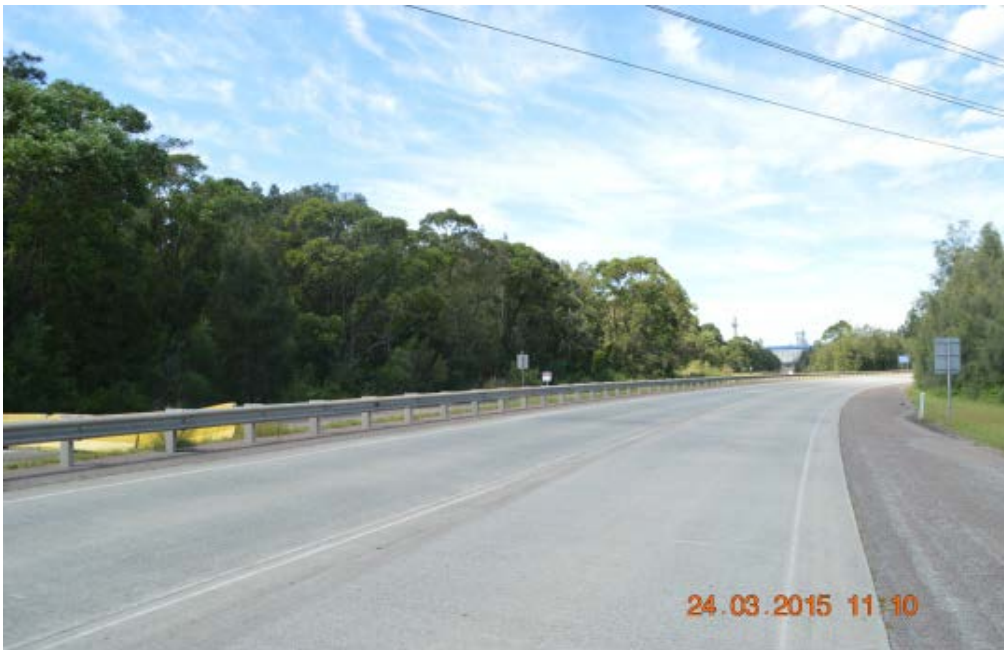
Refer to photo 136.

Showing removal of road sign.

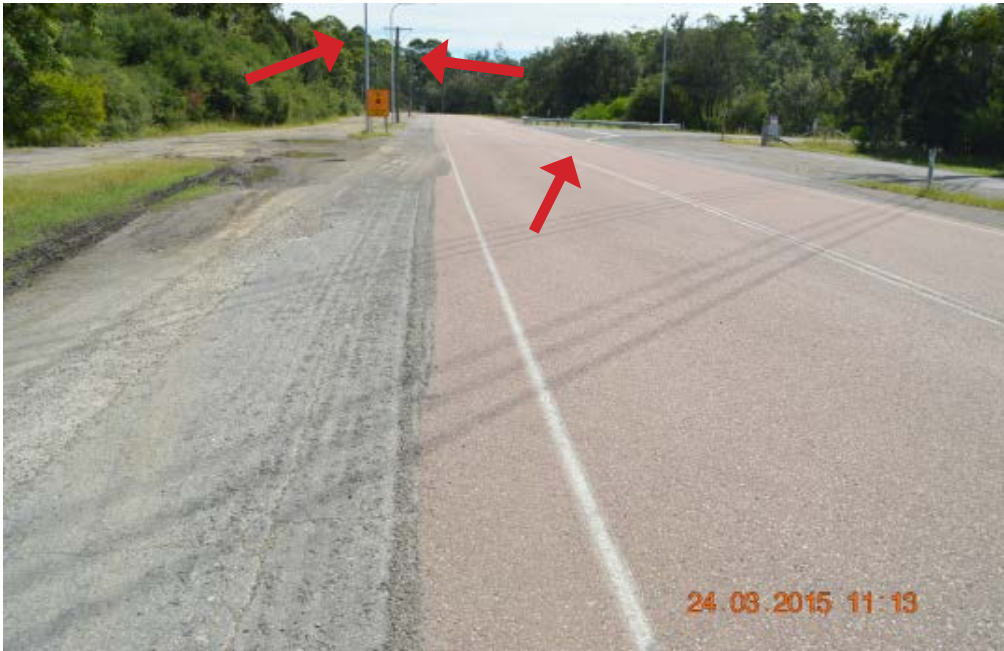
Refer to photo 141.

Showing new street lights and side road.

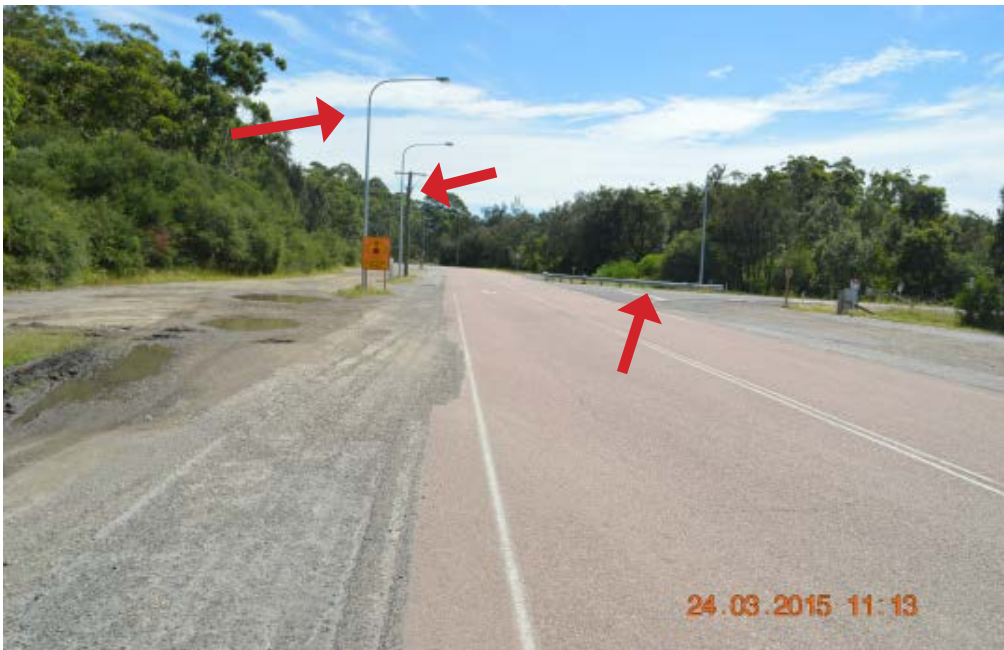
Refer to photo 142.

Showing additional street lights, power pole, and side road.

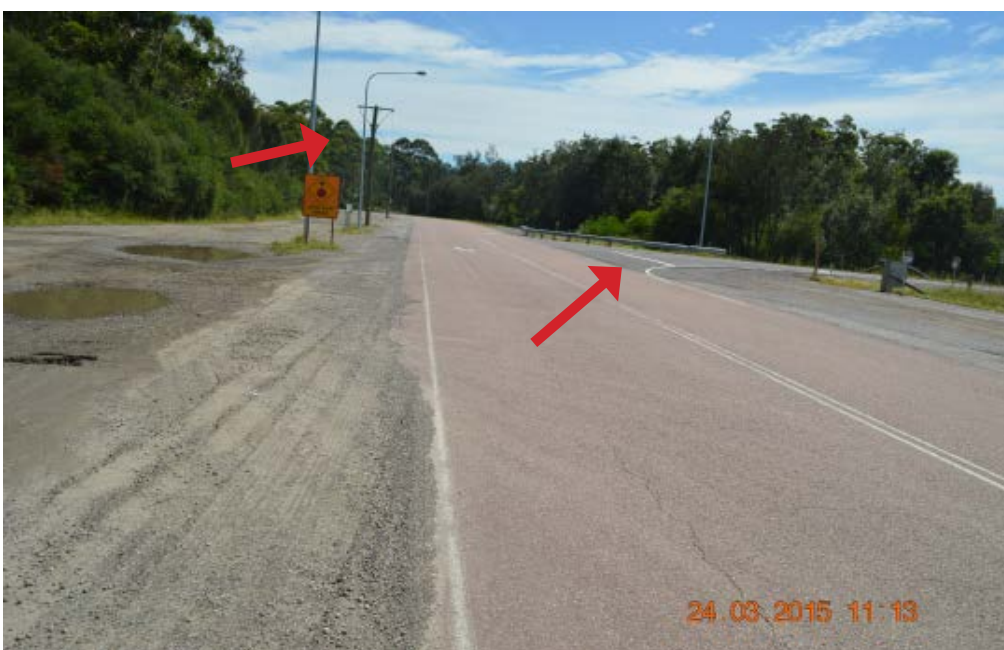
Refer to photo 143.

Showing additional street lights, power pole, and side road..

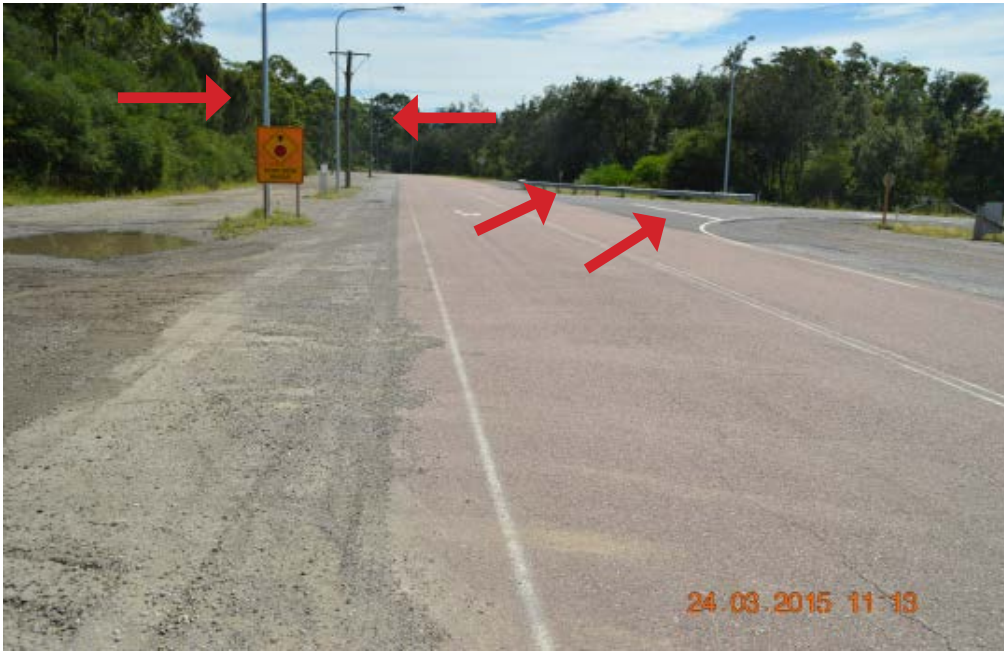
Refer to photo 144.

Showing additional street lights, power pole and side road.

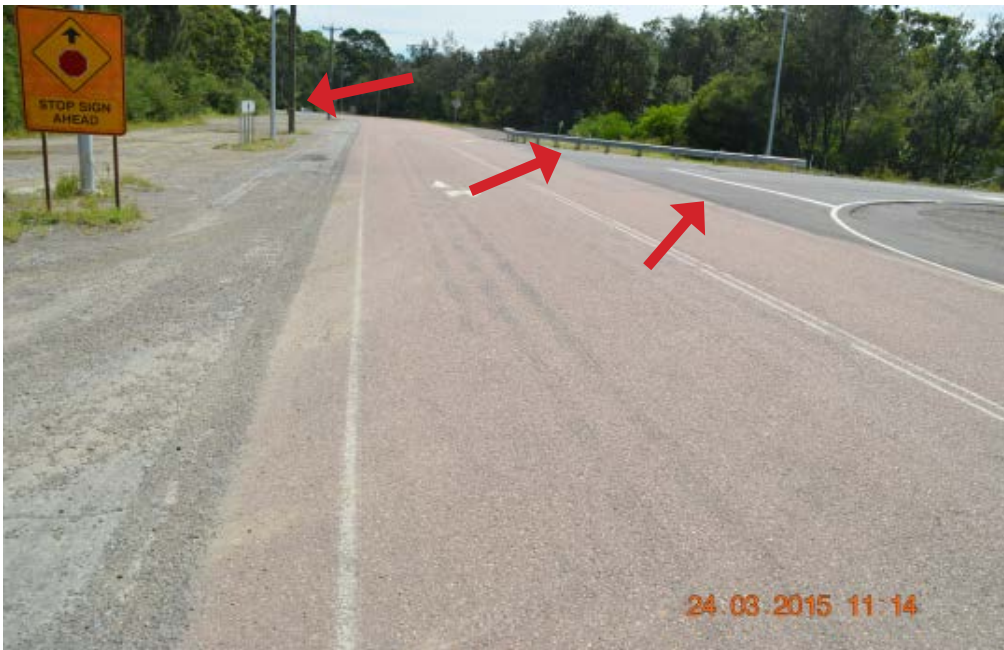
Refer to photo 145.

Showing additional street lights, power pole, barrier and side road.
