### PROPERTY CONDITION SURVEY

Old Punt Road  
TOMAGO NSW

24 March 2015

AD1475

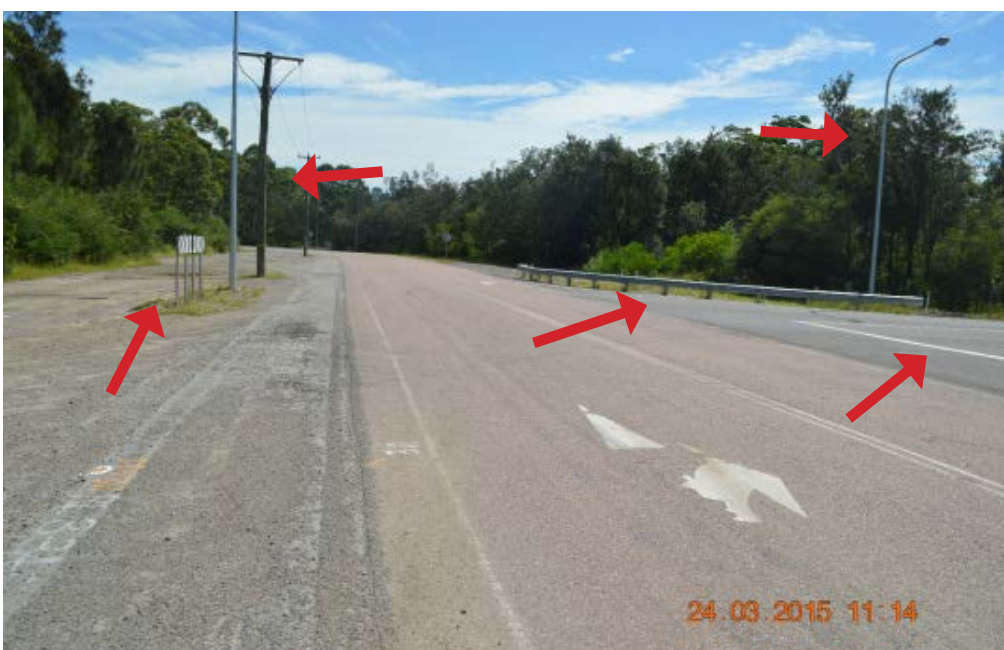
Refer to photo 146.

Showing additional street lights, hazard sign, power pole, barrier and side road.

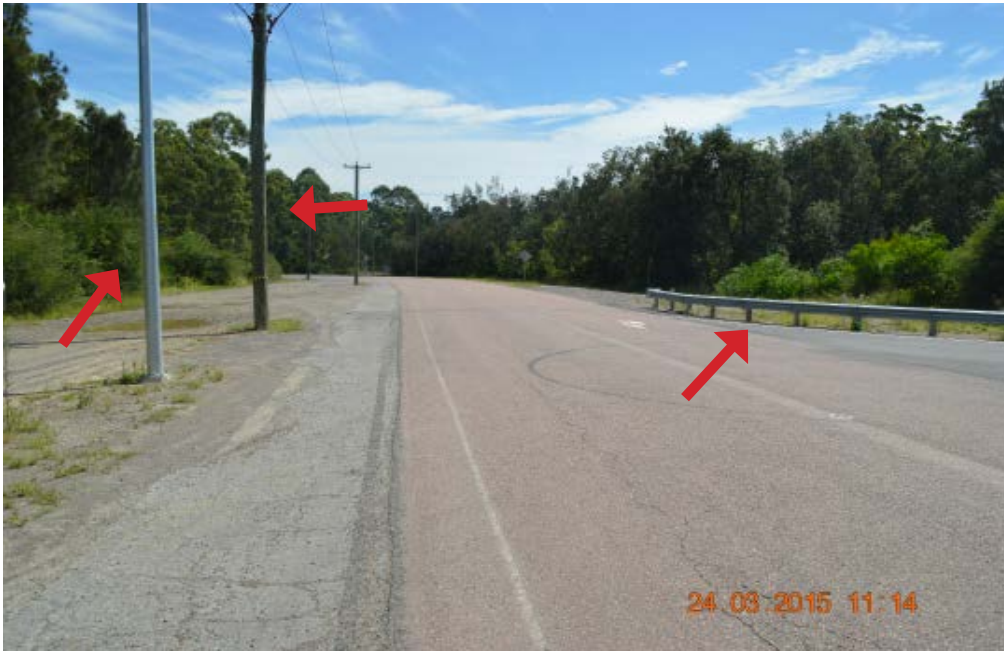
Refer to photo 147.

Showing additional street lights, hazard sign, power pole, barrier and side road.

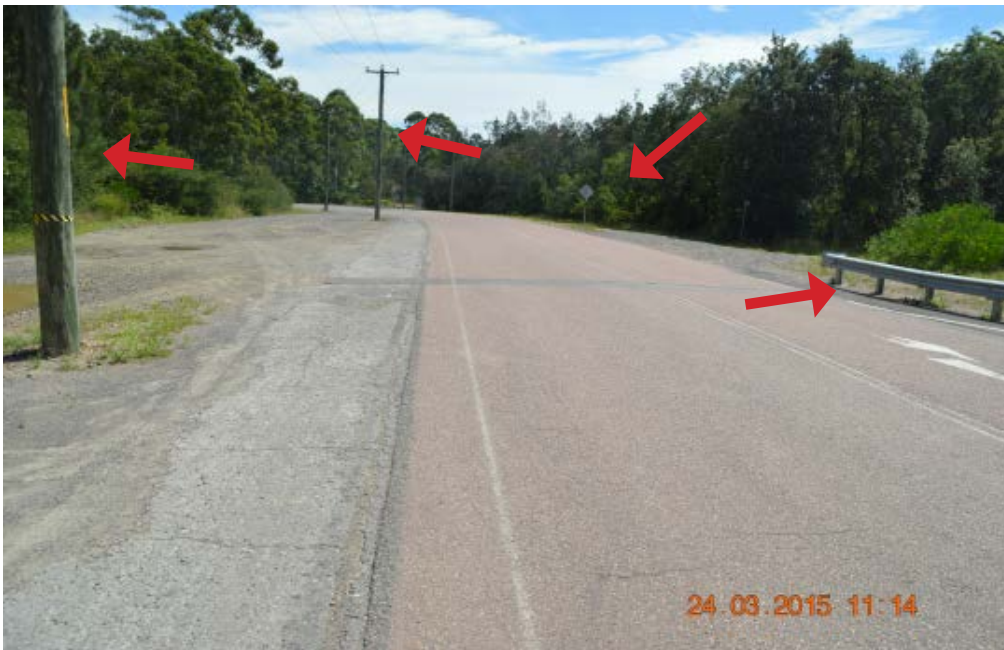
Refer to photo 148.

Showing new street light, power poles and barrier.

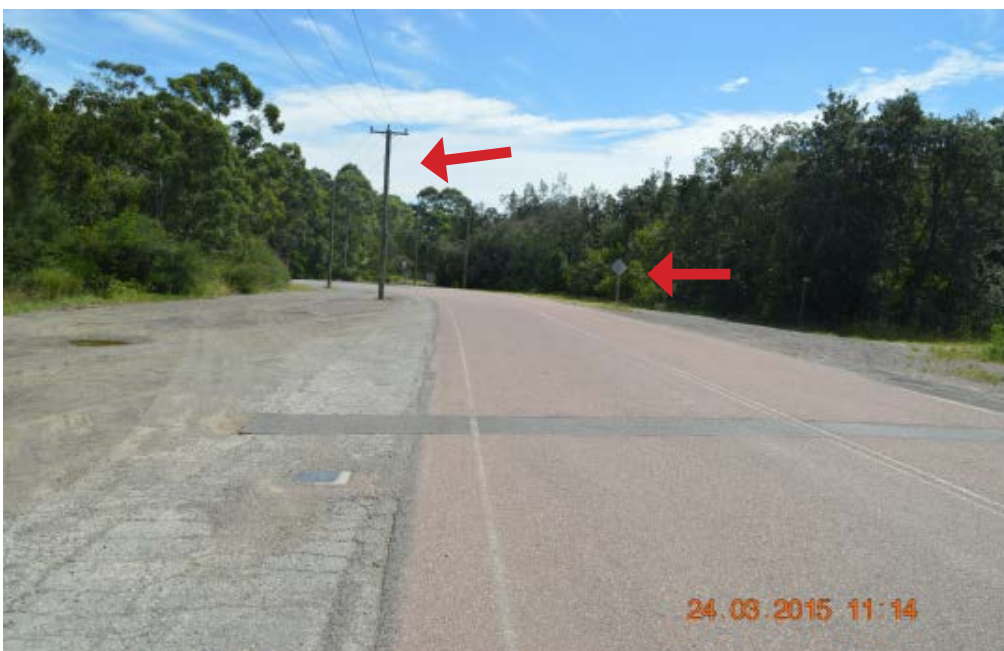
Refer to photo 149.

Showing new power poles, road sign and barrier.

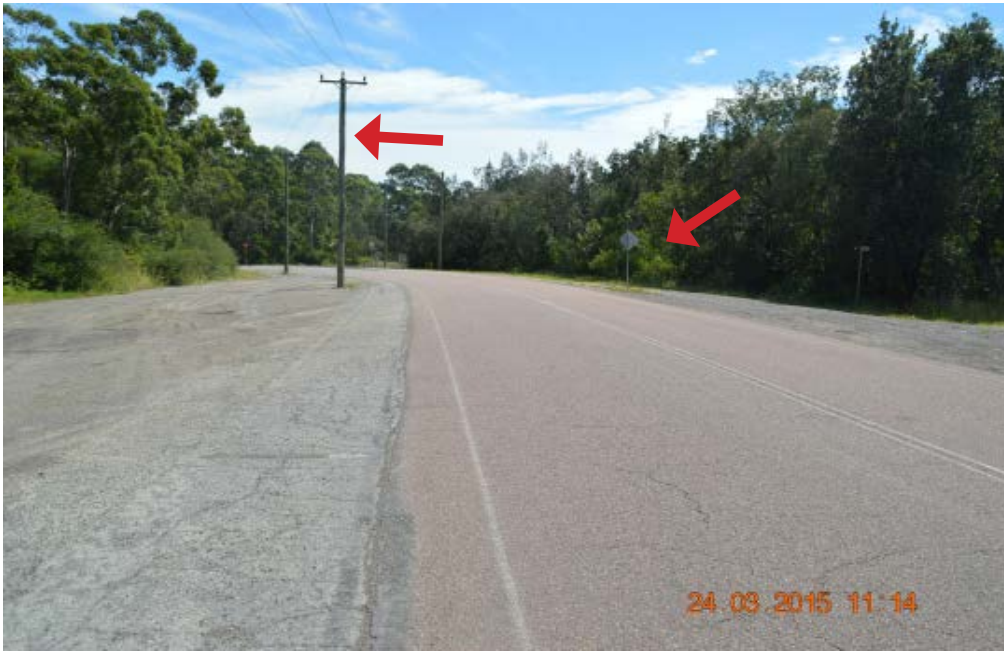
Refer to photo 150.

Showing new power poles and road sign.

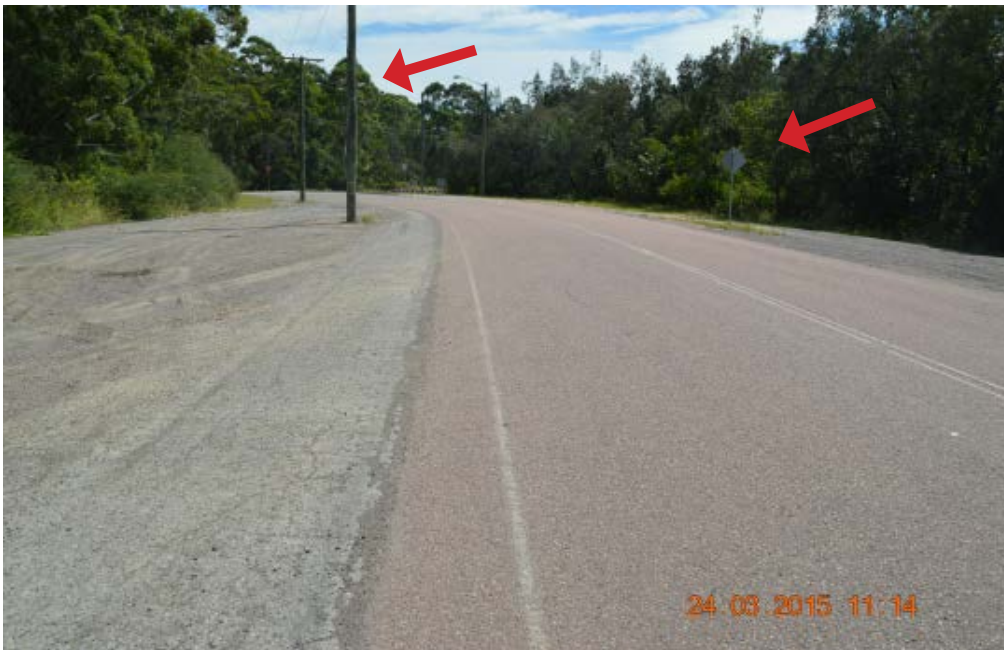
Refer to photo 151.

Showing new power poles and street sign.

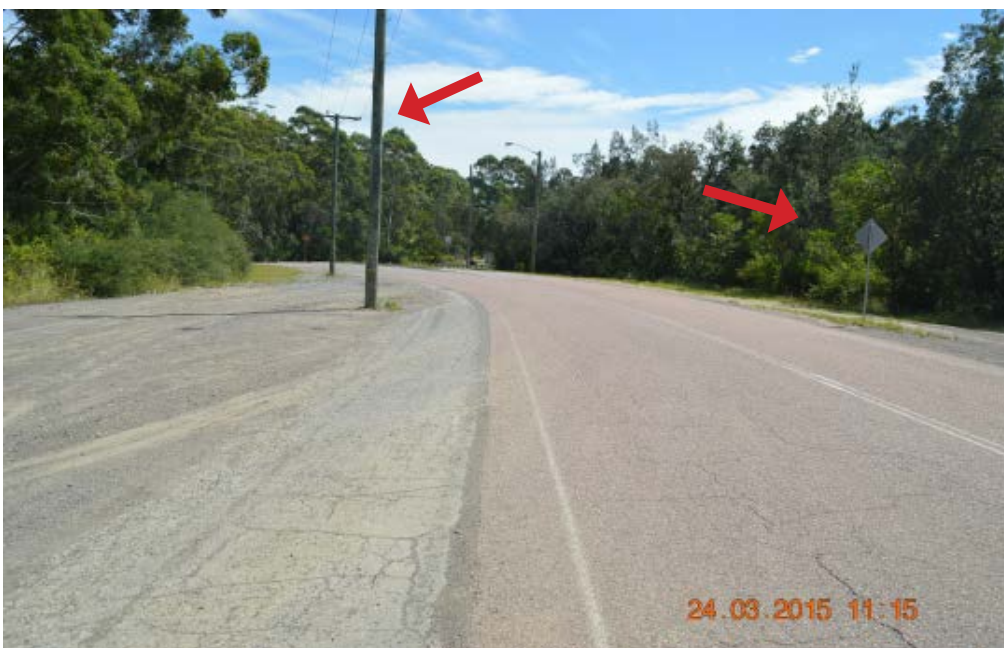
Refer to photo 152.

Showing new power poles and street sign.

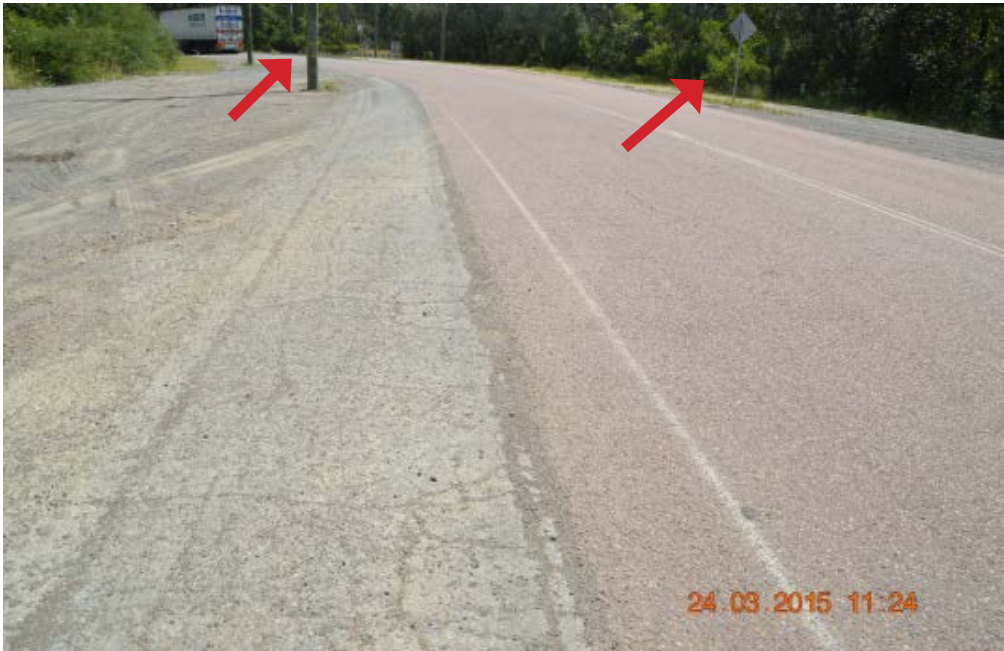
Refer to photo 153.

Showing new power poles and street sign.

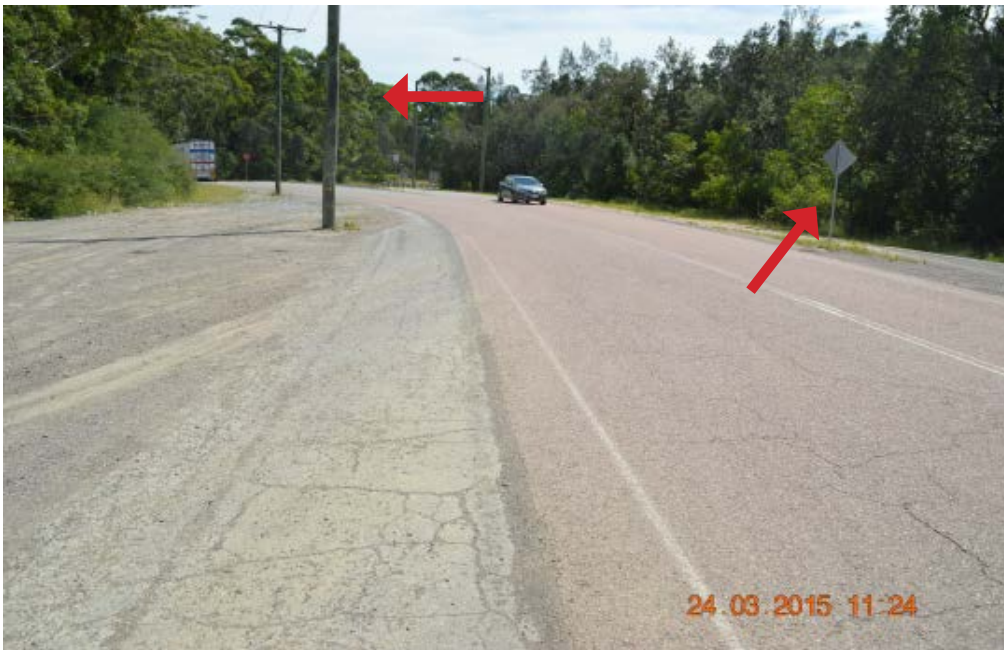
Refer to photo 154.

Showing new power poles and street sign.

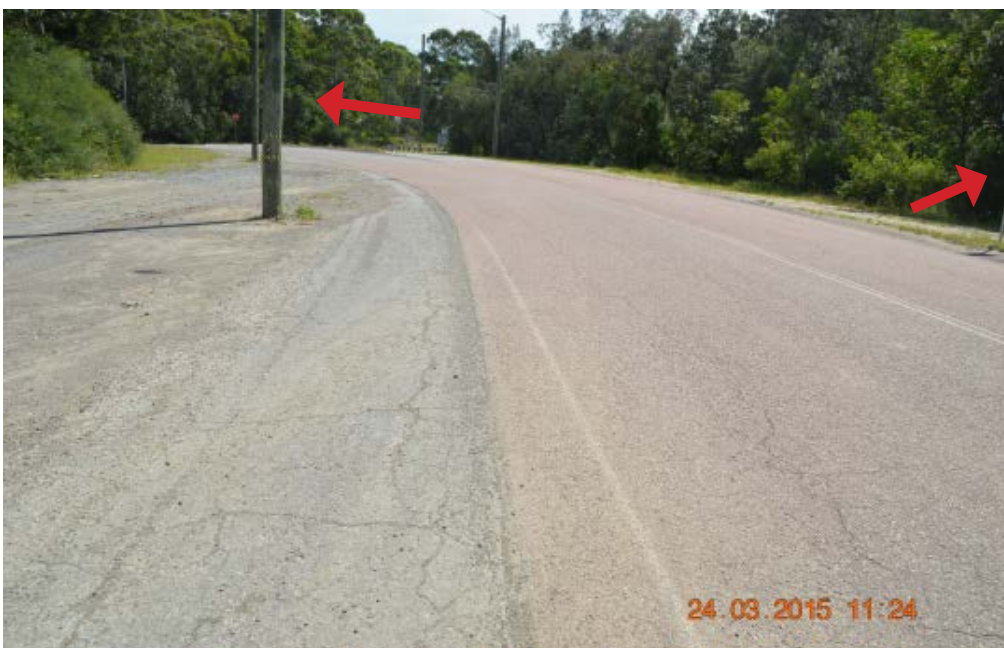
Refer to photo 155.

Showing new power poles and street sign.

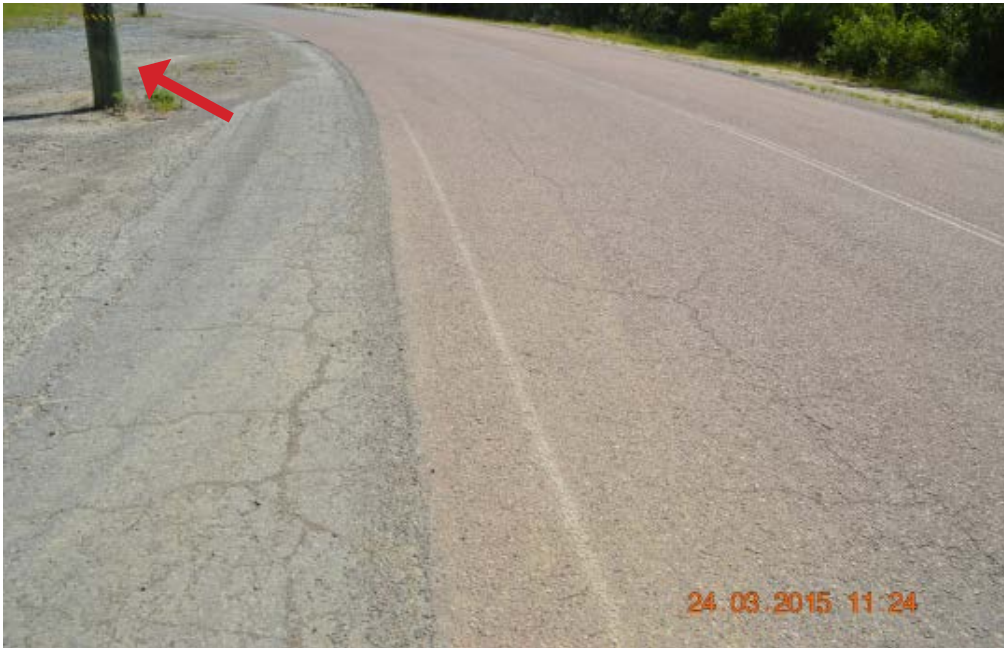
Refer to photo 155.

Showing new power poles and street sign.

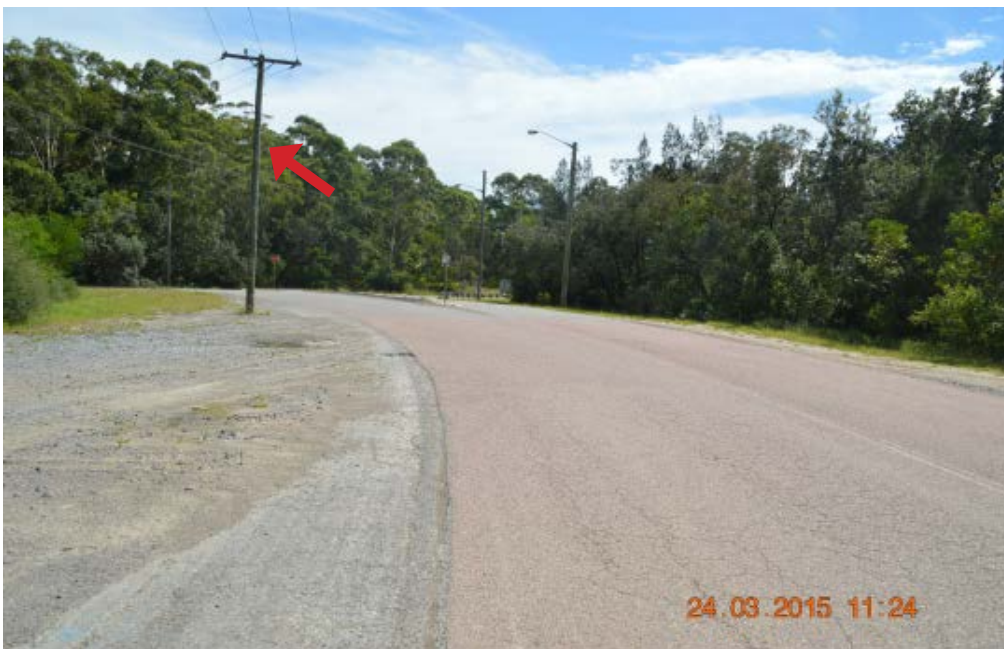
Refer to photo 155.

Showing additional power pole.

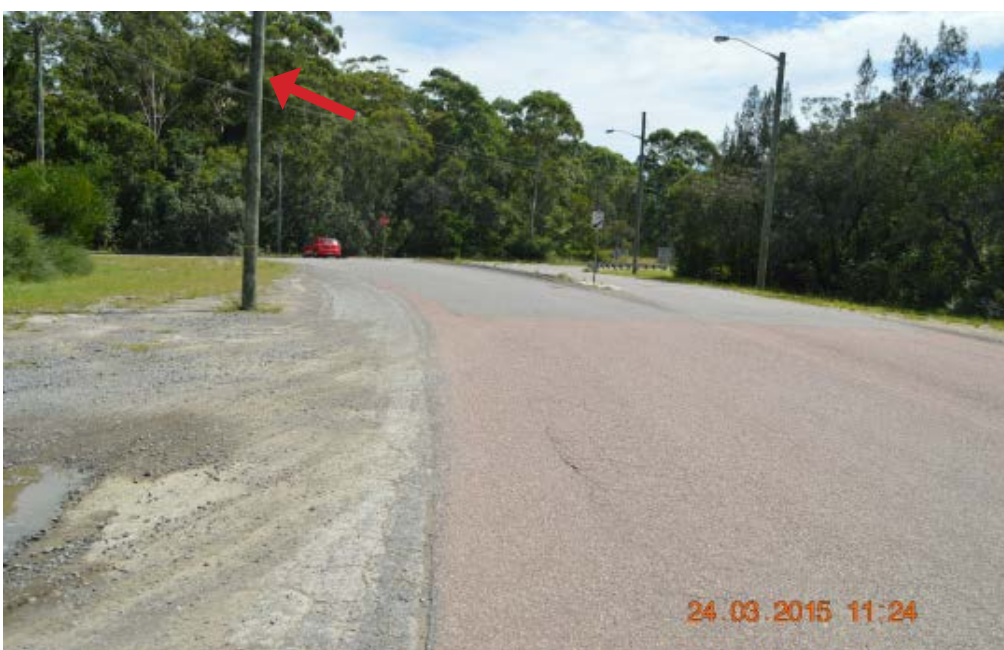
Refer to photo 155.

Showing additional power poles and street sign.

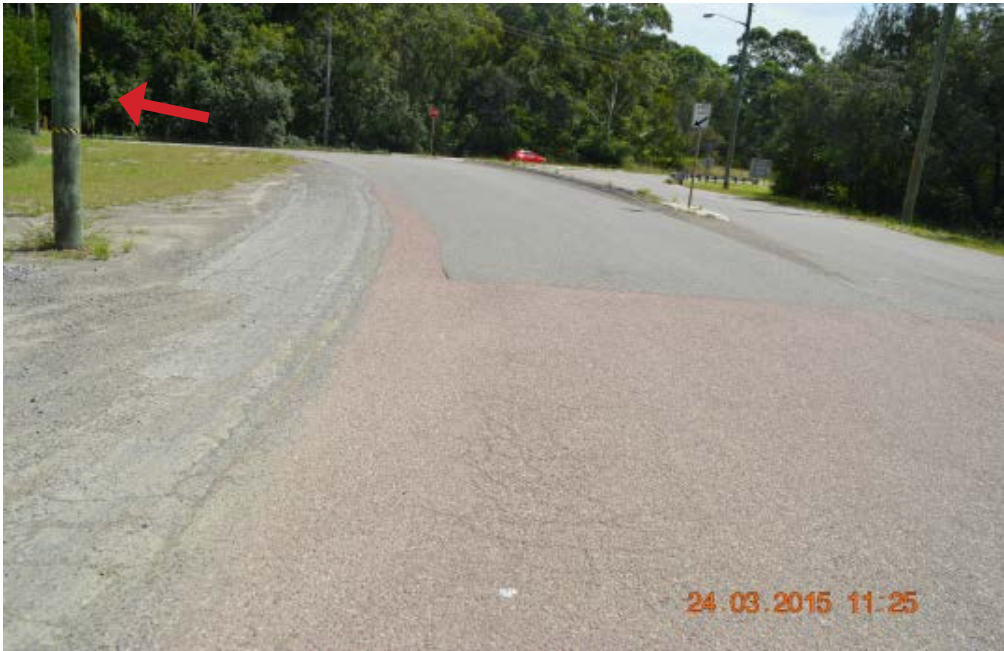
Refer to photo 156.

Showing additional power pole.

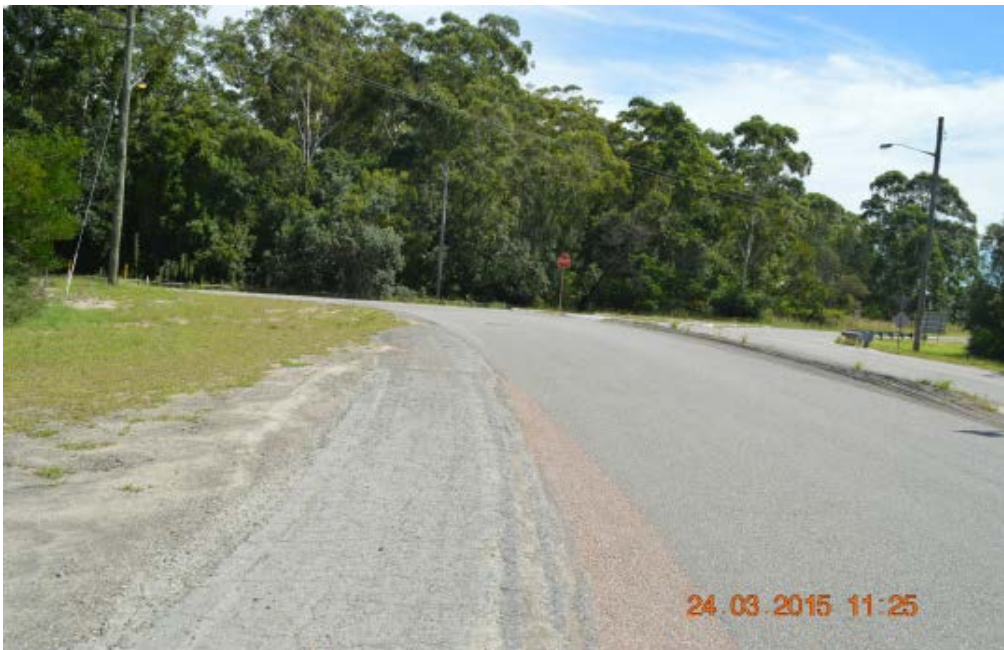
Refer to photo 157.

Showing additional power pole.

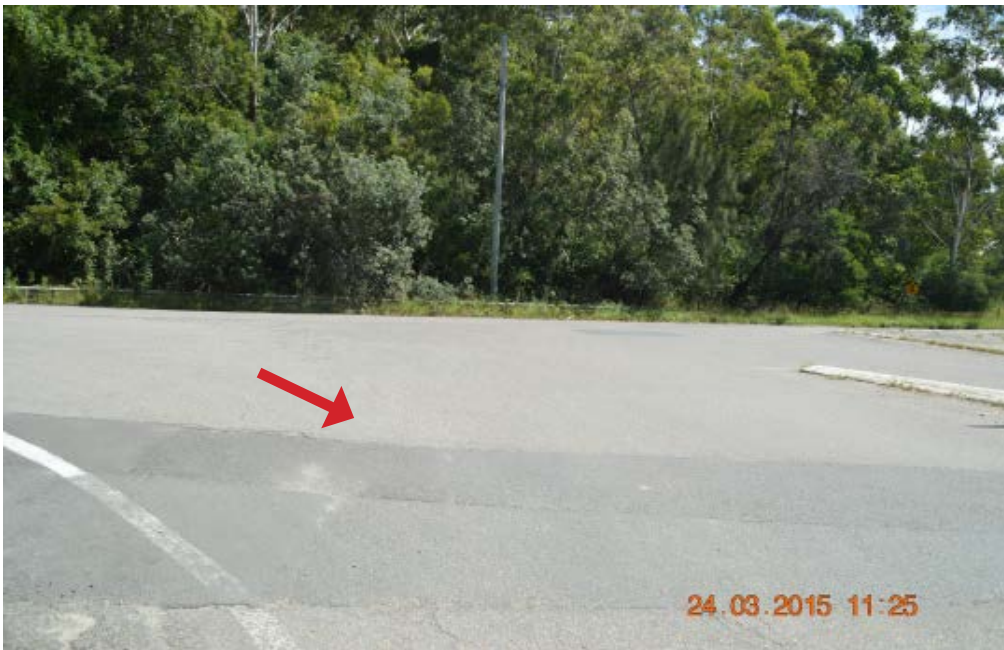
Refer to photo 160.

New patching to the road.

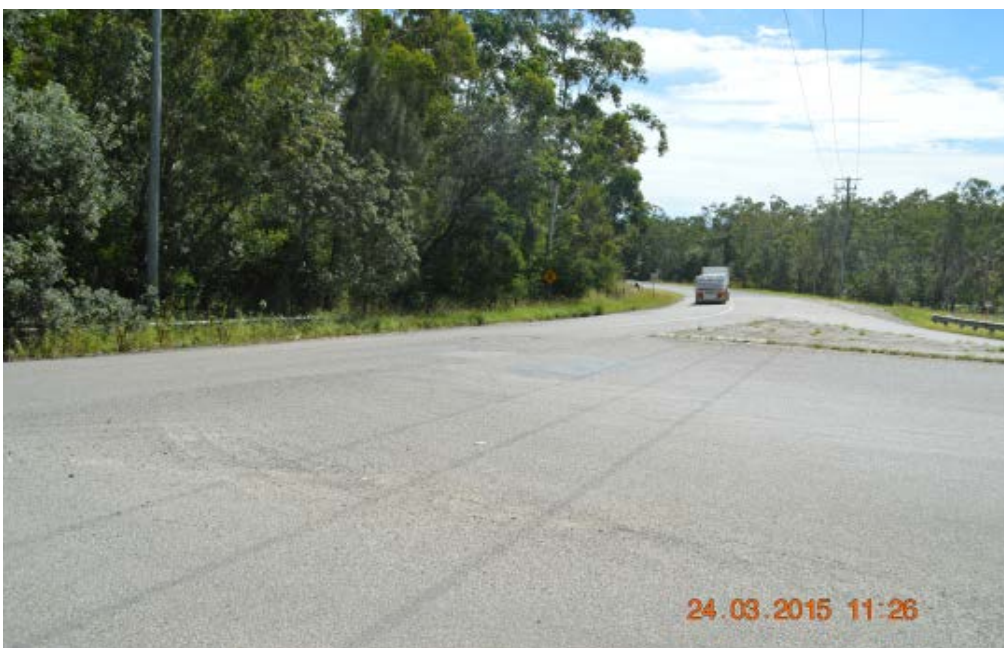
Refer to photo 161.

New patching to the road.

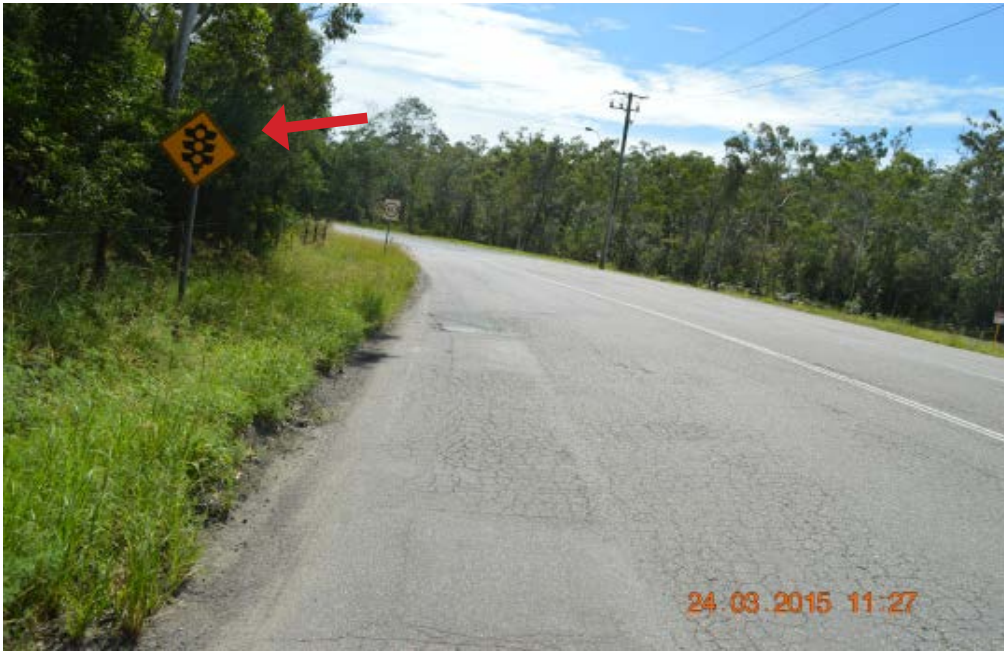
Refer to photo 165.

Showing additional road sign.

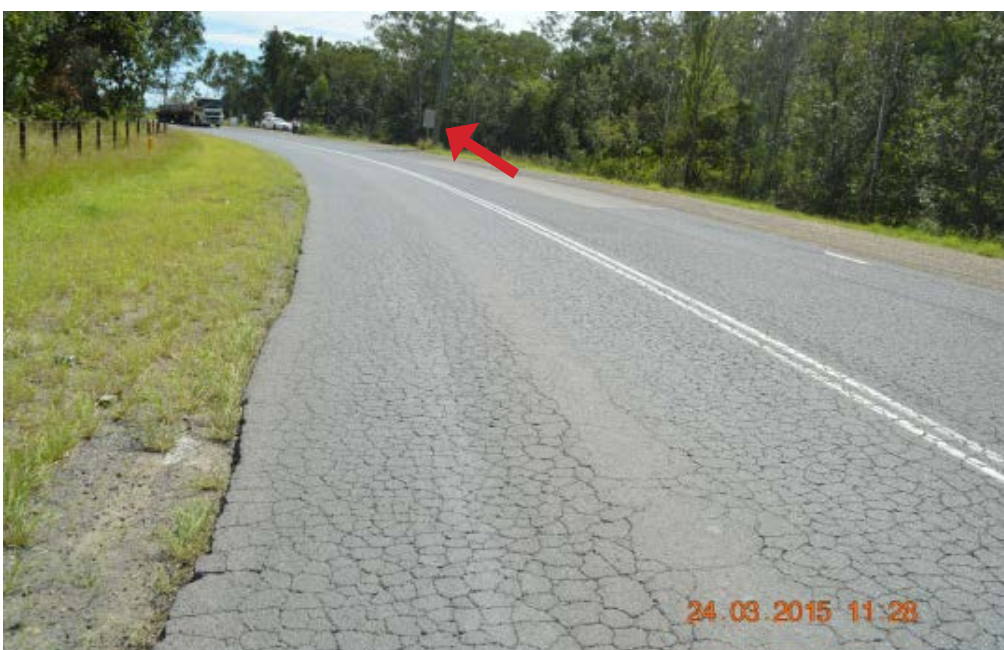
Refer to photo 174.

West side of the roadway at 350 metres to the north of the guard rail near site.

Showing additional road sign.

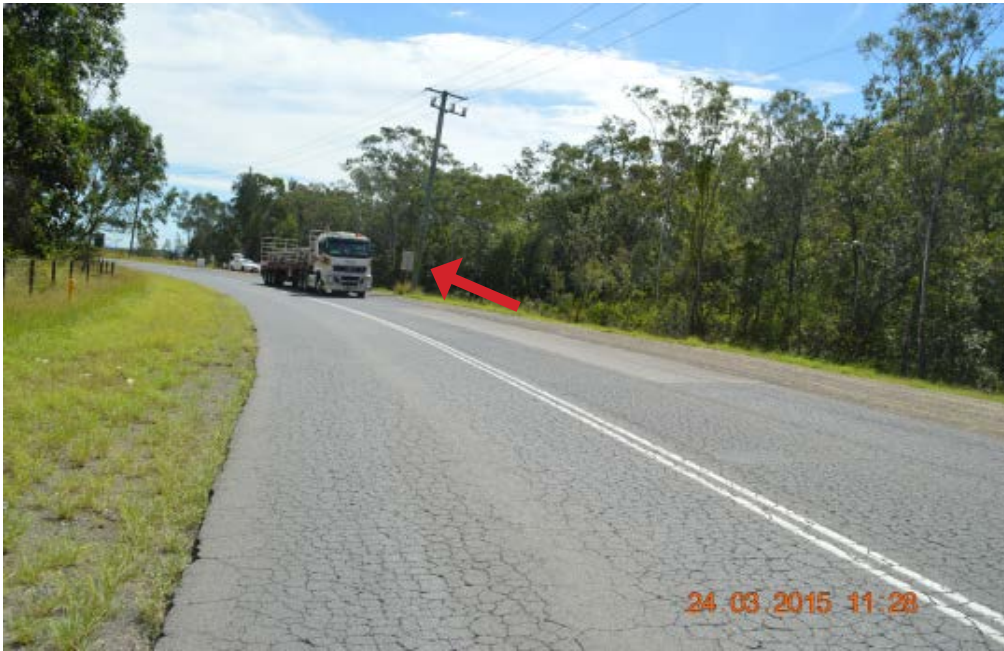
Refer to photo 175.

West side of the roadway at 360 metres to the north of the guard rail near site.

Showing additional road sign.

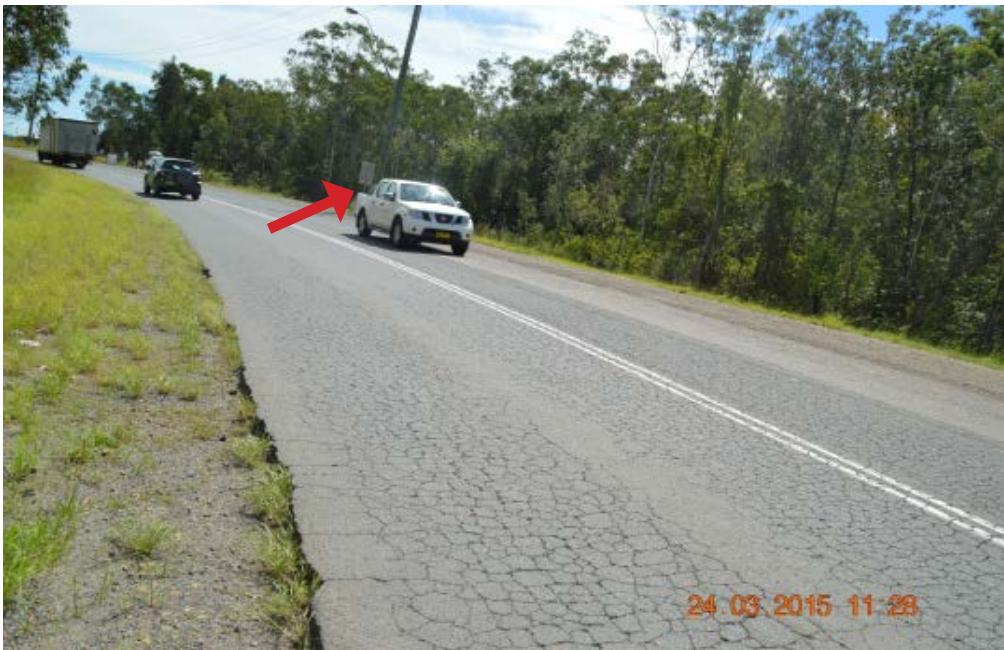
Refer to photo 176.

West side of the roadway at 370 metres to the north of the guard rail near site.

Showing additional road sign.

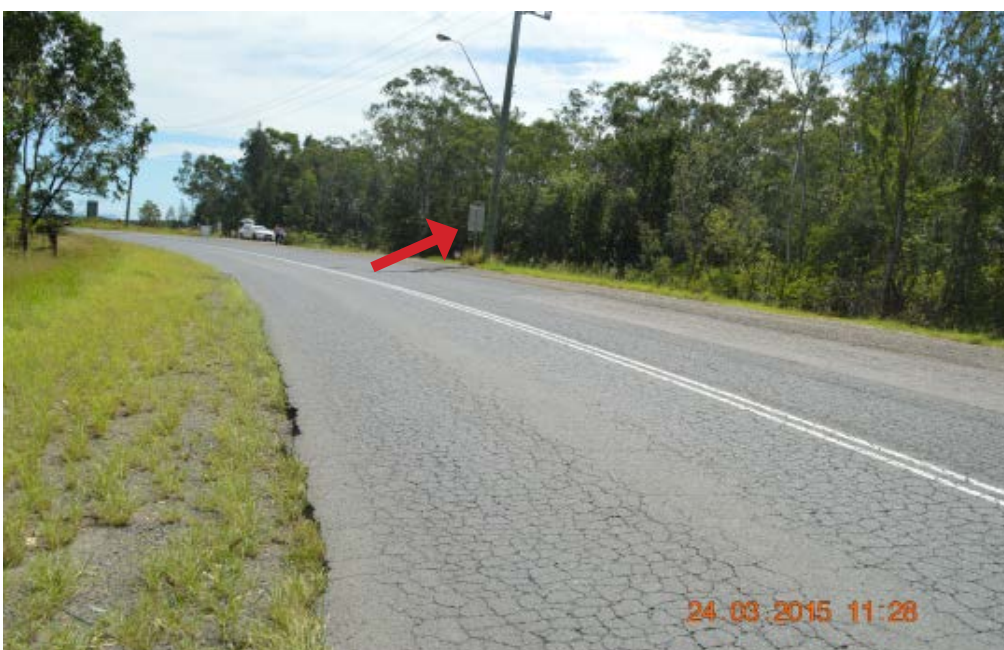
Refer to photo 177.

West side of the roadway at 380 metres to the north of the guard rail near site.

Showing additional road sign.

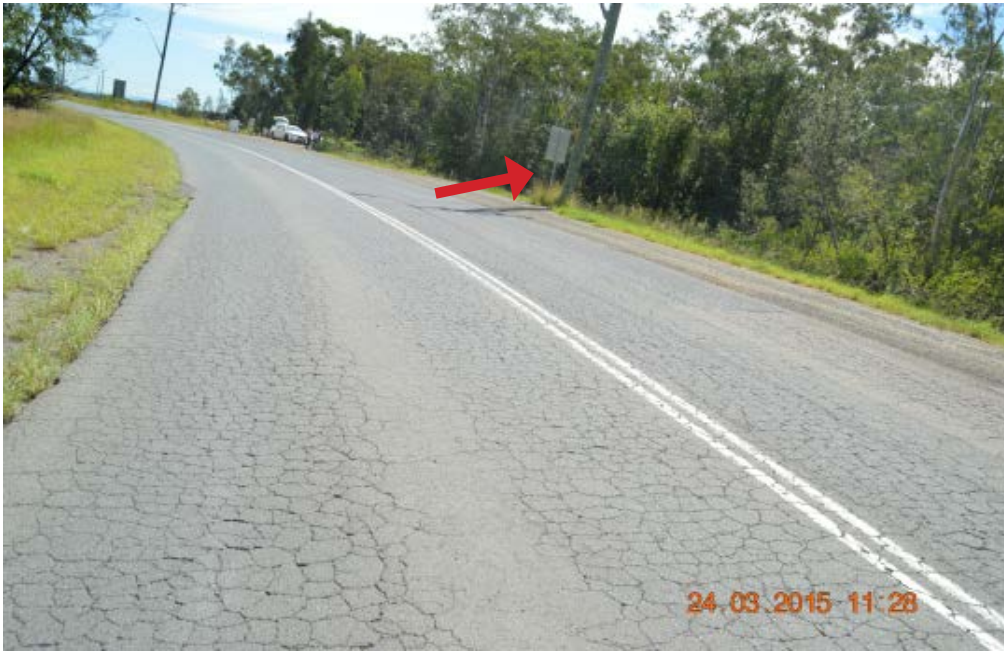
Refer to photo 178.

West side of the roadway at 390 metres to the north of the guard rail near site.

Showing additional road sign.

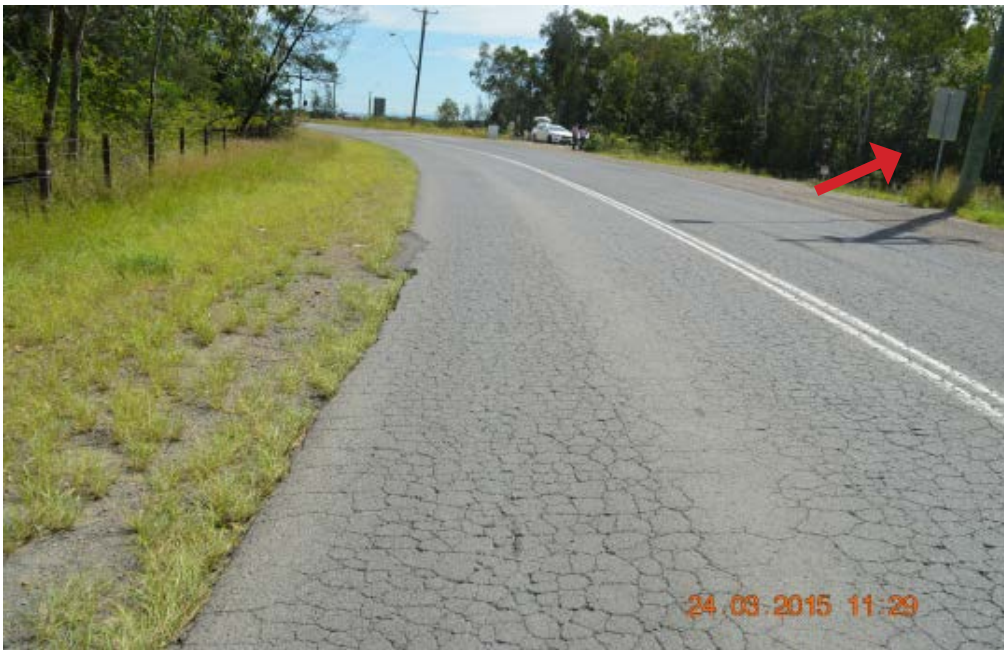
See photo 179.

West side of the roadway at 400 metres to the north of the guard rail near site.

Showing additional road sign.

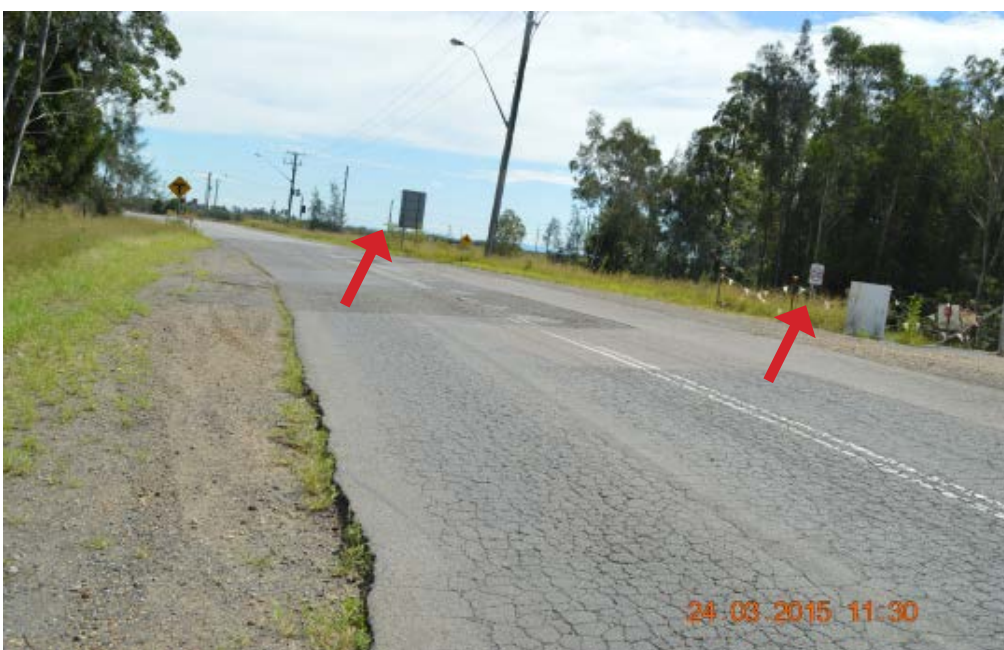
Refer to photo 183.

West side of the roadway at 440 metres to the north of the guard rail near site.

Showing new road signs.

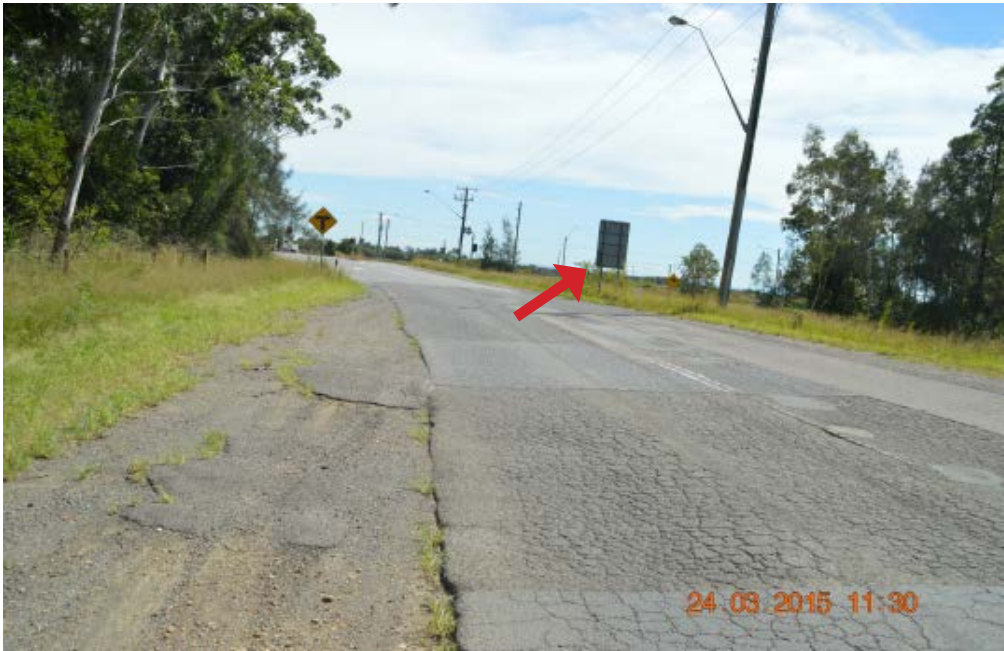
Refer to photo 183.

West side of the roadway at 440 metres to the north of the guard rail near site.

Showing new road sign.

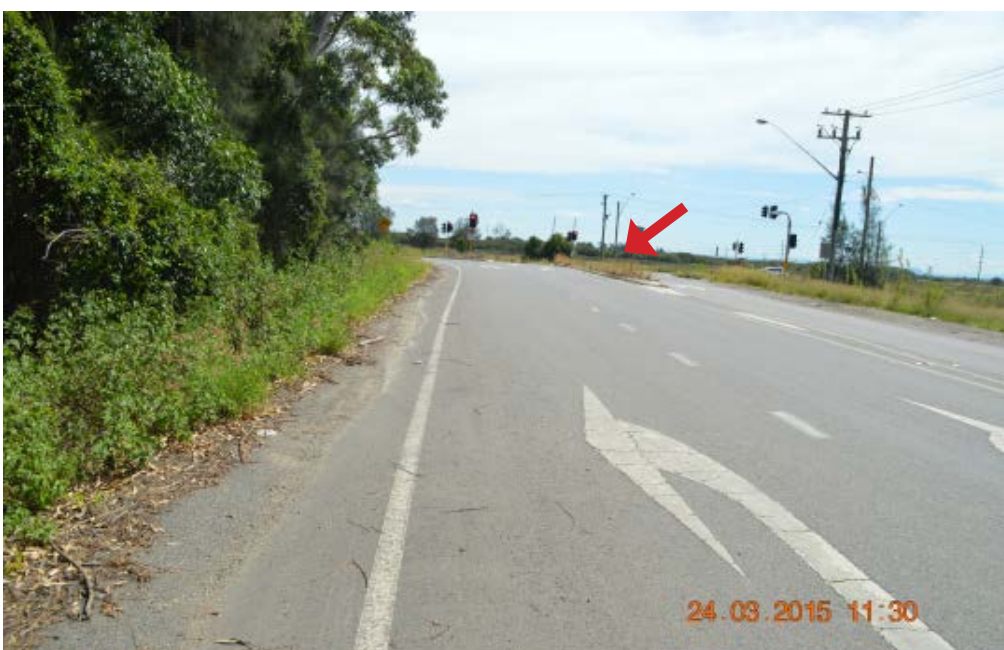
48. Shows removal of street sign. See photo 189.

West side of the roadway at 500 meters to the north of the guard rail near site.

Shows removal of street sign.

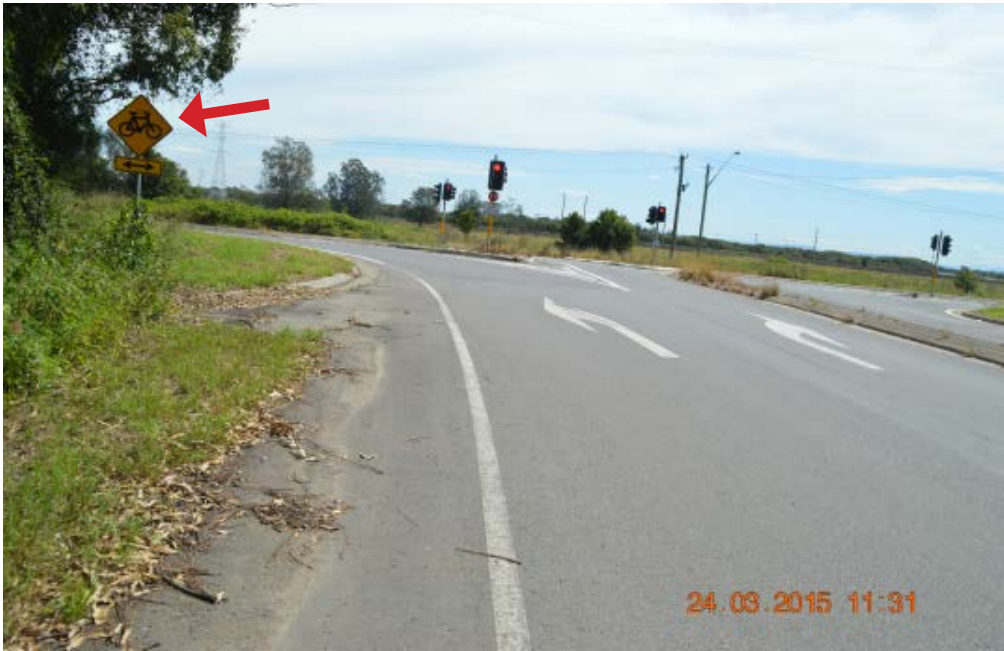
Refer to photo 193.

West side of the roadway at 540 metres to the north of the guard rail near site.

Showing additional road sign

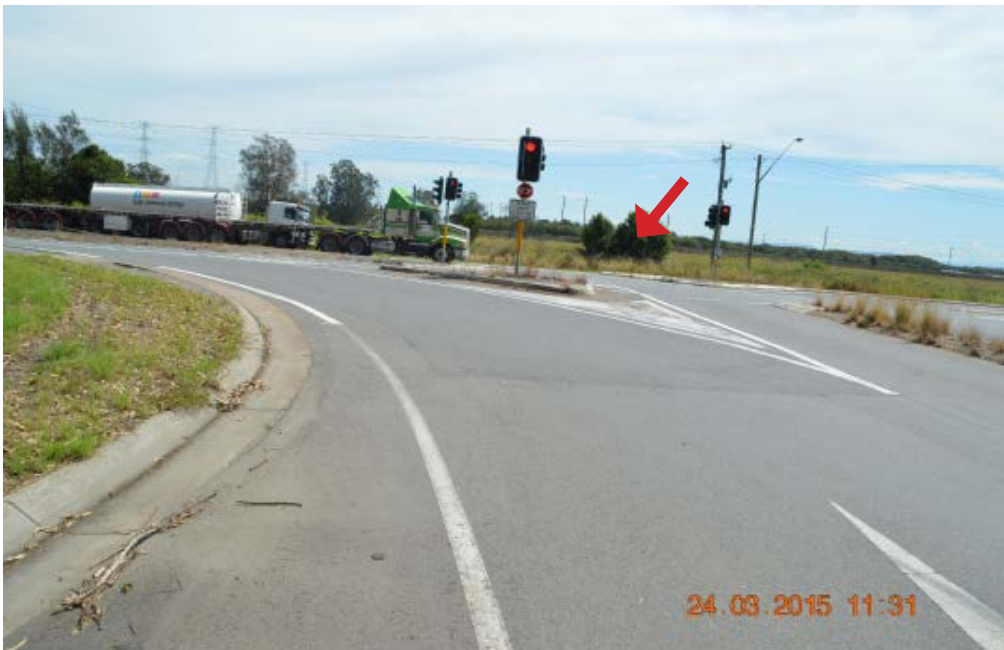
Refer to photo 194.

West side of the roadway at 550 metres to the north of the guard rail near site.

Showing removal of hazard sign.
